NATIONAL HISTORIC SITES SERVICE

MANUSCRIPT REPORT NUMBER 46

EXCAVATIONS AT CASTLE HILL

September 1971

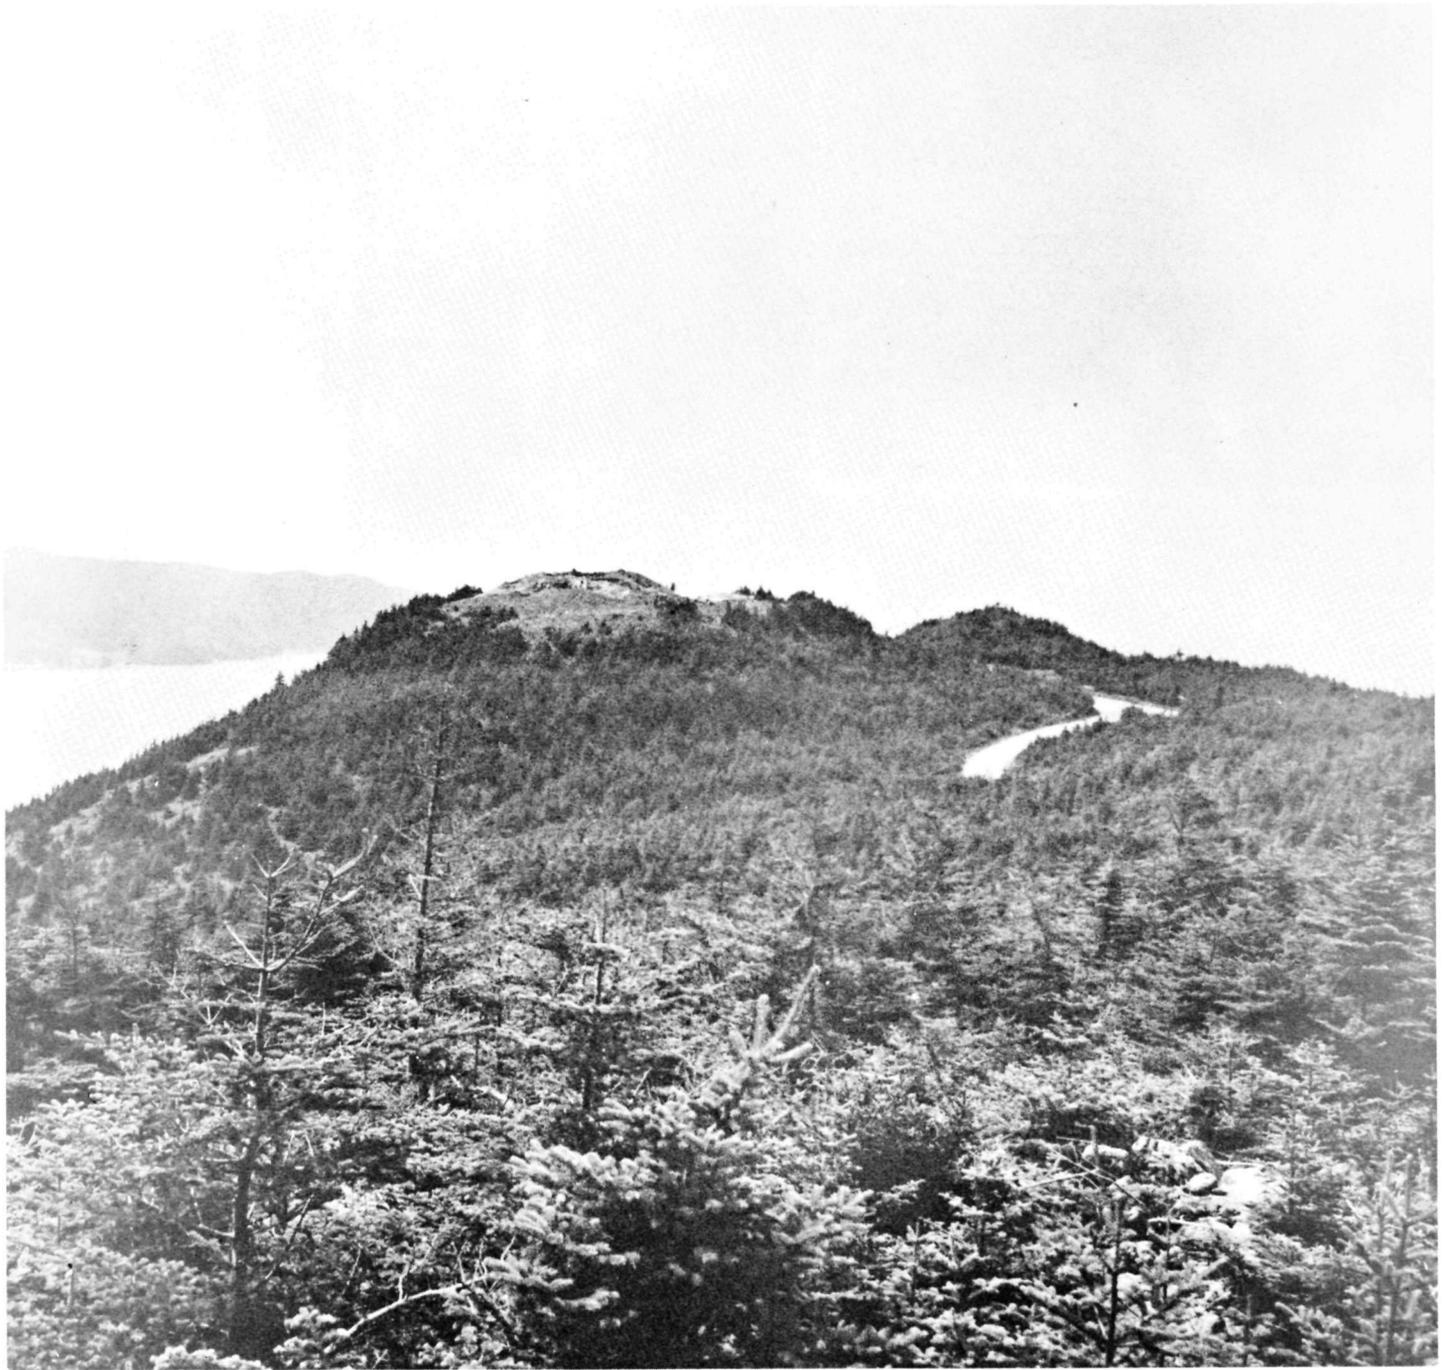
Figure 4. General view of Castle Hill looking west from the Gaillardin.

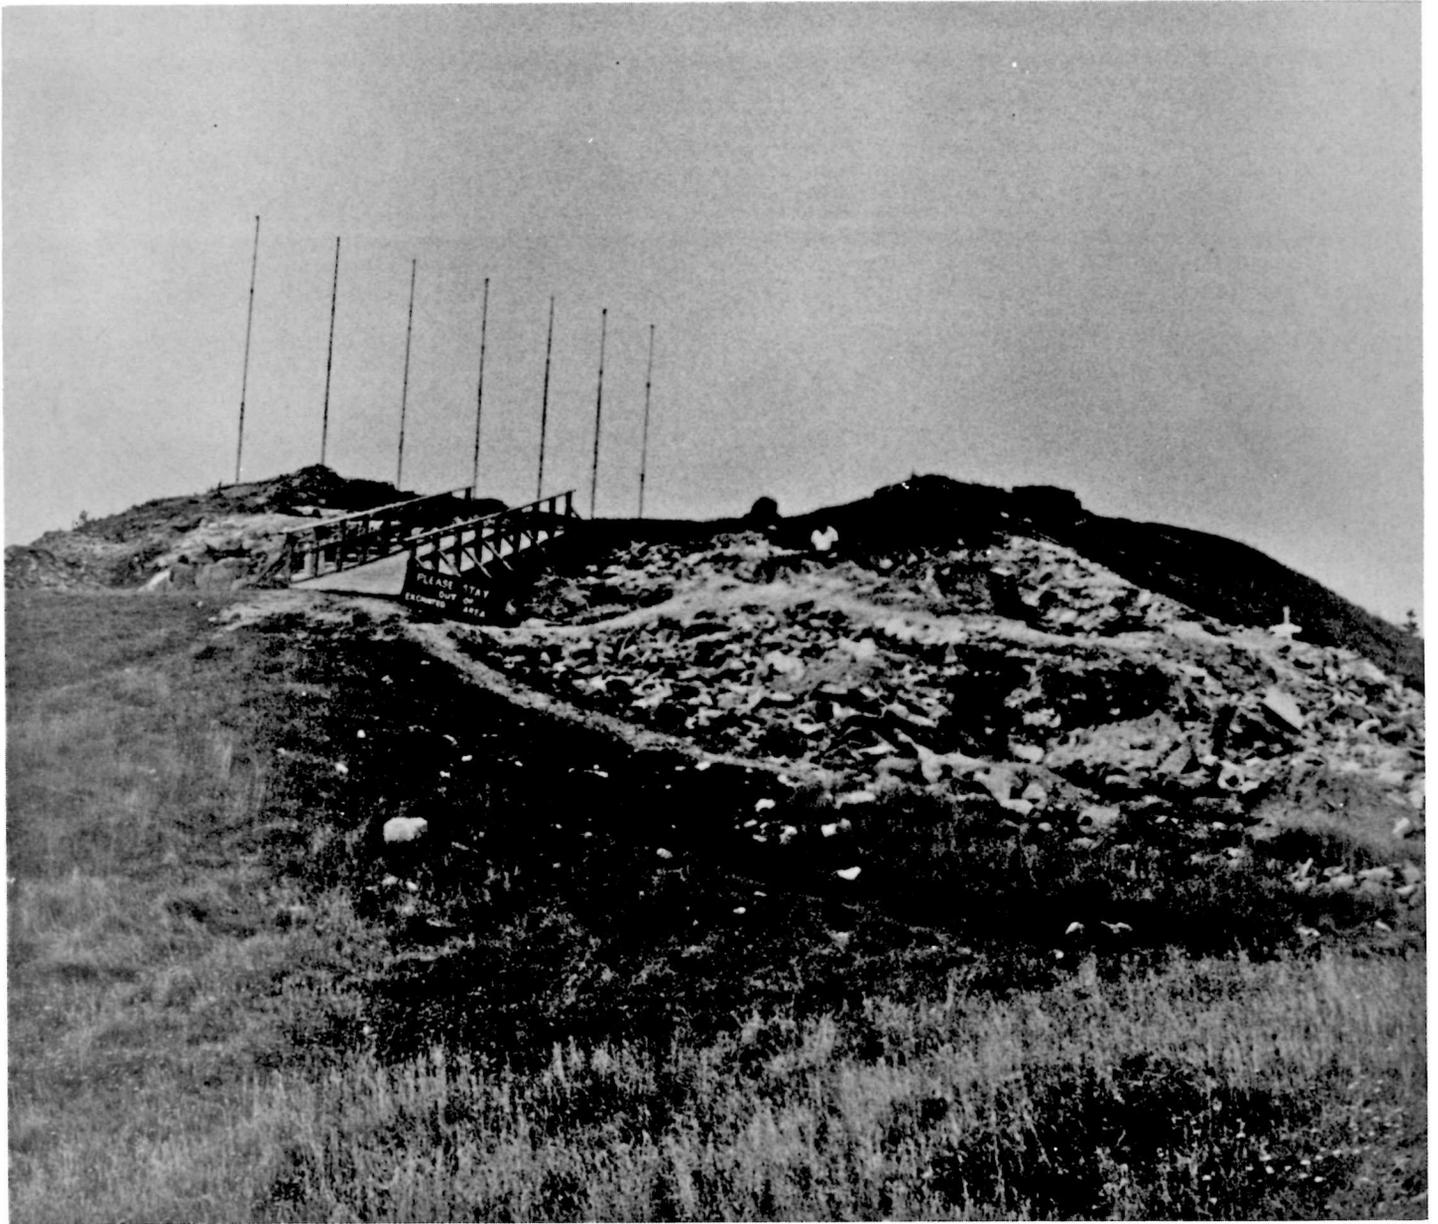
Figure 5. View of the east side of the fort looking toward the southwest. Glacis and modern footbridge are on the left and the northeast bastion during excavation is on the right.

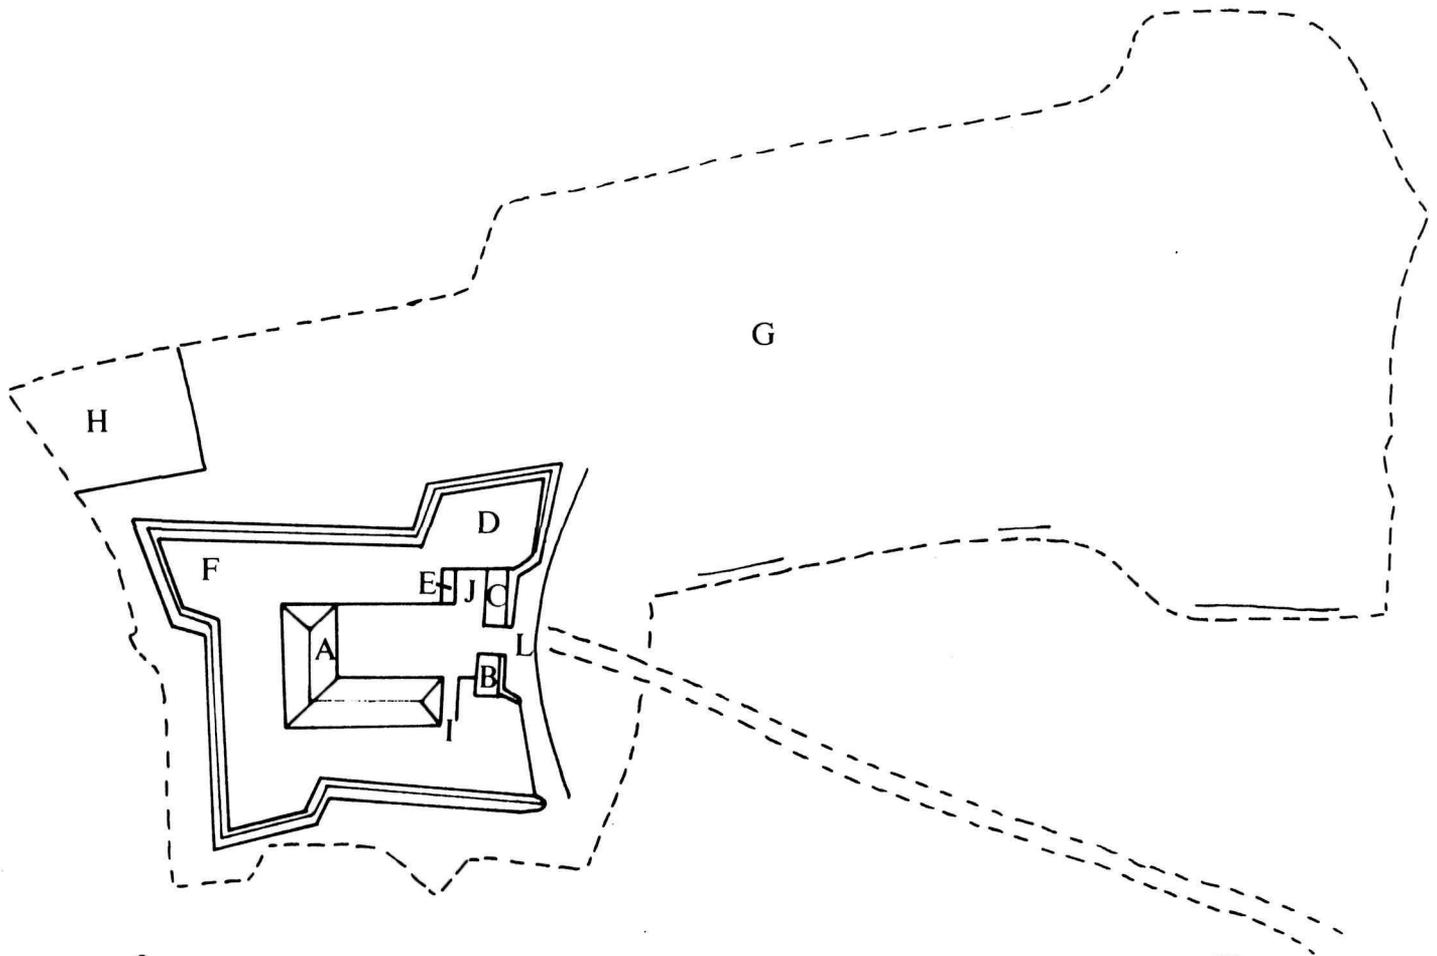
Figure 8. Plan of Fort Royal enlarged from the French plan of 1709. Features shown: L-shaped barracks (a), guardroom (b), hangar (c), magazine (d), stairs (e), gun platform (f), dry-wall around the site (g), battery for two mortars, (h), ramp up to gun platform (i), ramp down to magazine (j), path down to Placentia (k), and unfinished ditch in front of the redoubt (l). Scale in toises. Plan du Fort de Plaisance et des environs. H1/140-Plaisance-1709, Map Division, Public Archives of Canada.

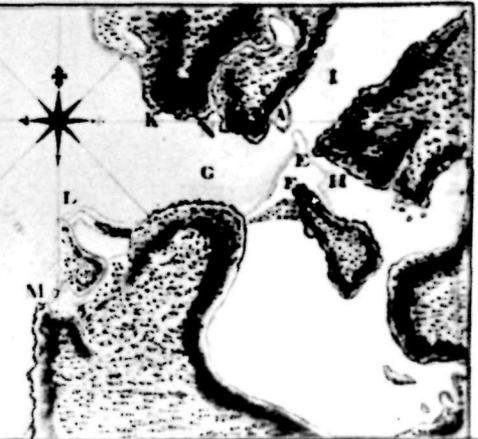
**CARTE PARTICULIERE
 DES ENVIRONS DE
 PLAISANCE**

Figure 9. French plan of 1713. Plan du Fort de Plaisance. C140, 1713 plan-H3/140, Map Division, Public Archives of Canada.

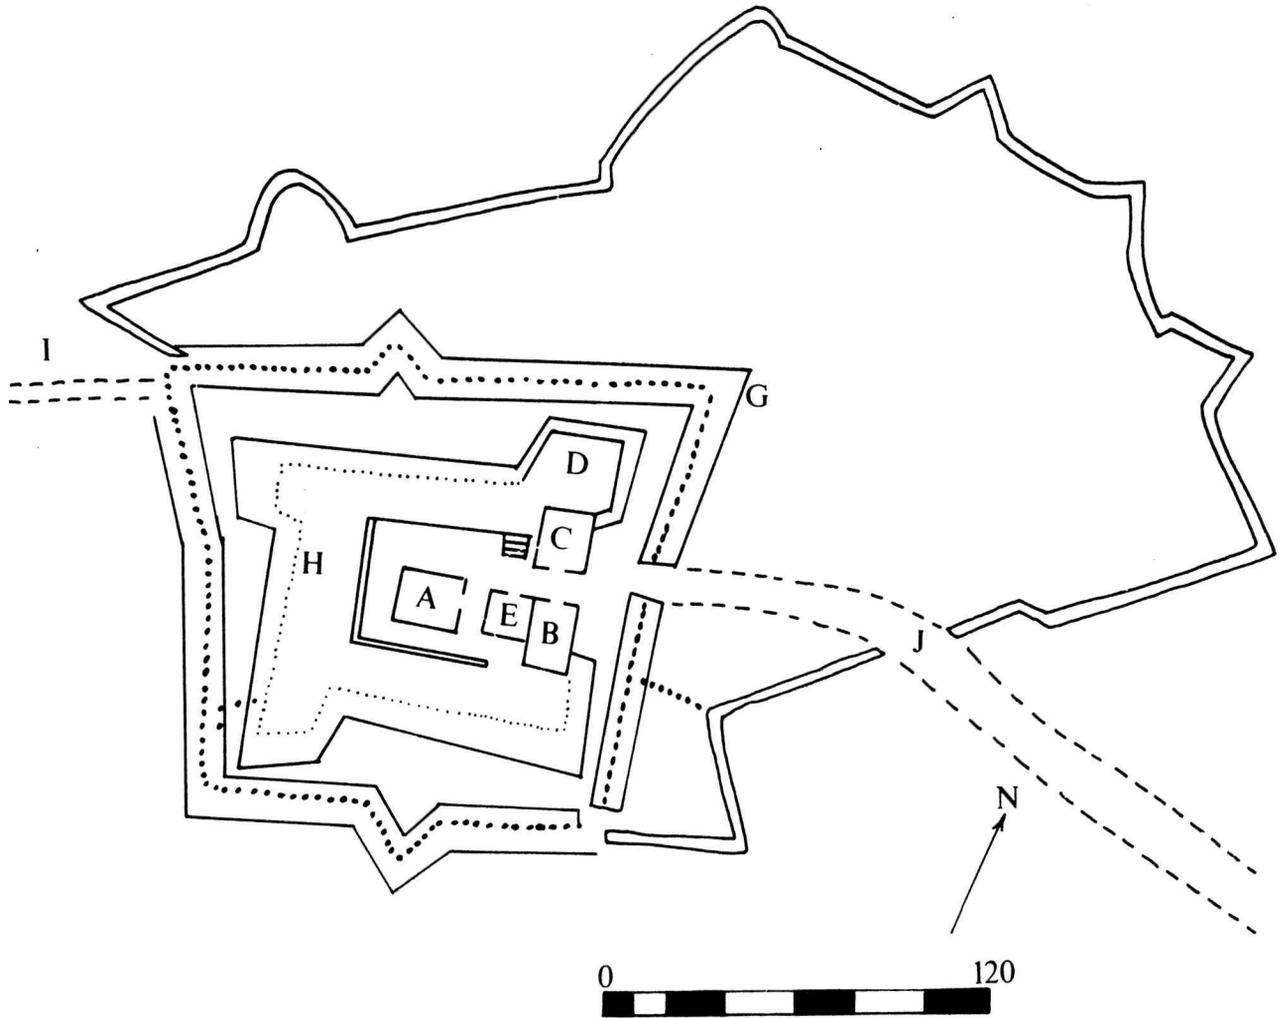
Figure 12. Plan of Castle Graves enlarged from the English plan of 1762. Features shown: blockhouse (a), officers' guardroom (b), main guardroom (c), magazine (d), storehouse (e), line of stone dry-wall (f), palisade (g), picket line replacing parapet (h), path to nearby gun positions (i), path down to Placentia (j). Scale in feet. A Plan of the Fort on Castle Hill. Public Archives of Canada.

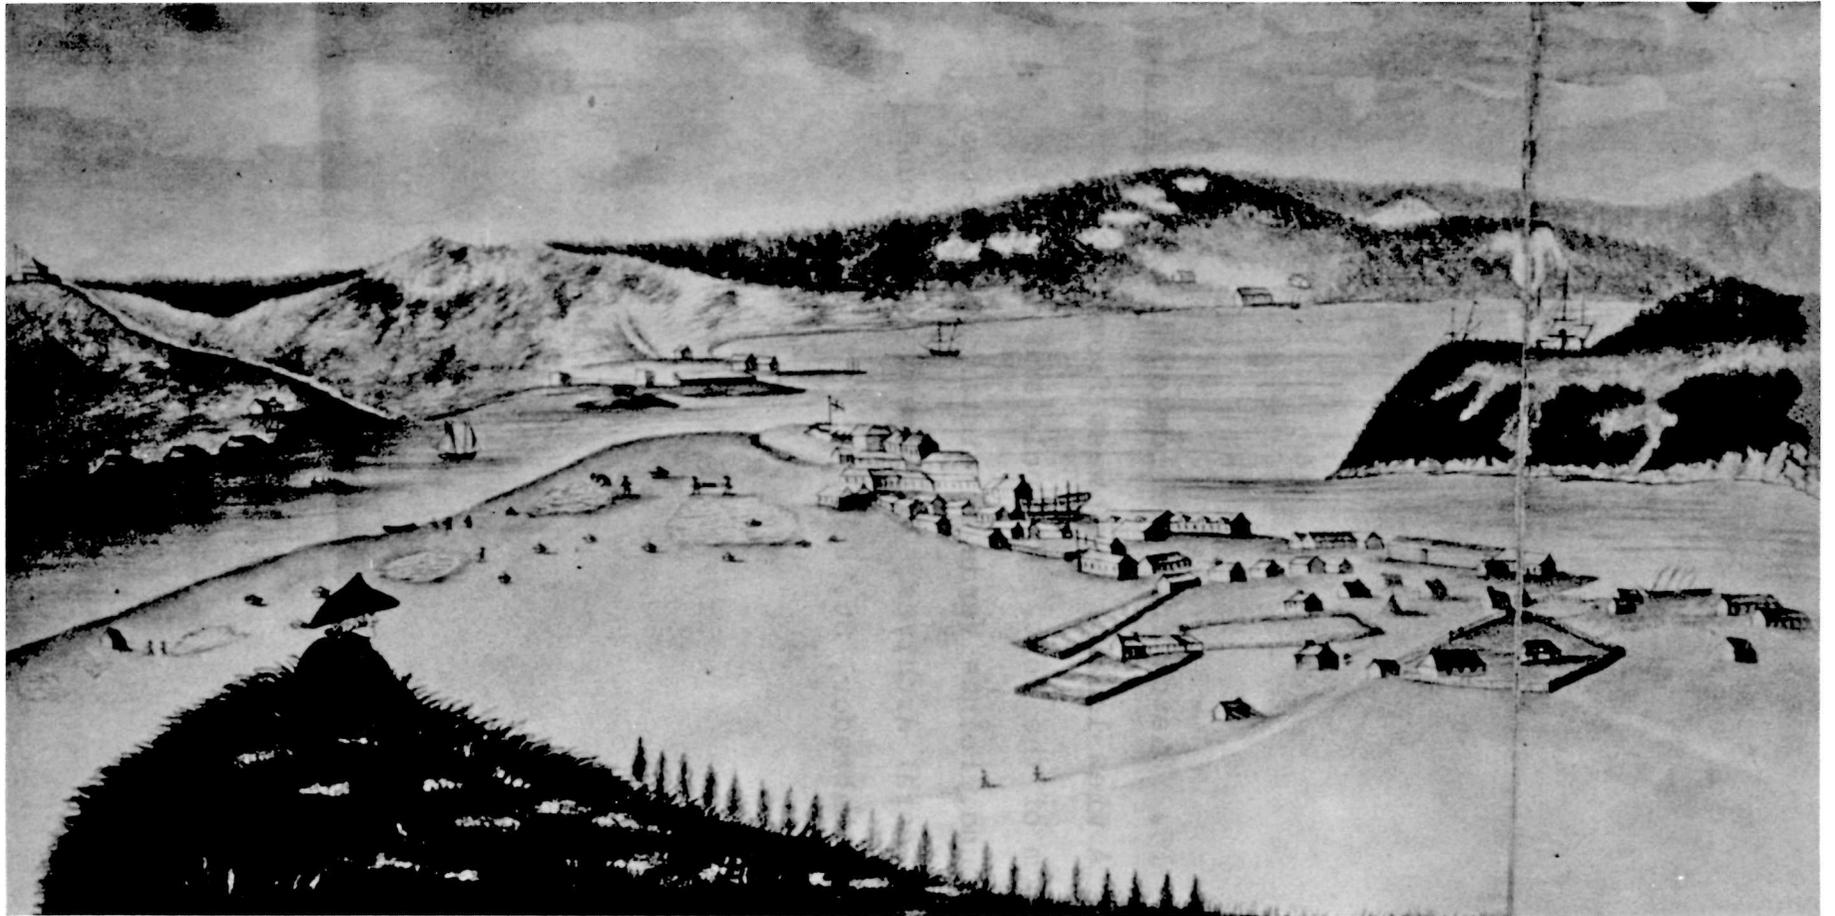
Figure 14. Sketch from the log of H.M.S. Pegasus, 1786. A view of Placentia harbour looking north-east from Quarry Hill. Castle Hill with its blockhouse is at the extreme left. Courtesy of Provincial Archives, Government of Newfoundland and Labrador, St. John's.

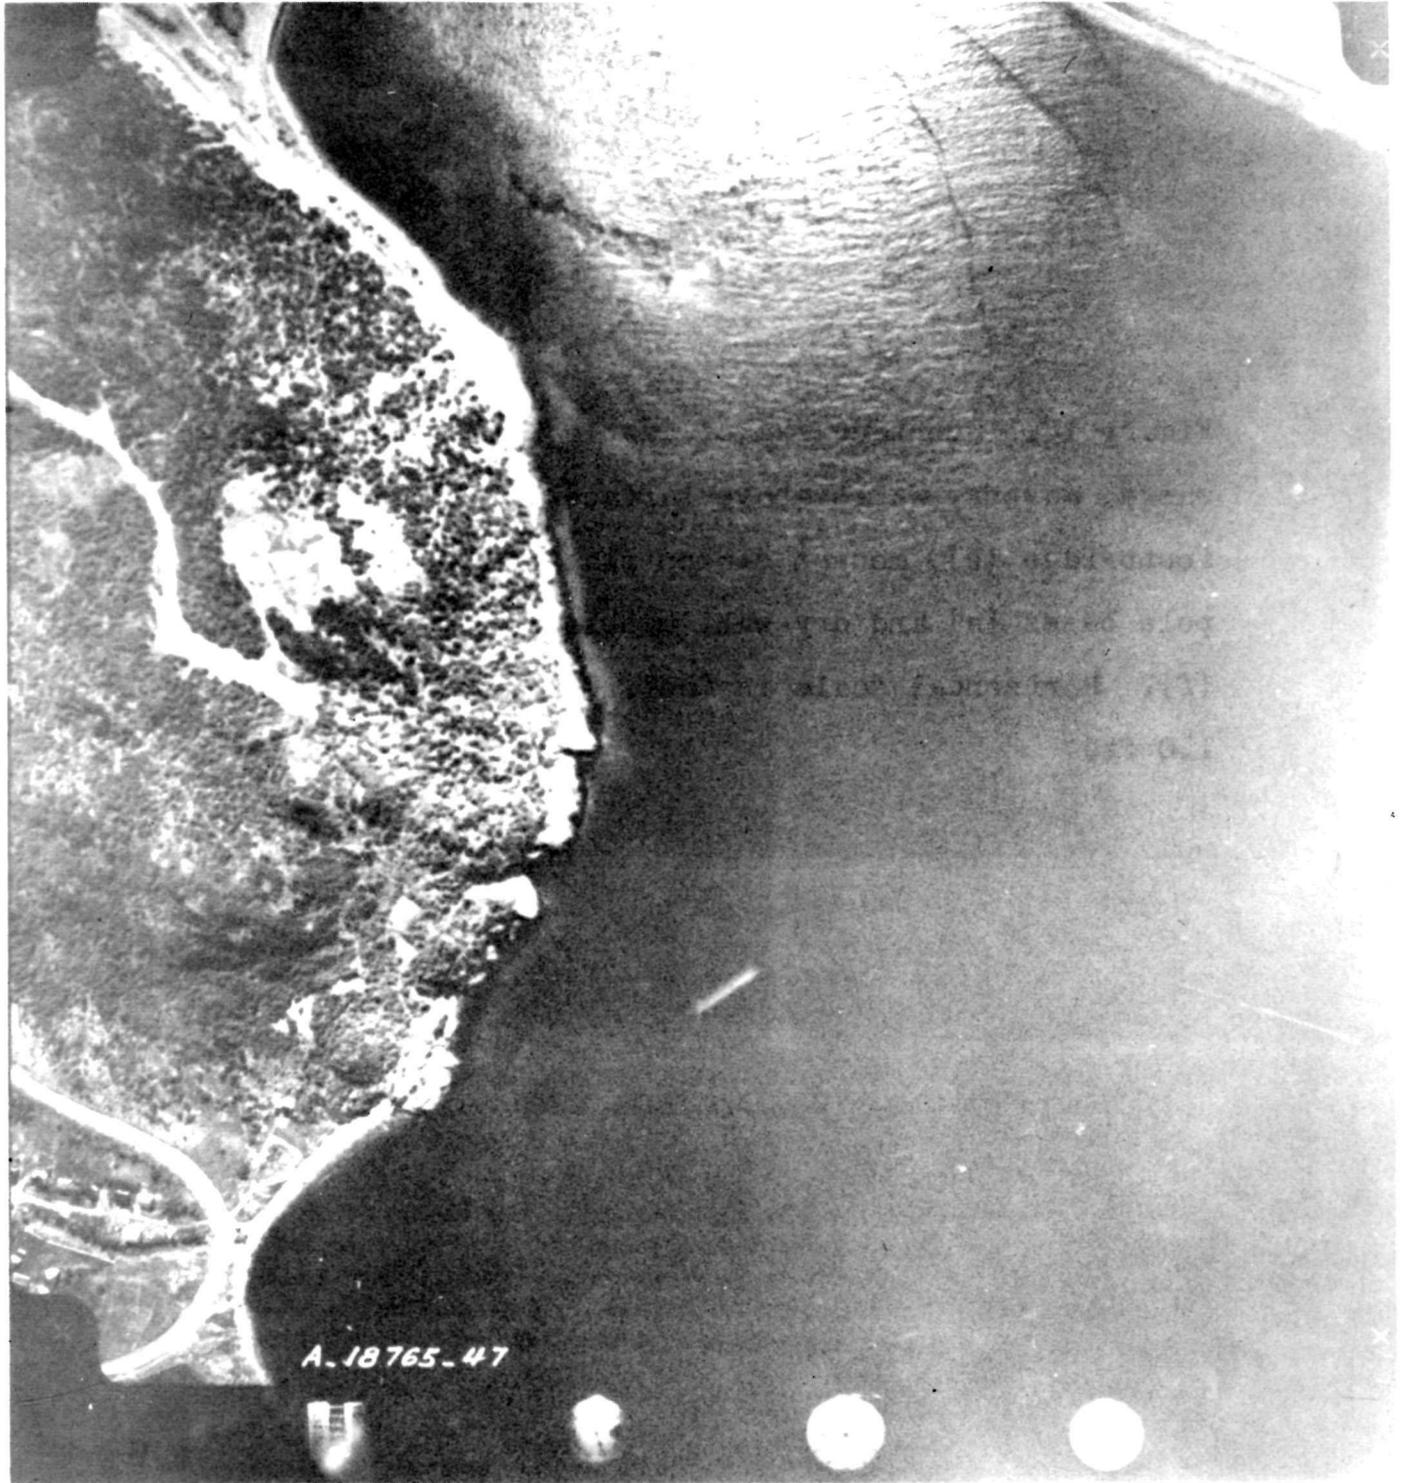
A. 18765-47

Figure 17. Enlarged section of air photo showing the site prior to excavation. L.S.C. Job P/2600/65 Area "B" ICAS-65-33 R.Q. 2923 Placentia, Nfld. A 18765 (27-49) 152.54 mm. lens AASL 2400'

Date 27-6-65. National Historic Sites Service.

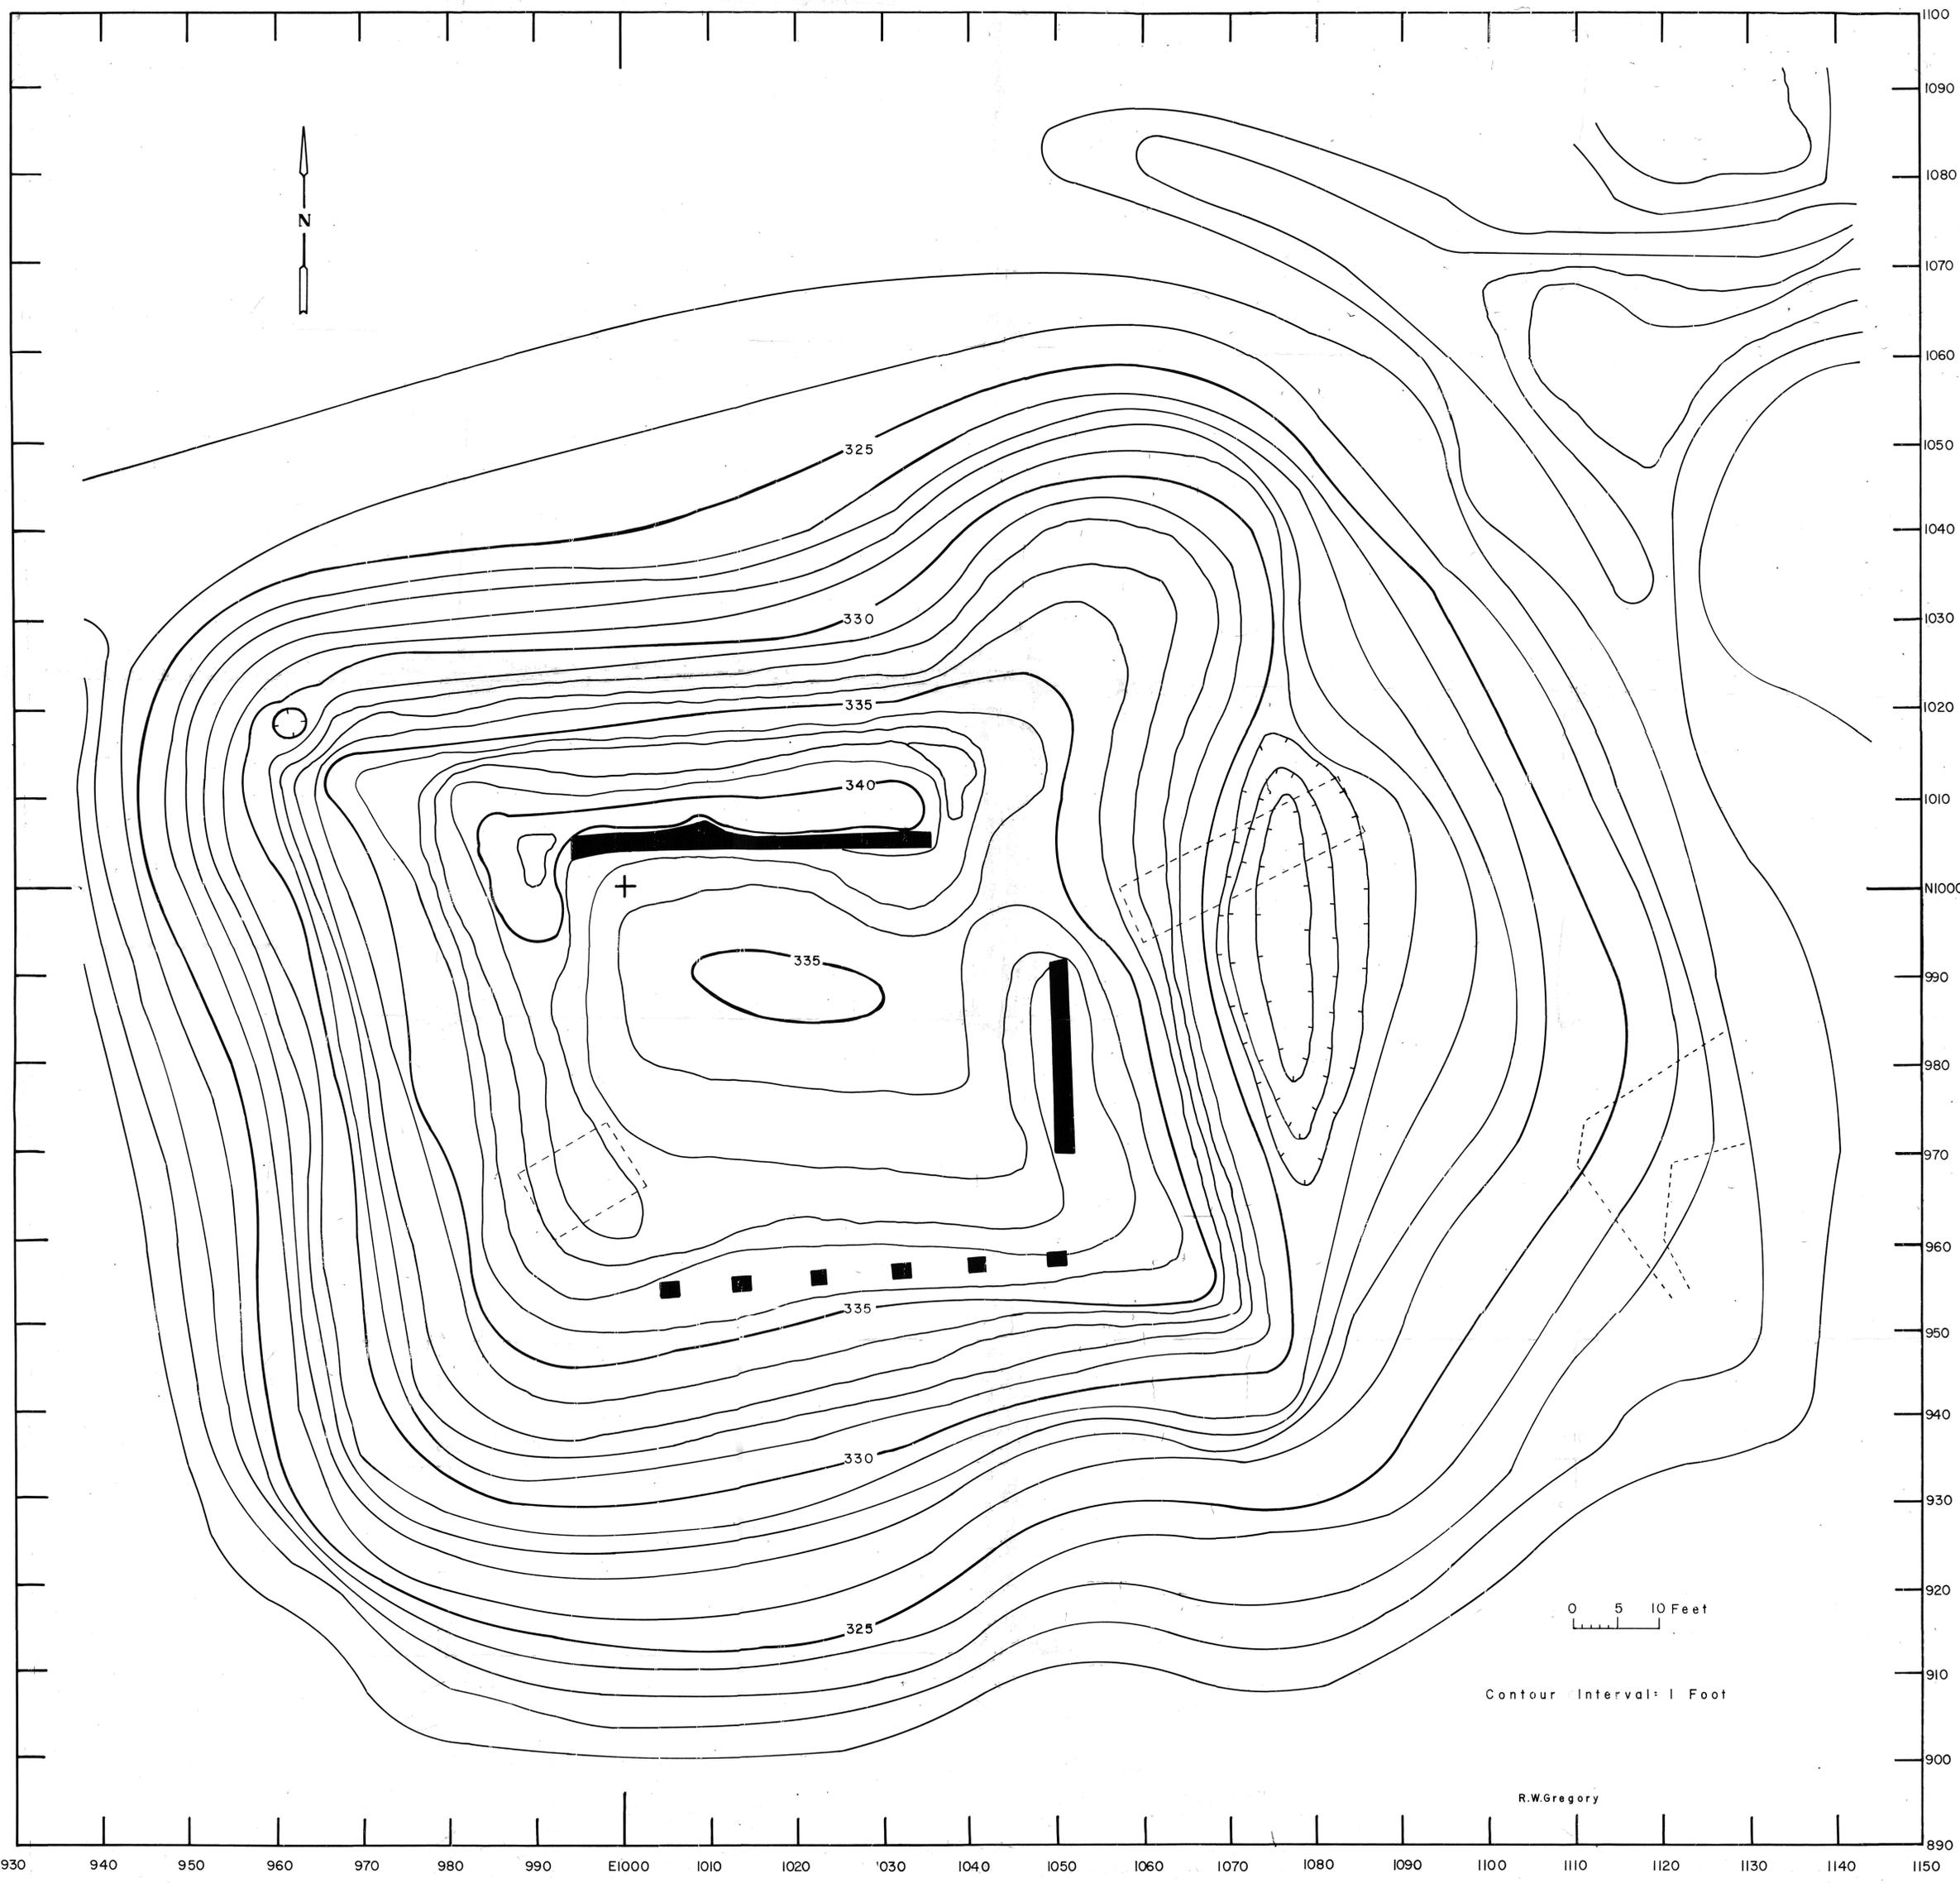
FIGURE 18

Figure 18. Countour map of Castle Hill. Features shown: masonry walls above surface (a, b), modern footbridge (c), modern cannon platform (d), flag-pole bases (e) and dry-wall rubble on surface (f). Horizontal scale in feet. Contour interval, 1.0 ft.

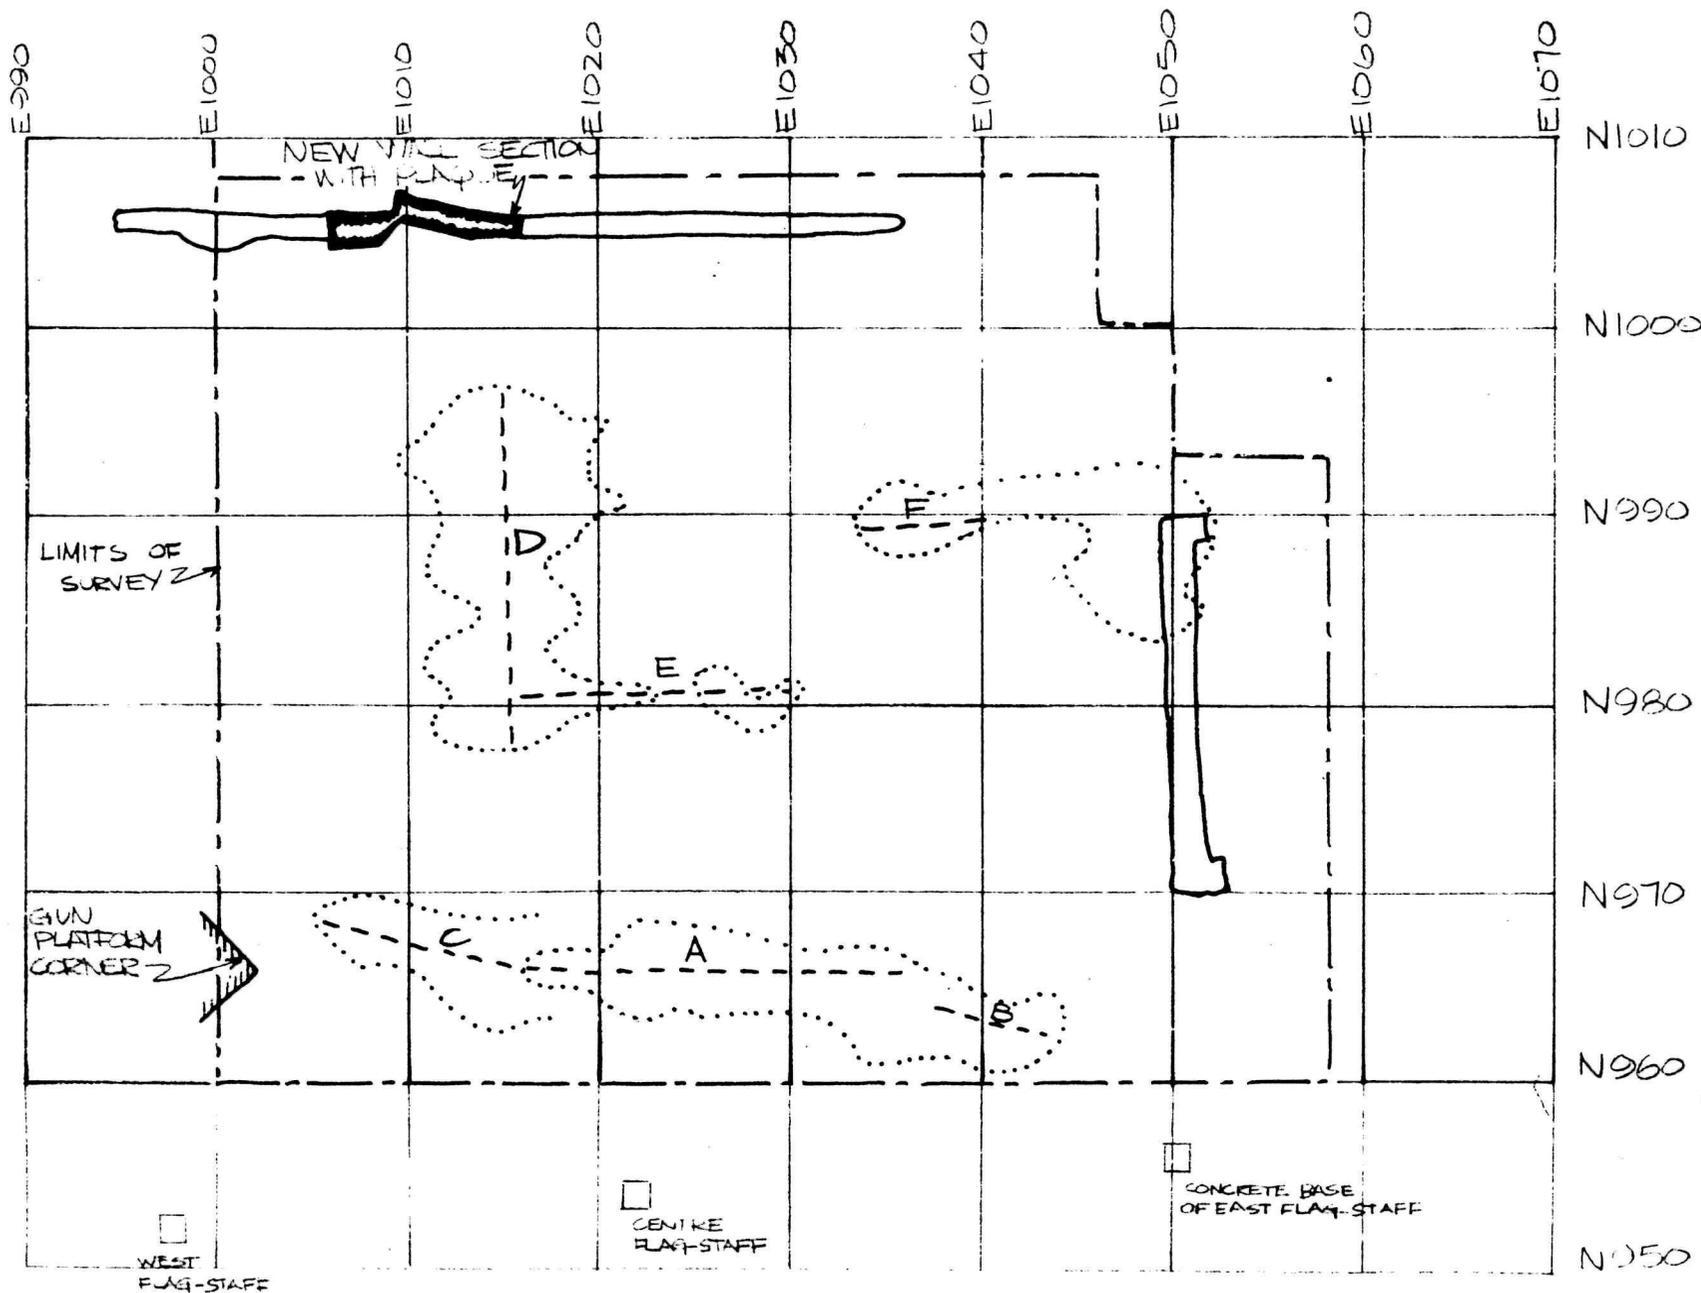
Figure 20. Geohm Resistivity Meter Survey of the "Castle", Castle Hill, Nfld. A., B Medians of well defined high resistivity area. C., relatively weak continuation of area A. D., E., Medians of moderately well defined high resistivity areas. F. Median of poorly defined high resistivity area. (The wall along E1050, just above ground level, produced an anomaly of equally poor definition.) The survey was made by the four-probe method on lines running north at 2.0 ft. intervals. Probe spacing was 2.0 ft. and probe penetration was 0.5 ft. or less. Scale 1.0 in. equals 10.0 ft.

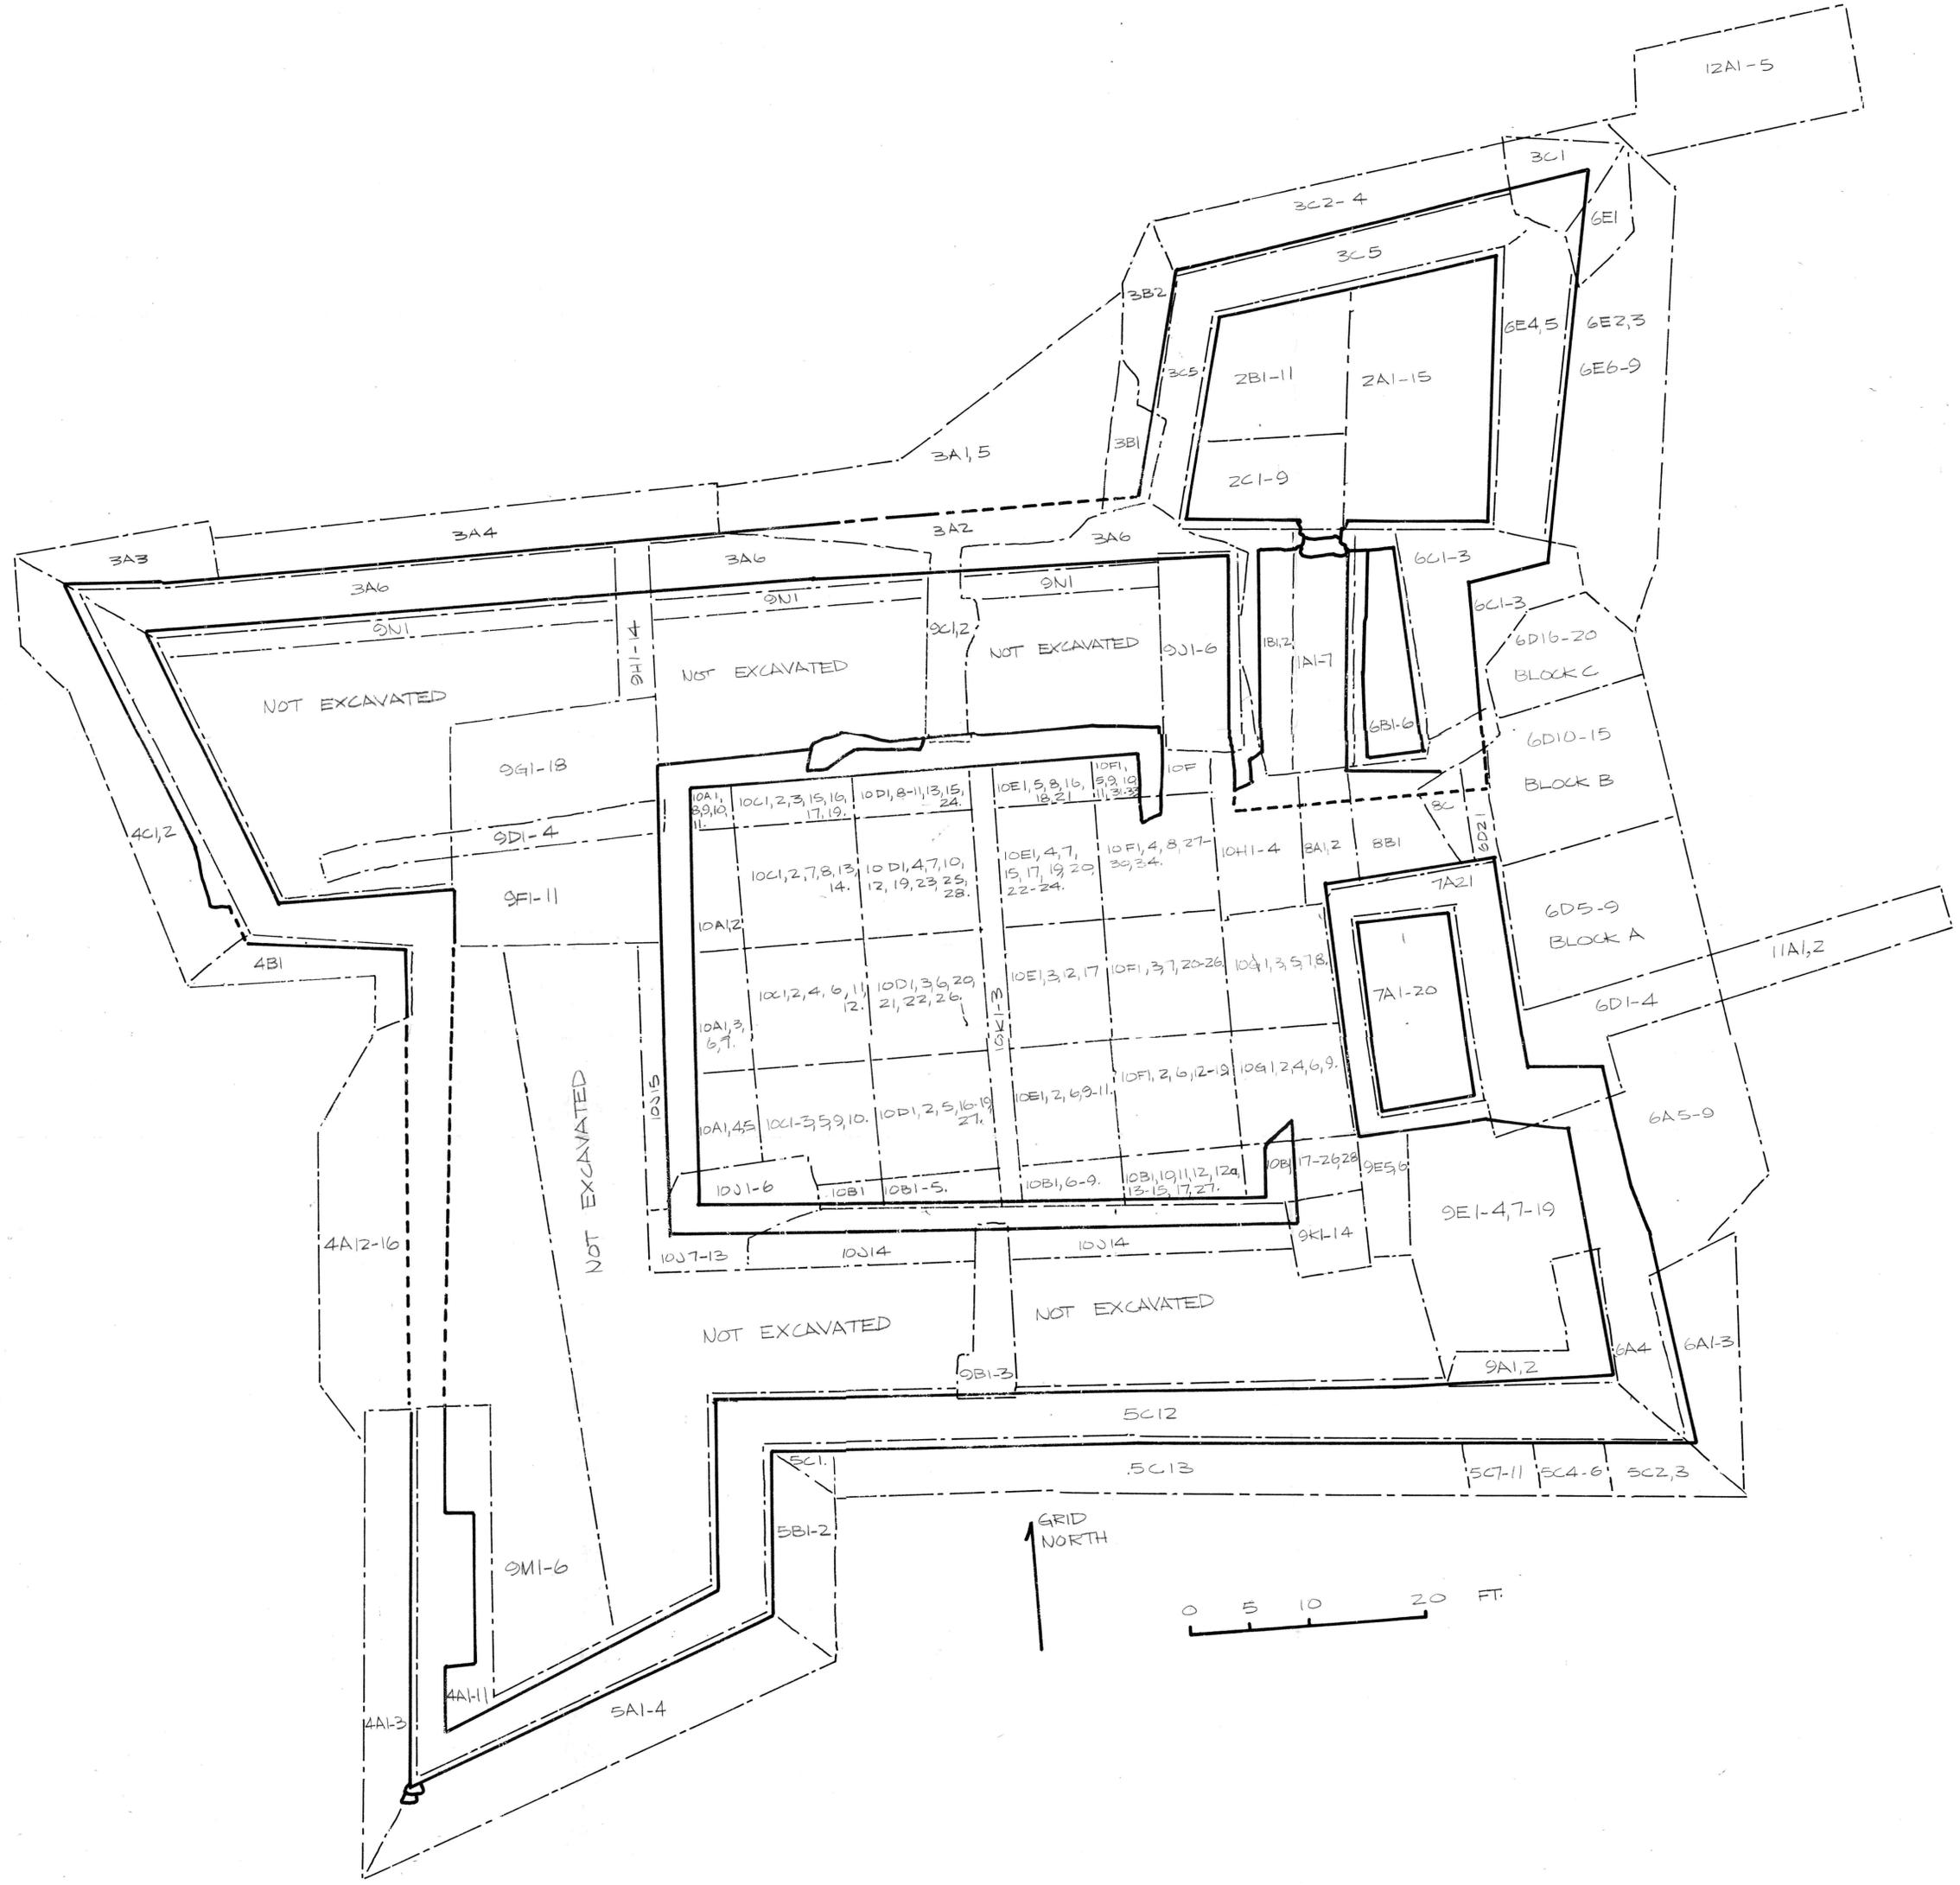
FIGURE 21

Figure 21. Plan of the excavations showing the location of operations, sub-operations and lots. sub-operation and lot numbers are shown.

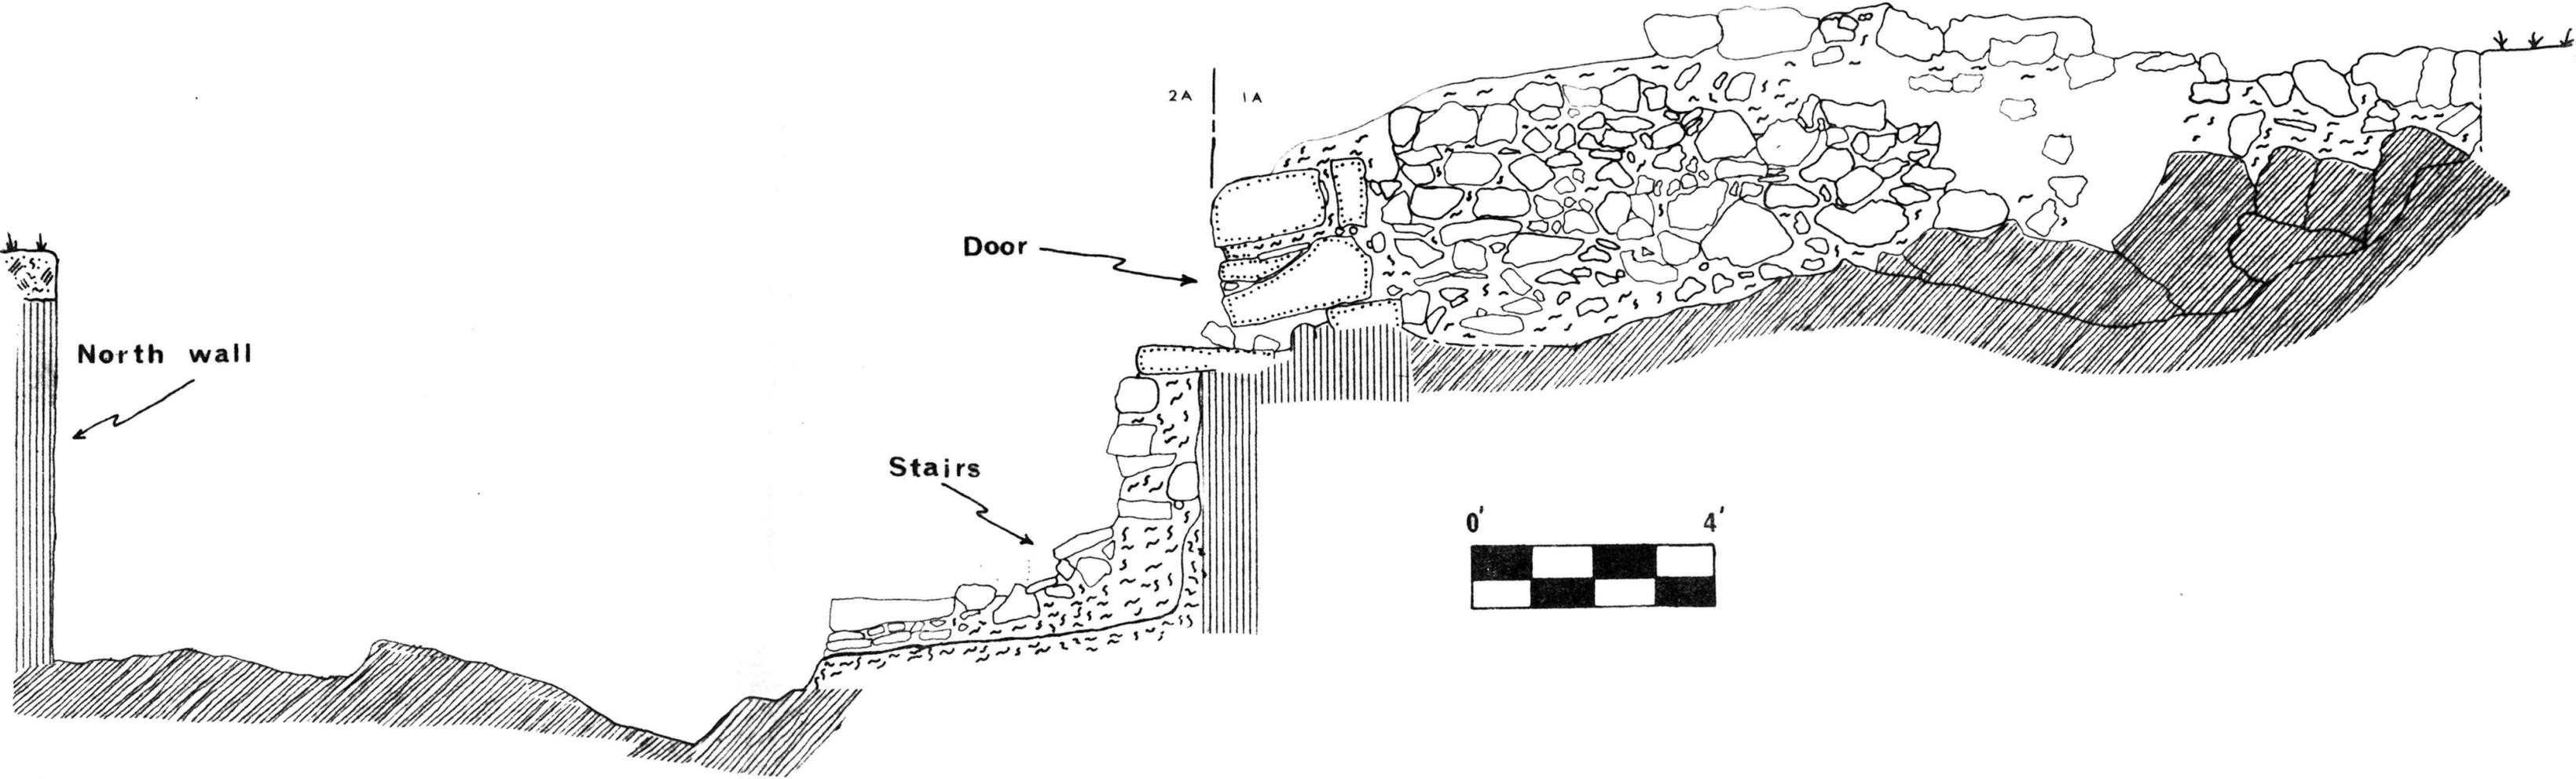
FIGURE 23

Figure 23. Operations 1 and 2. Elevation showing the east wall of operation 1, the doorway and stairs and cross-section of operation 2 along the same line. Scale in ft.
