NATIONAL HISTORIC SITES SERVICE

MANUSCRIPT REPORT NUMBER 46

EXCAVATIONS AT CASTLE HILL

September 1971

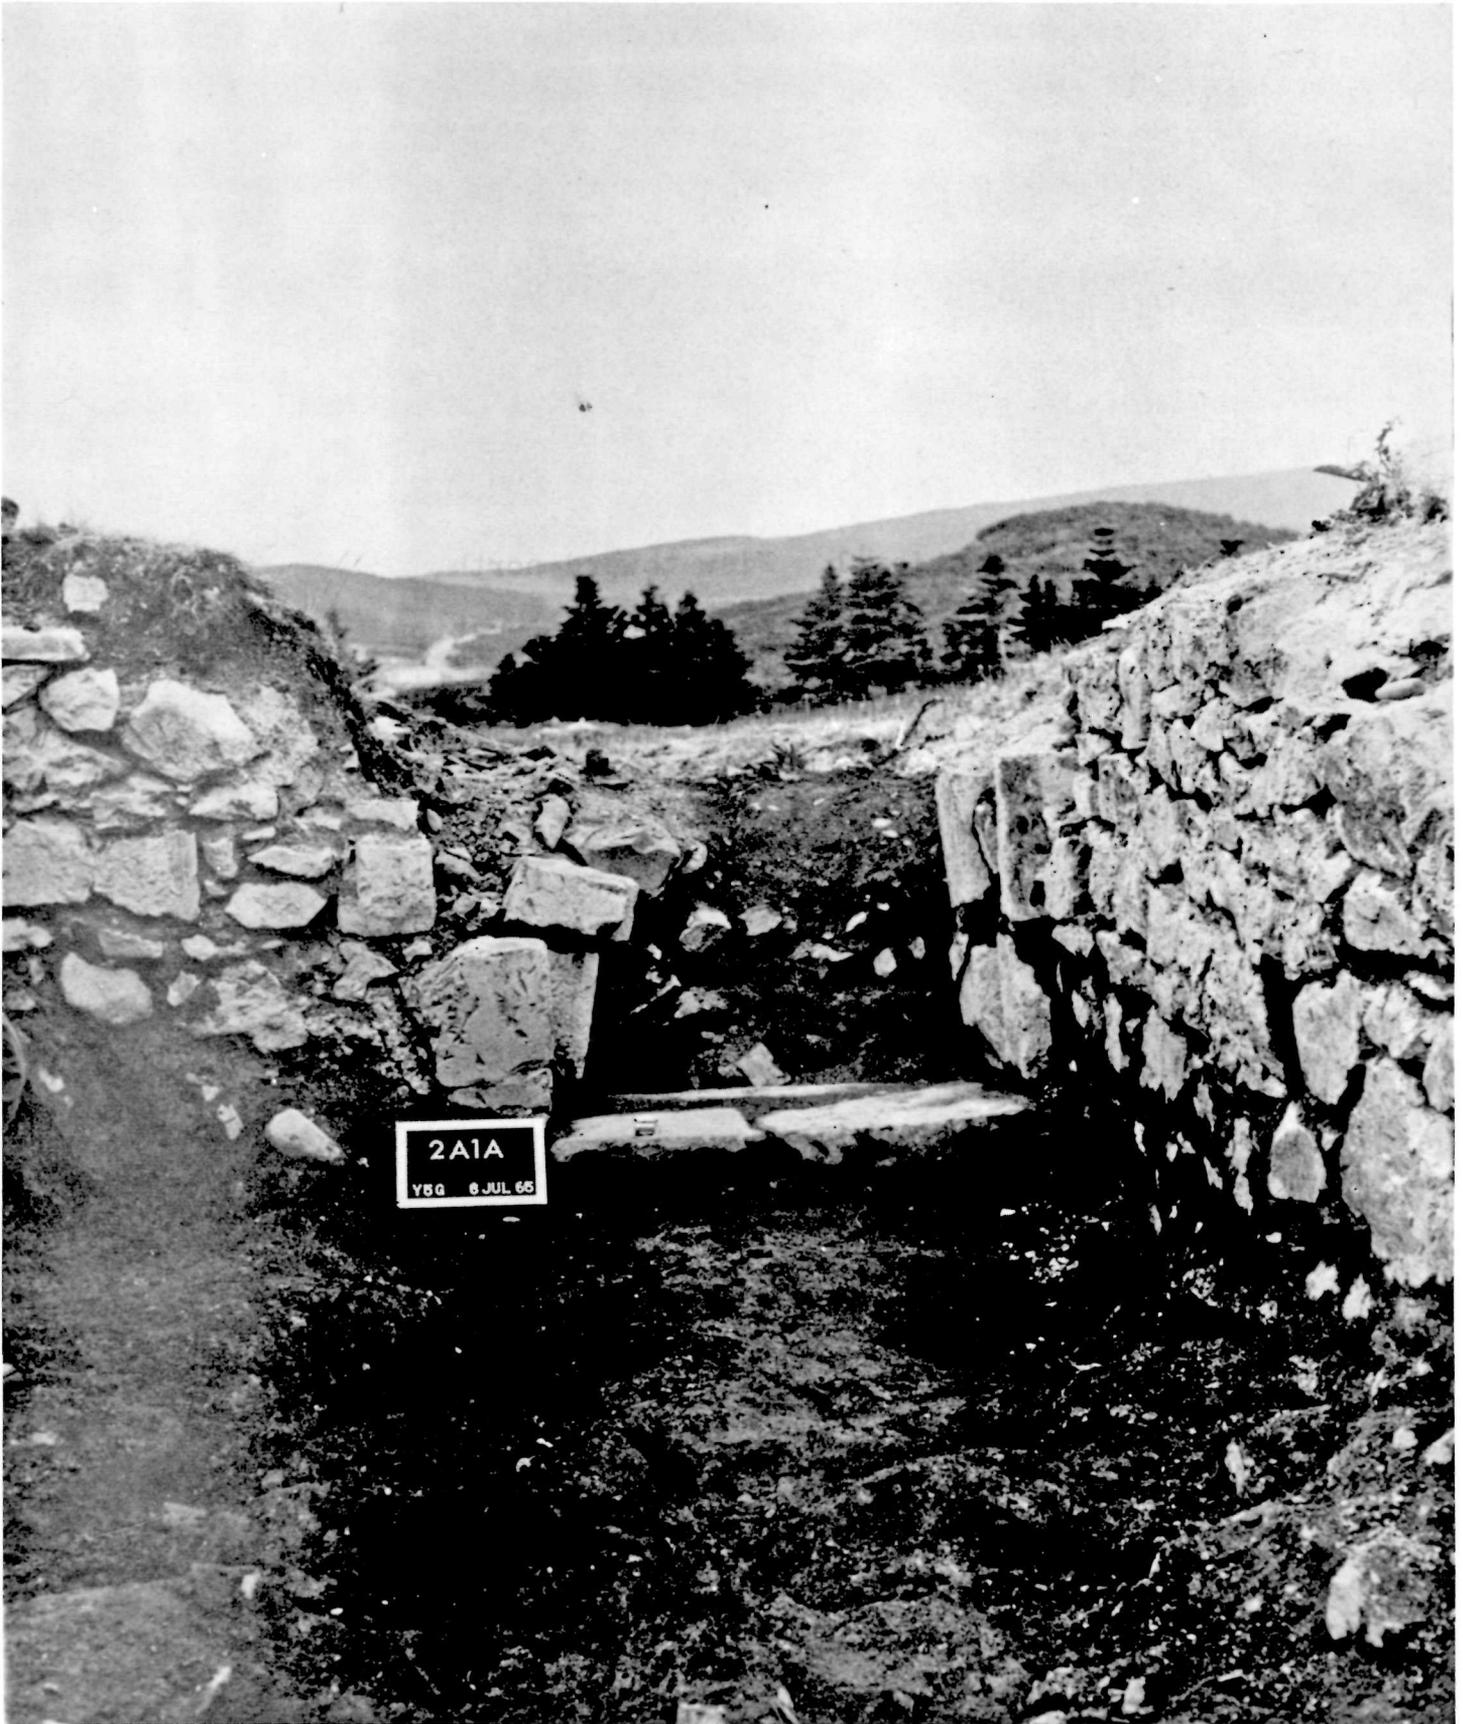
Figure 24. Operation 1. View to the north showing the doorway in the north end of operation 1.

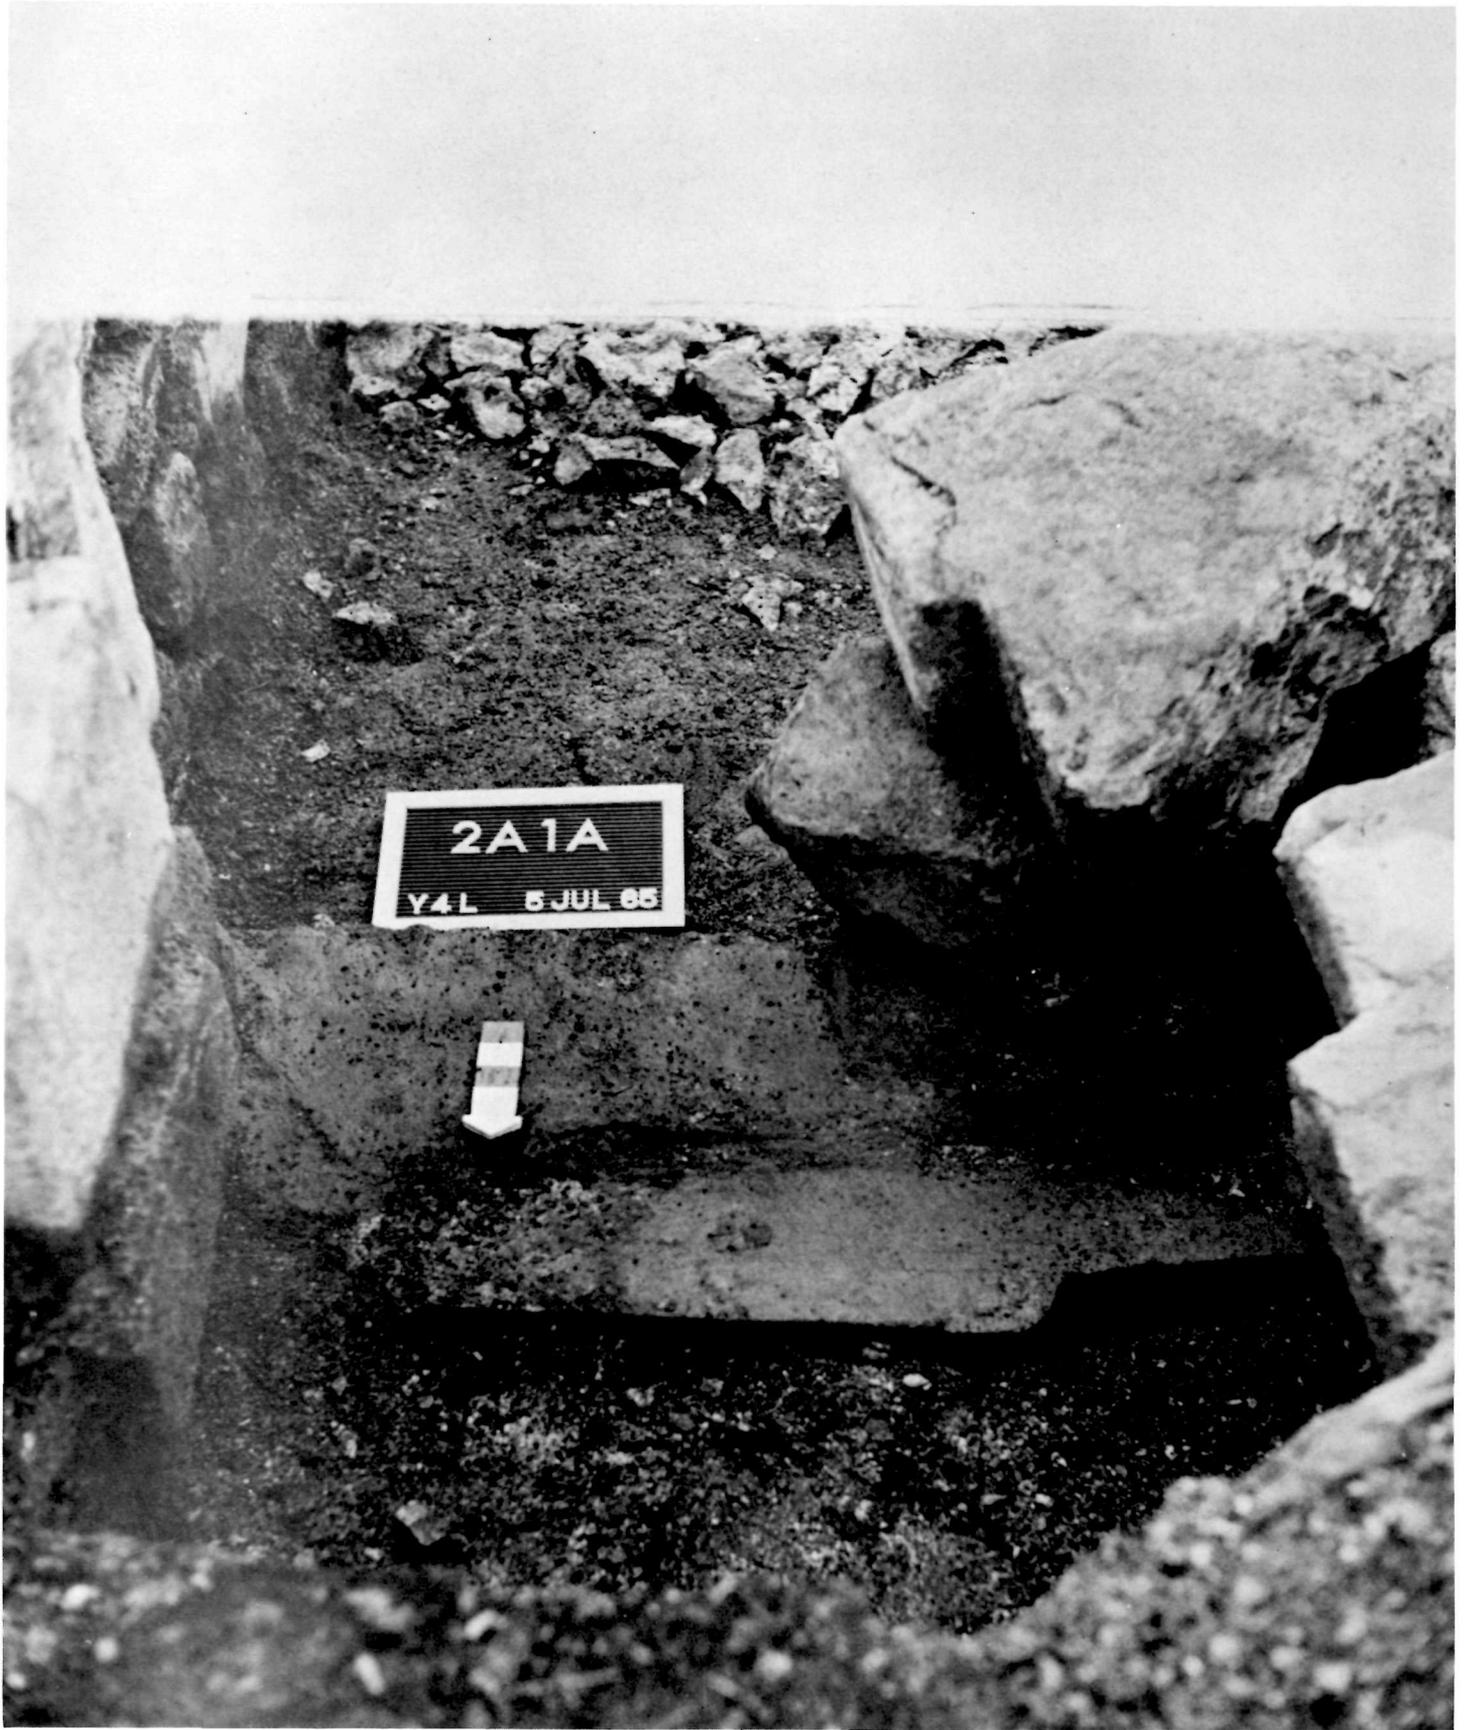
Figure 25. Operation 1. View toward north,
looking down on the threshold in the operation
1 doorway. Cut door stones in the upper right.

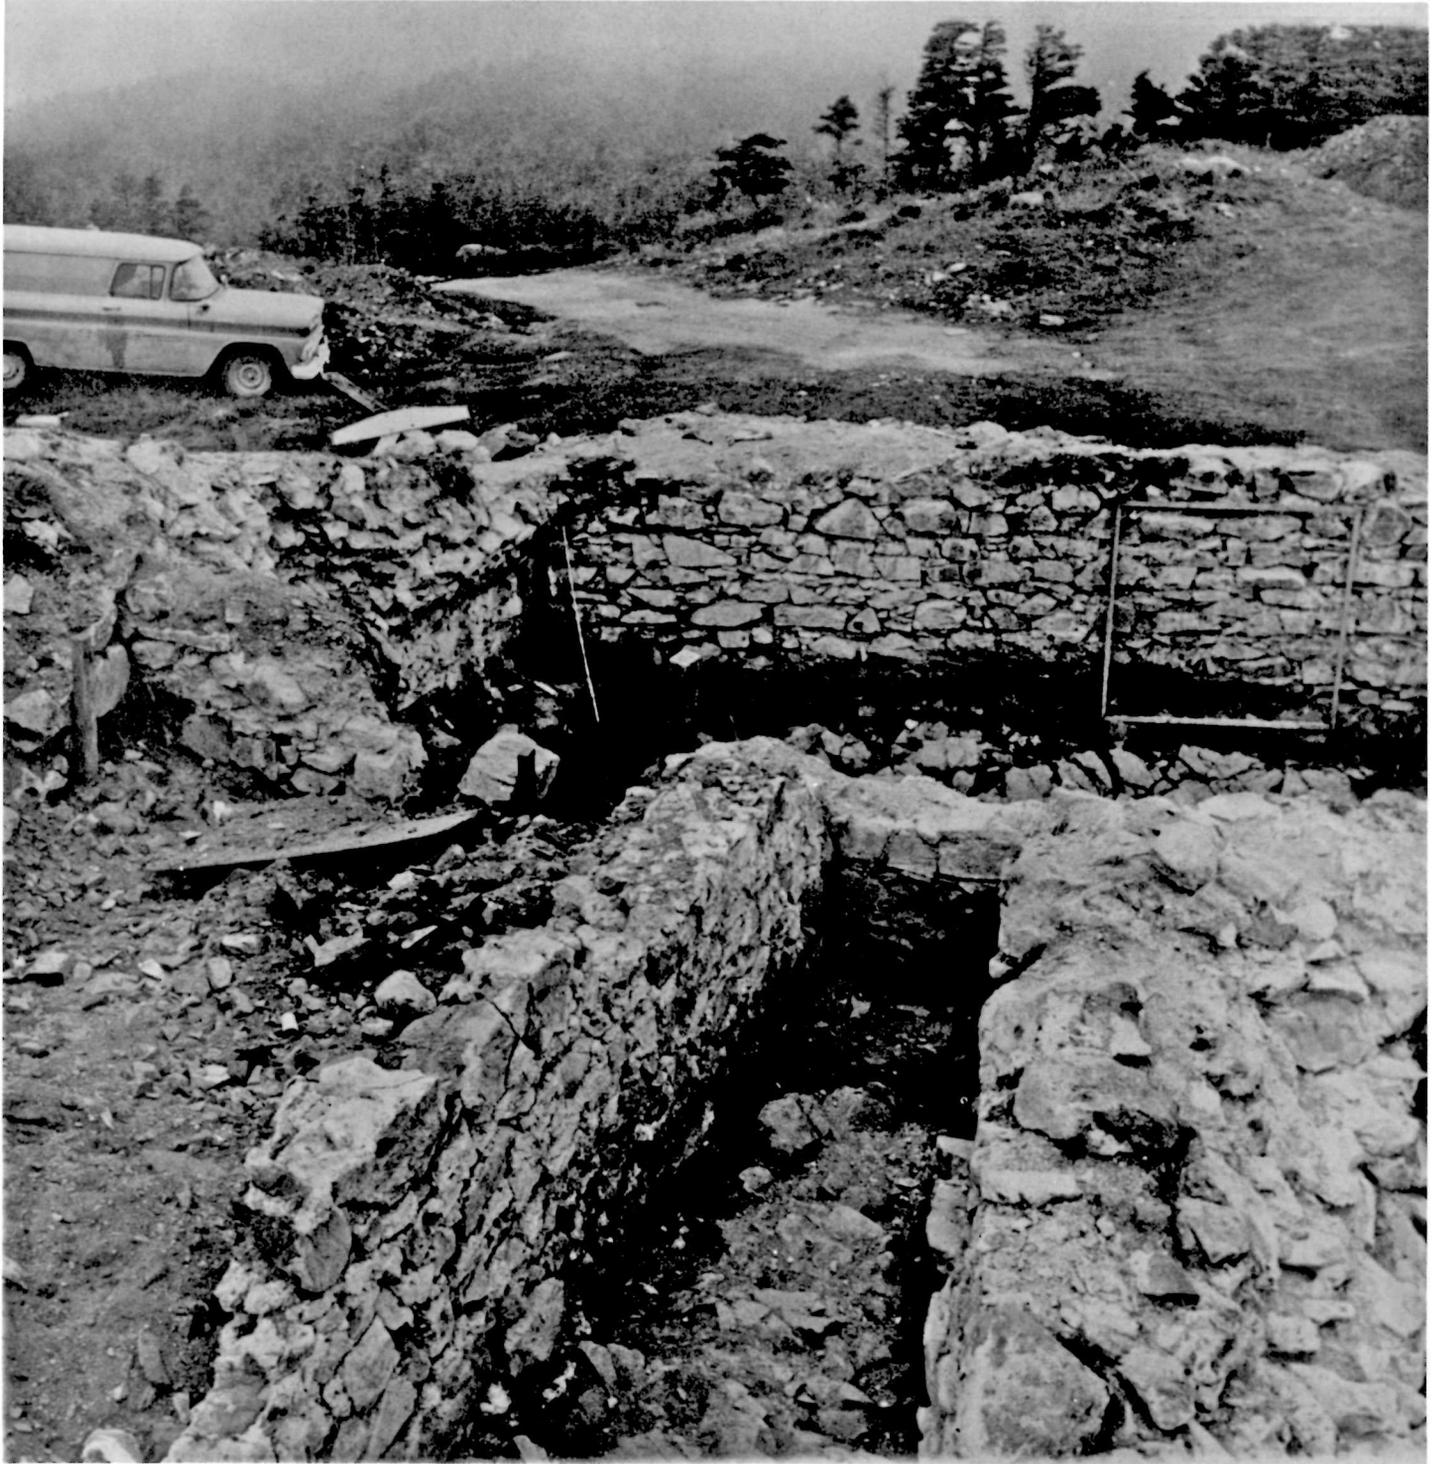
Figure 26. Operation 2 and sub-operation 6B.
View toward the north with operation 2 in the
background. Sub-operation 6B in foreground
showing wall between 6B and operation 1 on
the left, and eroded core of the east curtain
wall(6C) on the right.

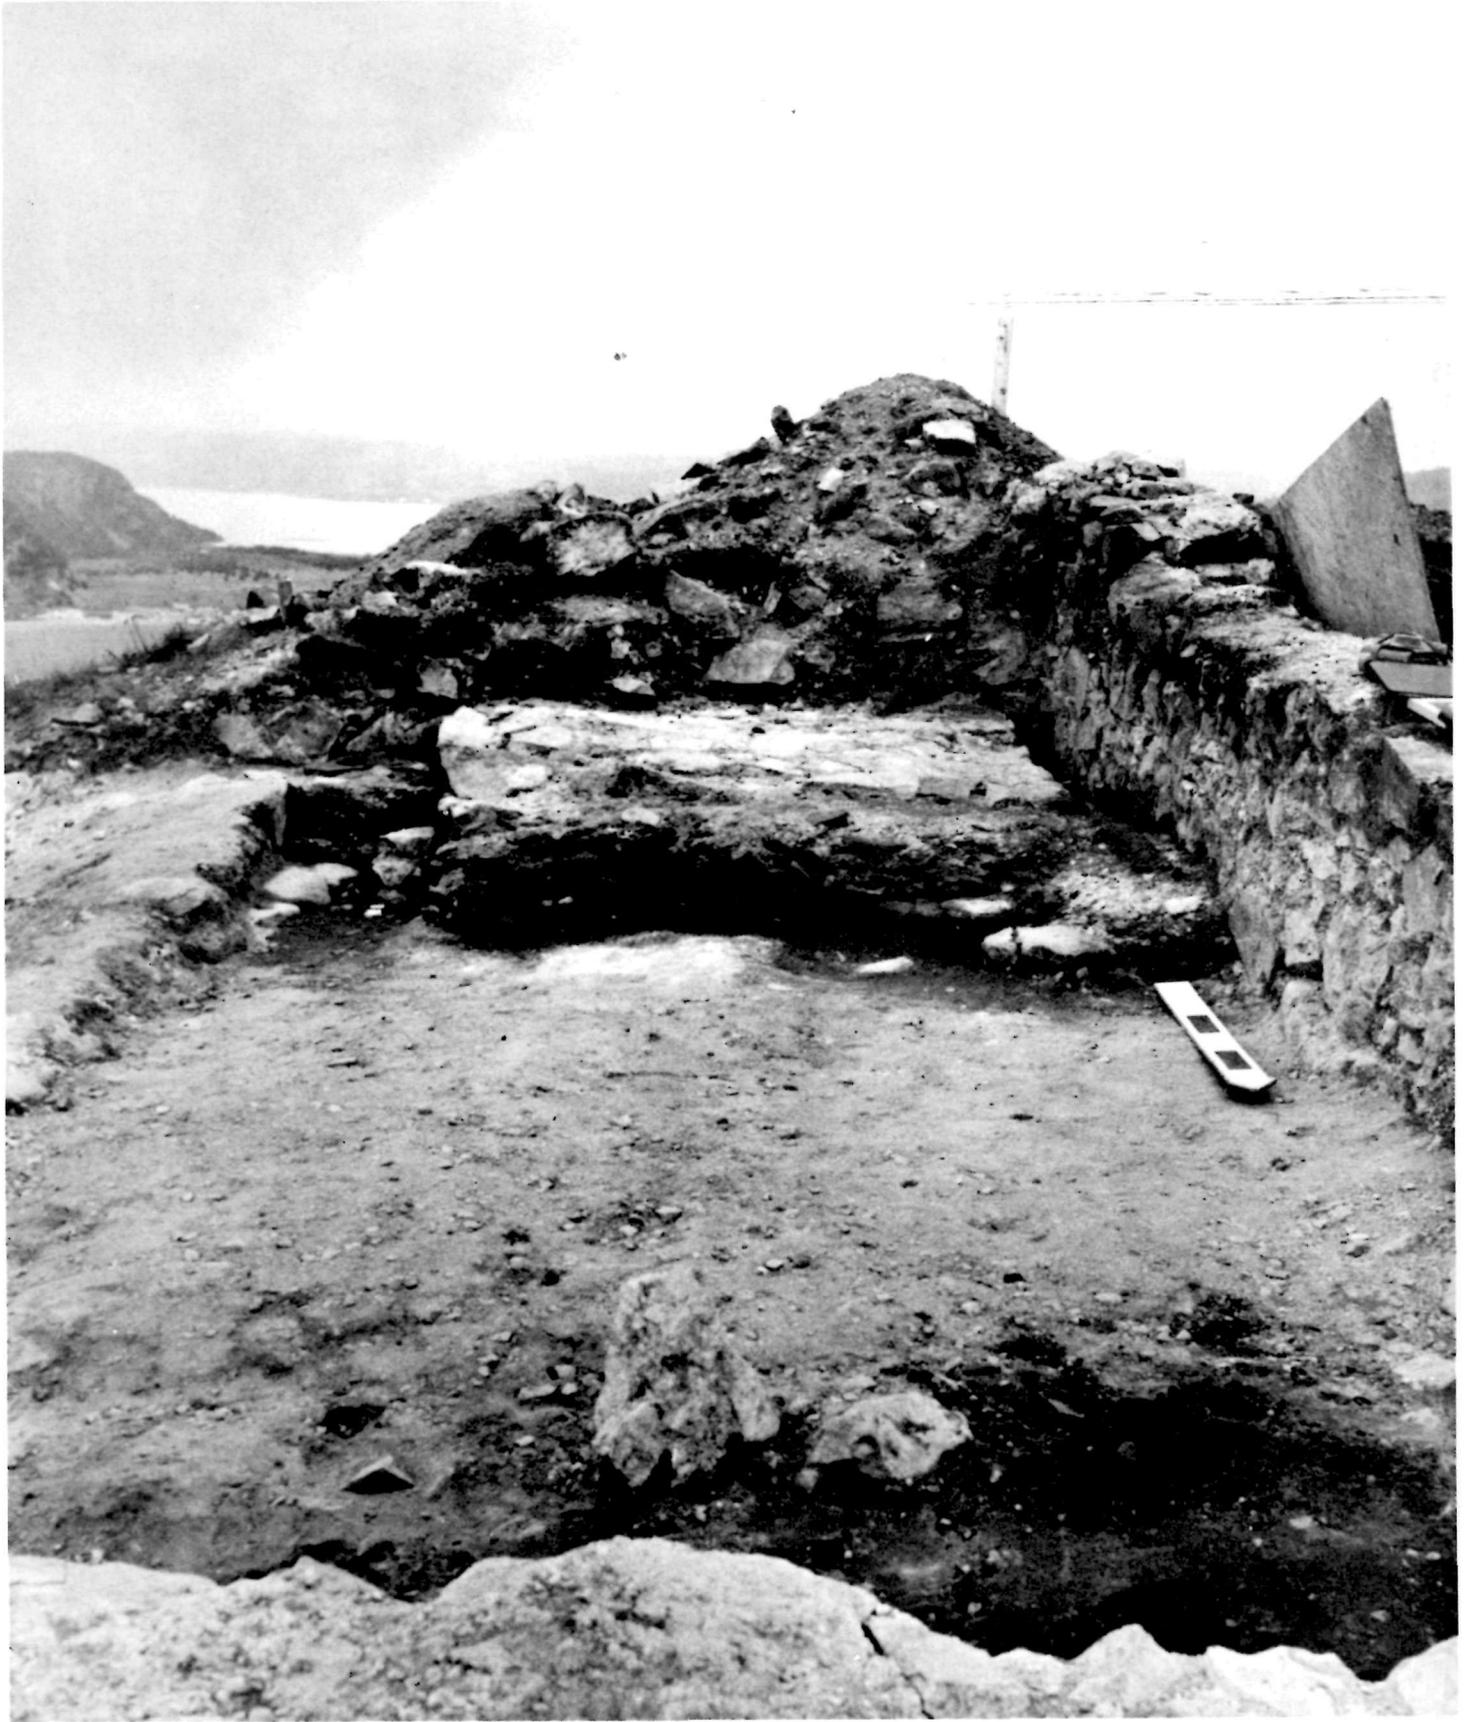
Figure 28. Operation 7. View toward the south showing the English hearth platform in the south end of the guardroom. West wall of room on right, remnant of east curtain wall on extreme left.

Dirt pile in background. Scale in ft.

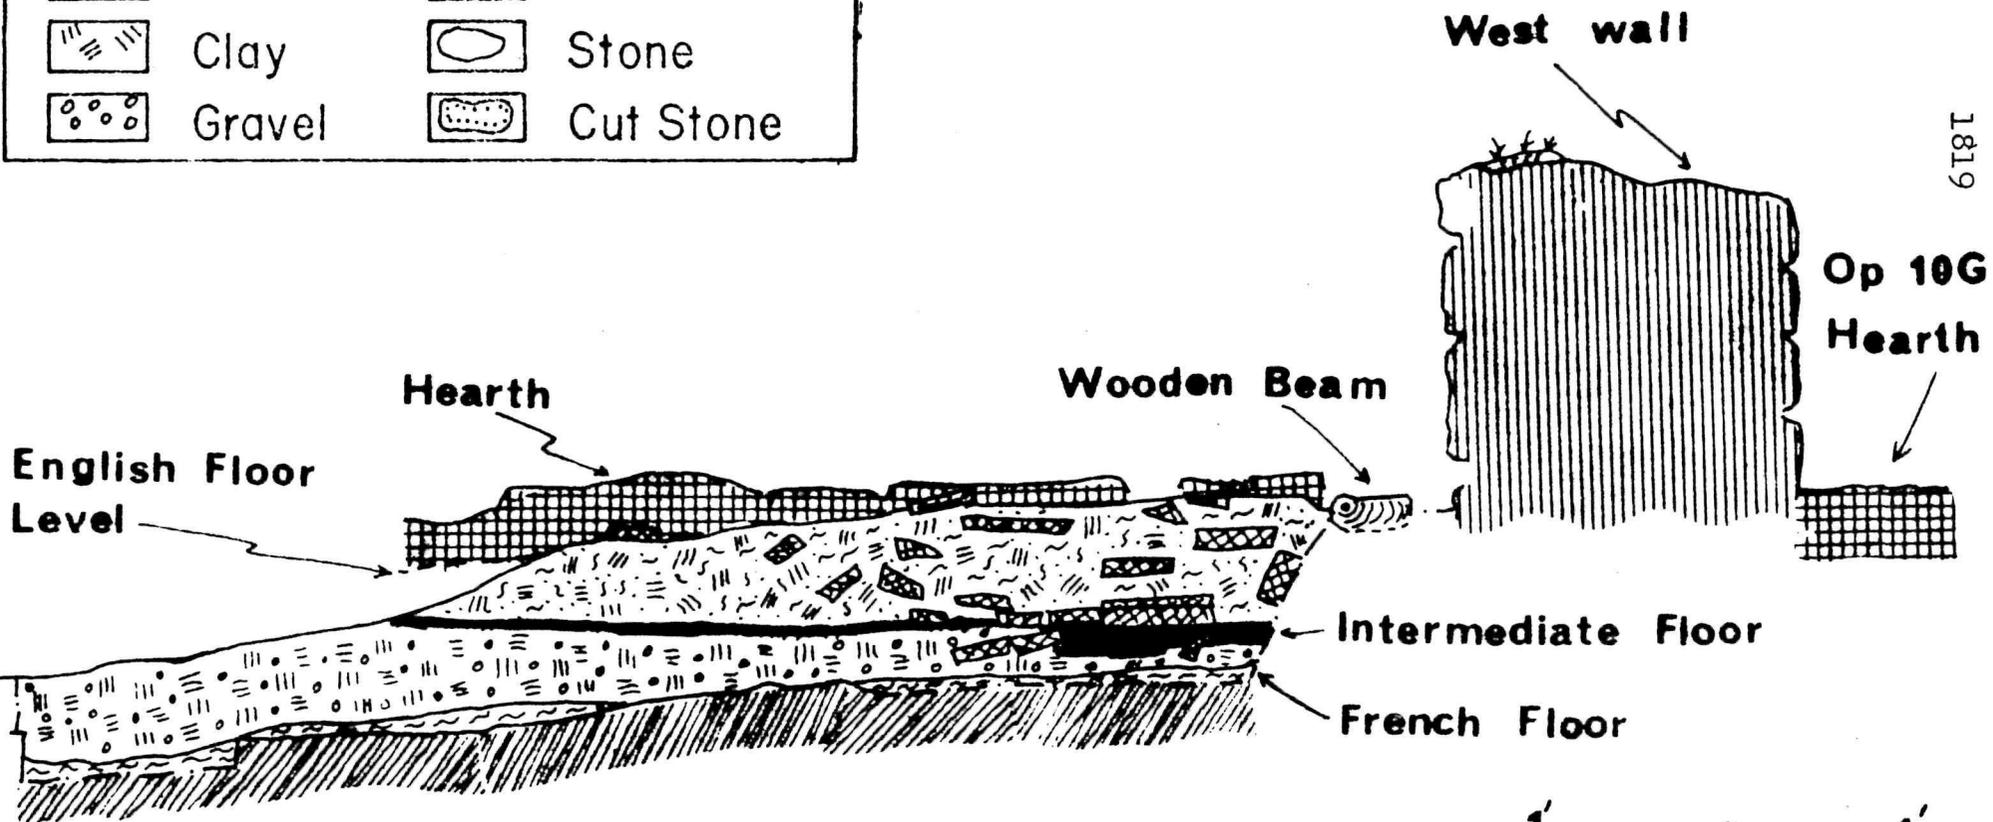
Figure 29. Operation 7. Looking south at profile showing English hearth platform and floor stratigraphy. Scale in ft.

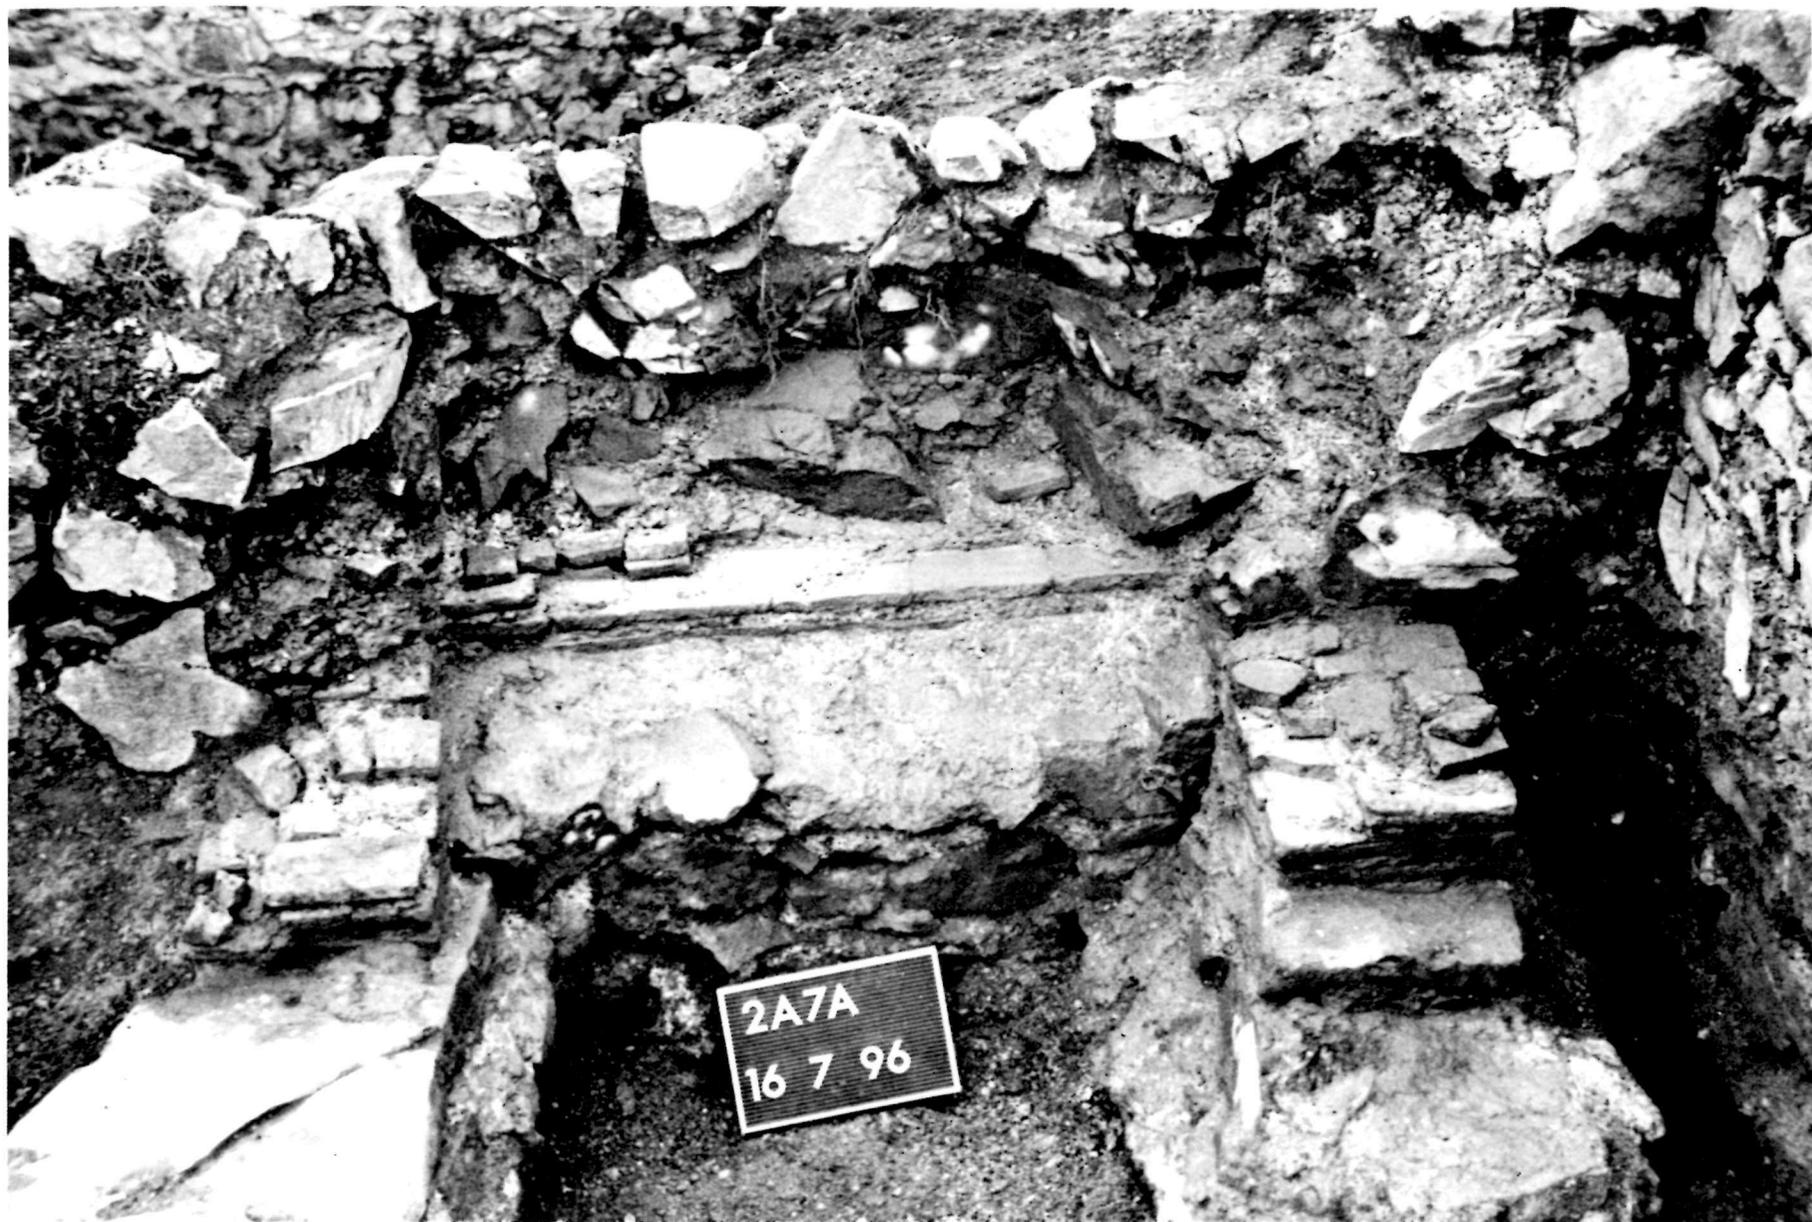
Figure 30. Operation 7. View toward the south showing French fireplace as found beneath English hearth. (Morton 1970: Fig. 11).

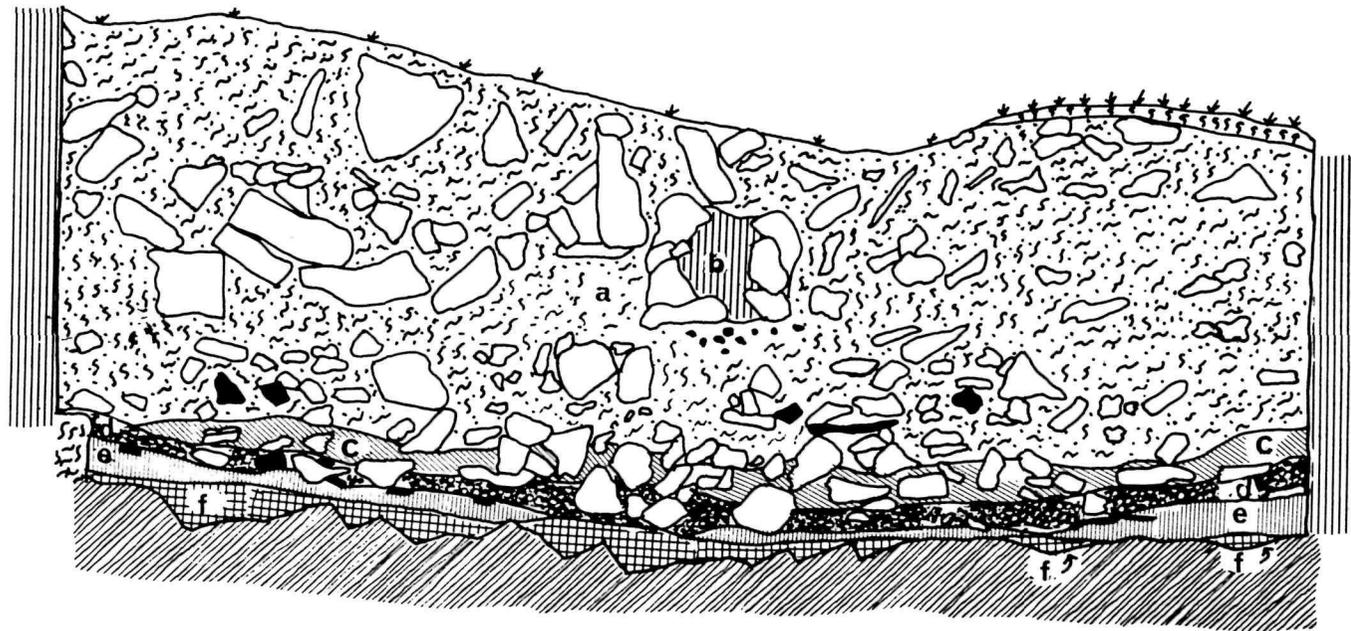
Figure 31. Operation 2. Cross-section of the magazine showing fill stratigraphy and floor deposits. Layers identified on drawing.
Scale in feet.

- a Fill
- b Fallen Arch
- c English Level
- d French Level
- e French Floor
- f Sub-floor Fill

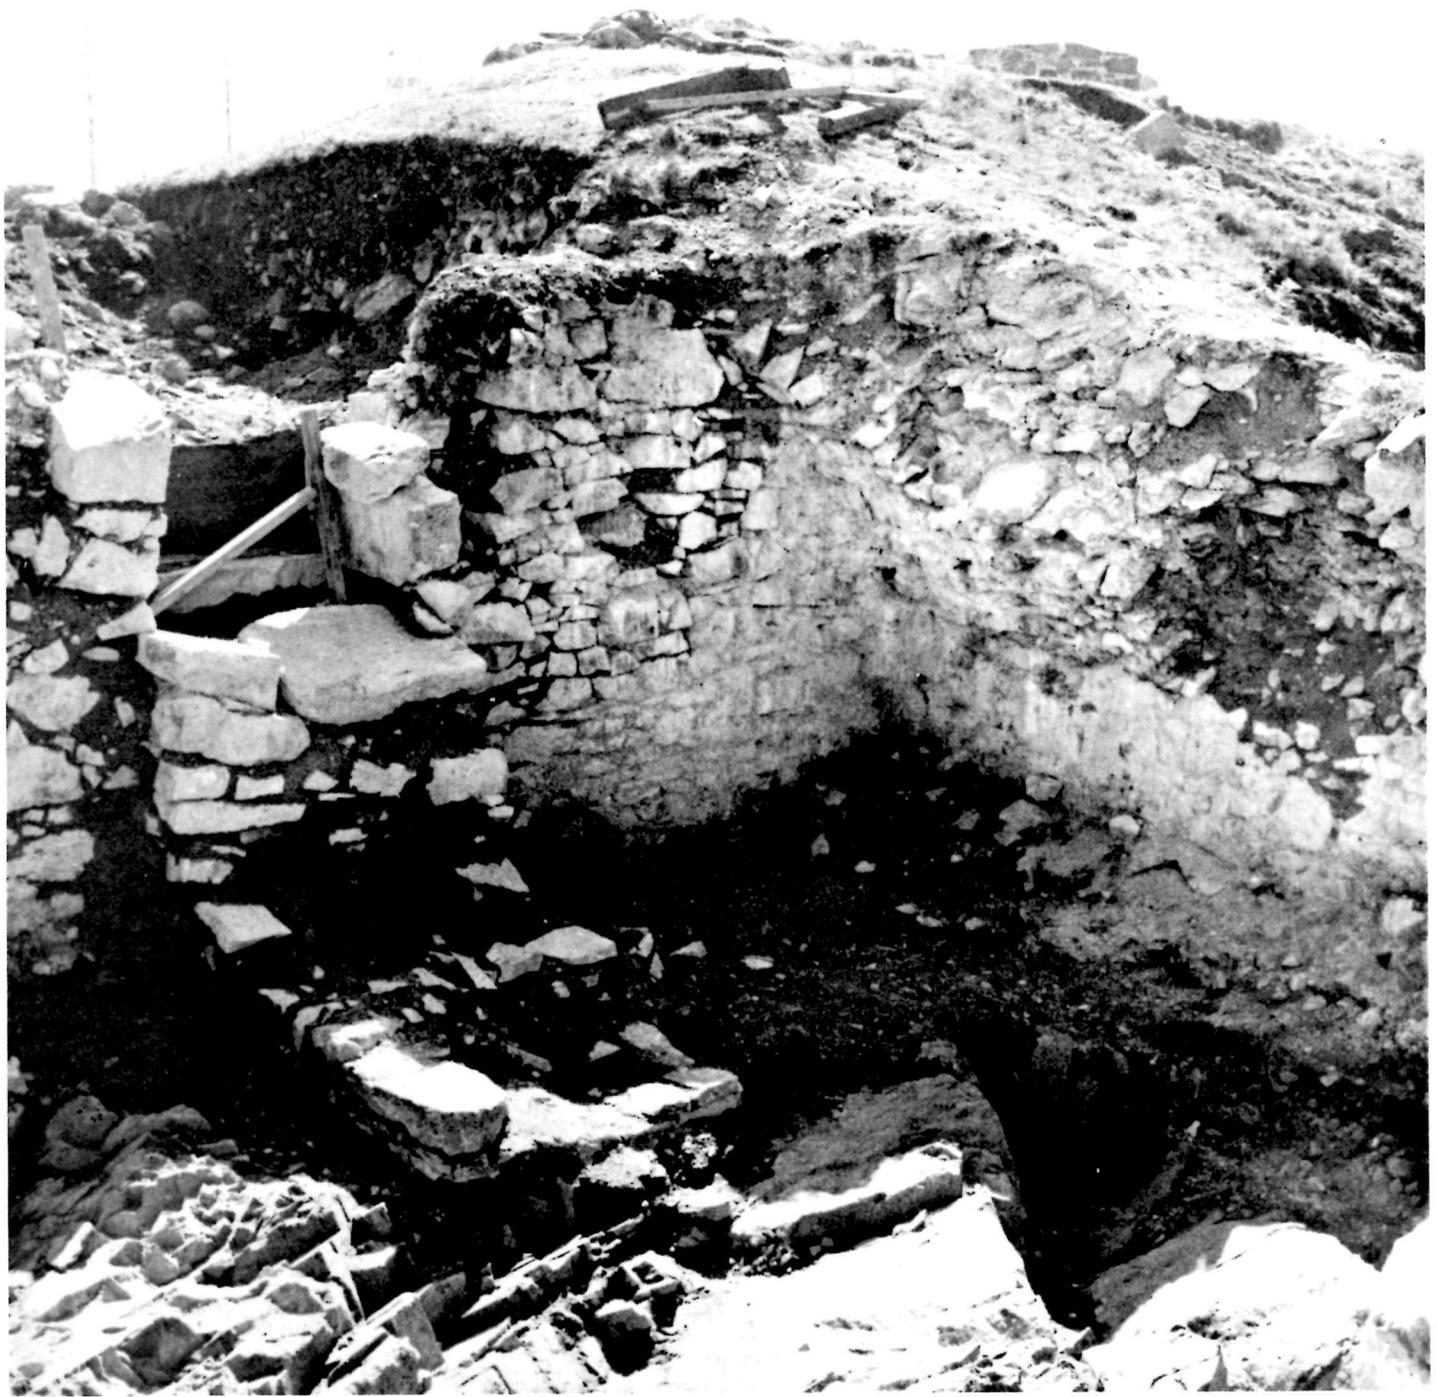
Figure 32. Operation 2. View toward the southwest showing the doorway, stairs and southwest corner of the magazine. Doorway is in the centre of the south wall.

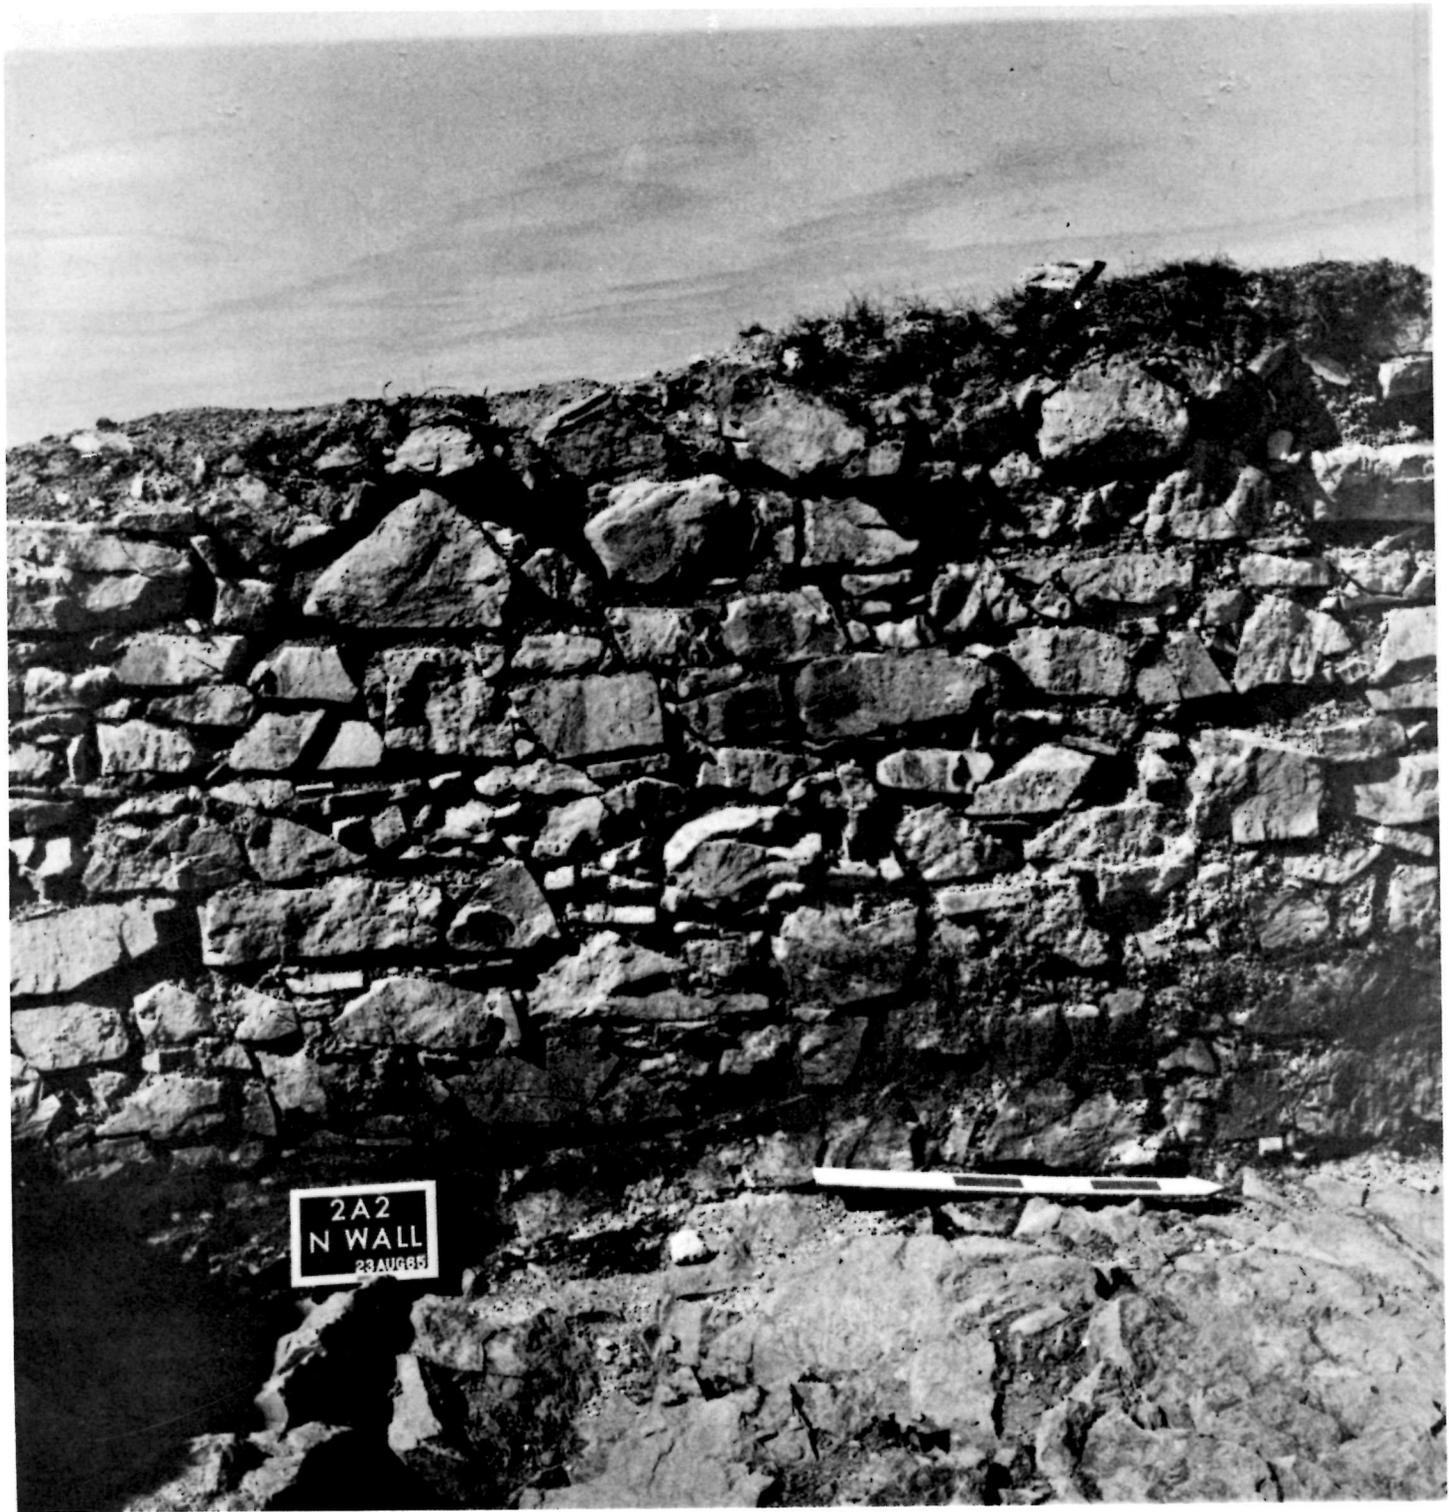
Figure 33. Operation 2. View toward the north, showing a section of the north interior wall of the magazine. Scale in ft.

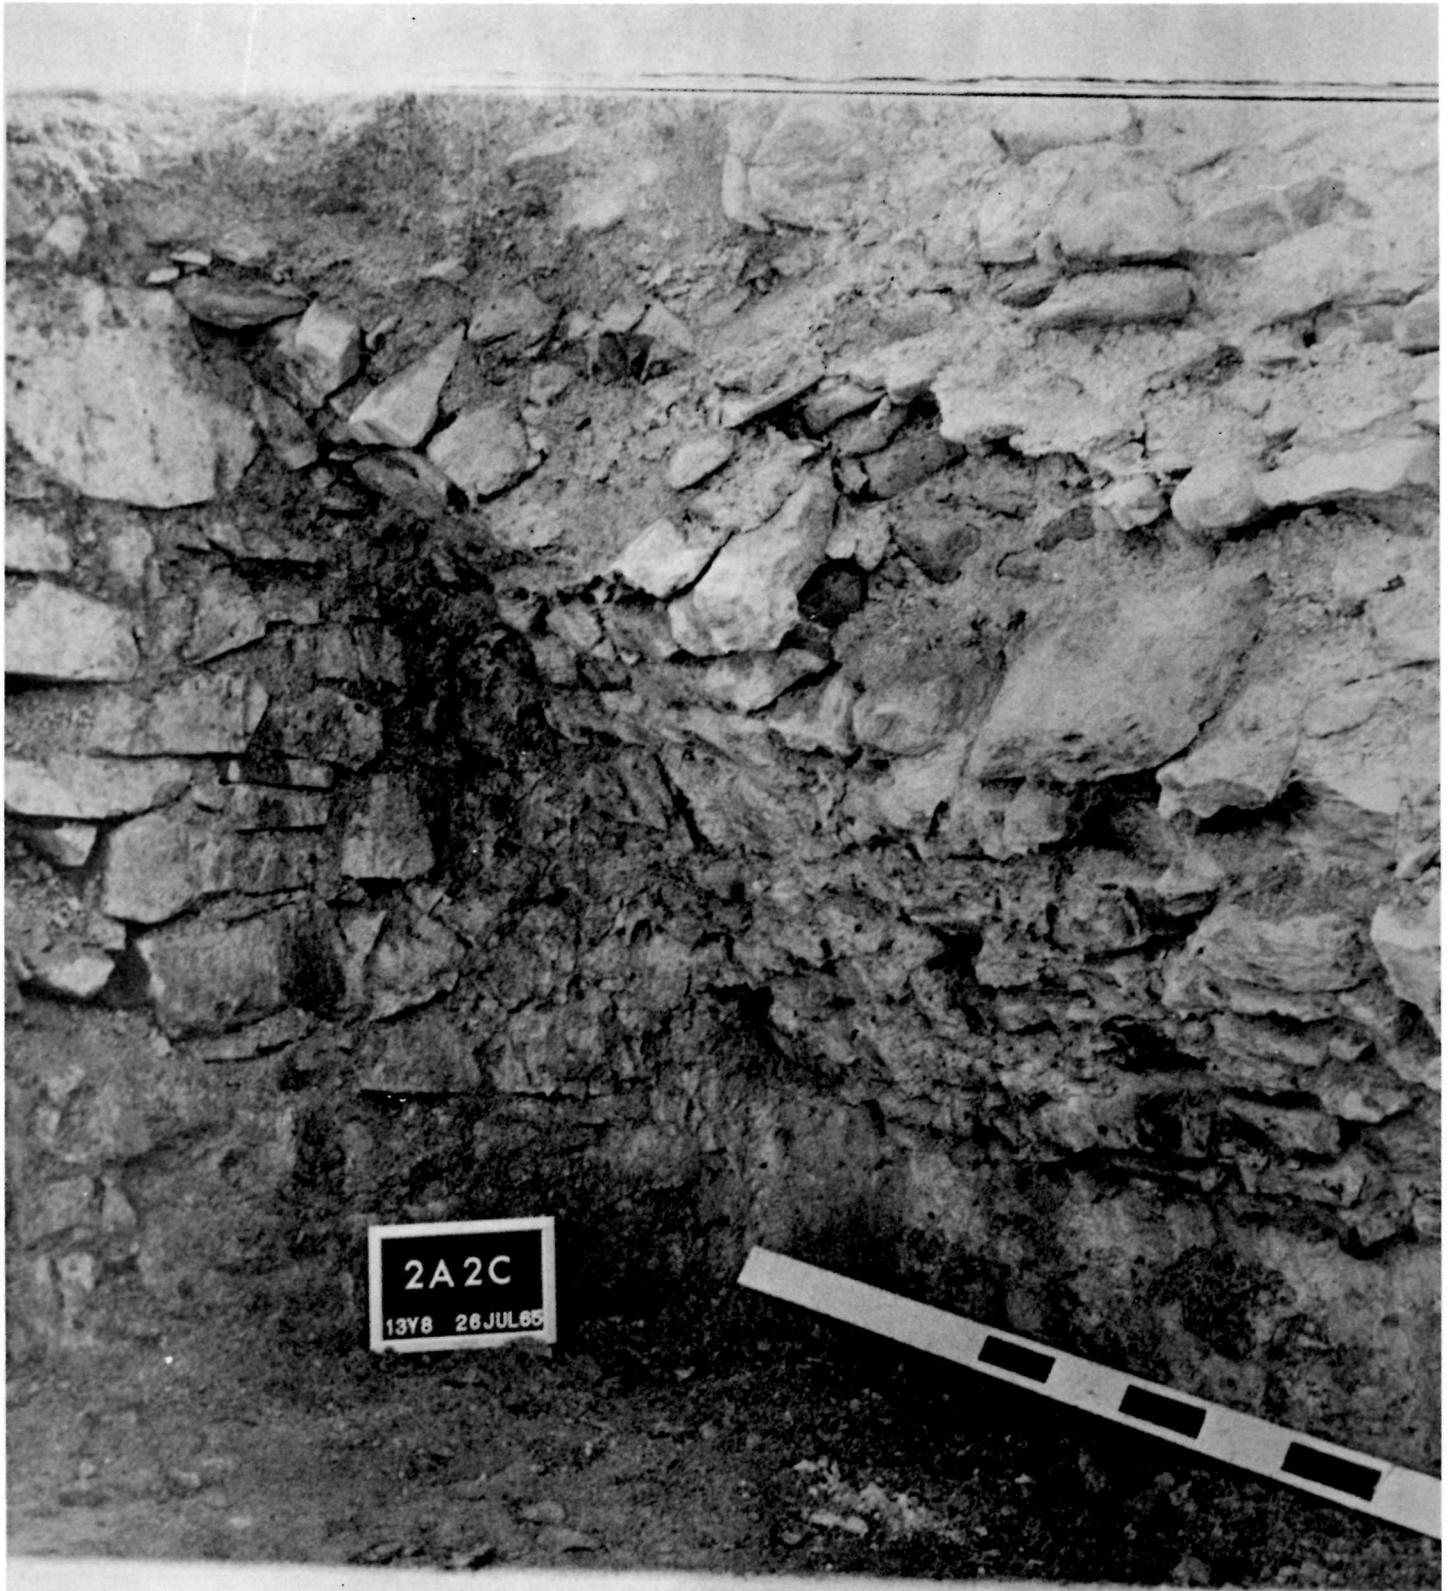
Figure 34. Operation 2. View toward the southwest showing the remnant of the arch in the southwest corner of the magazine. Scale in ft.
