NATIONAL HISTORIC SITES SERVICE

MANUSCRIPT REPORT NUMBER 46

EXCAVATIONS AT CASTLE HILL

September 1971

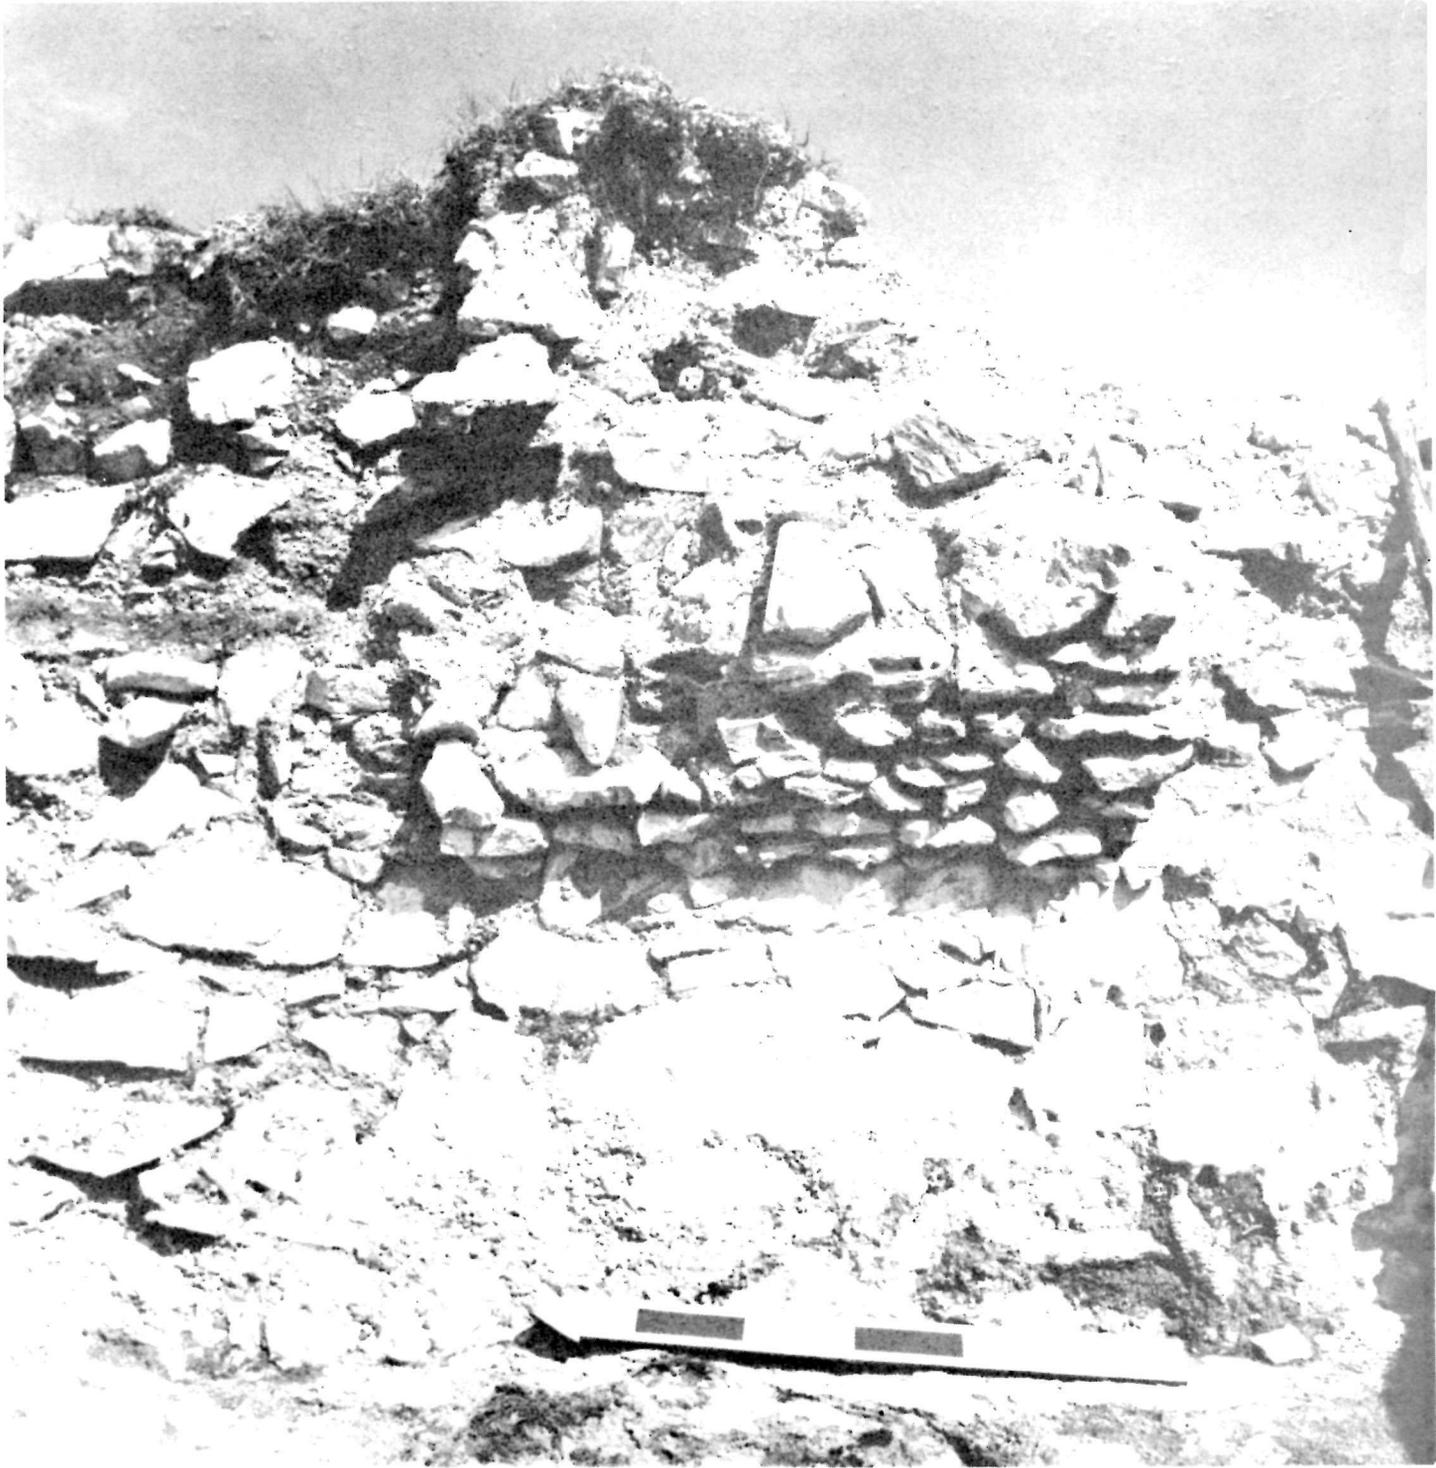
Figure 35. Operation 2. View toward the east showing a portion of the east wall of the magazine. Remnant of the arch may be seen above the vertical wall. Scale in ft.

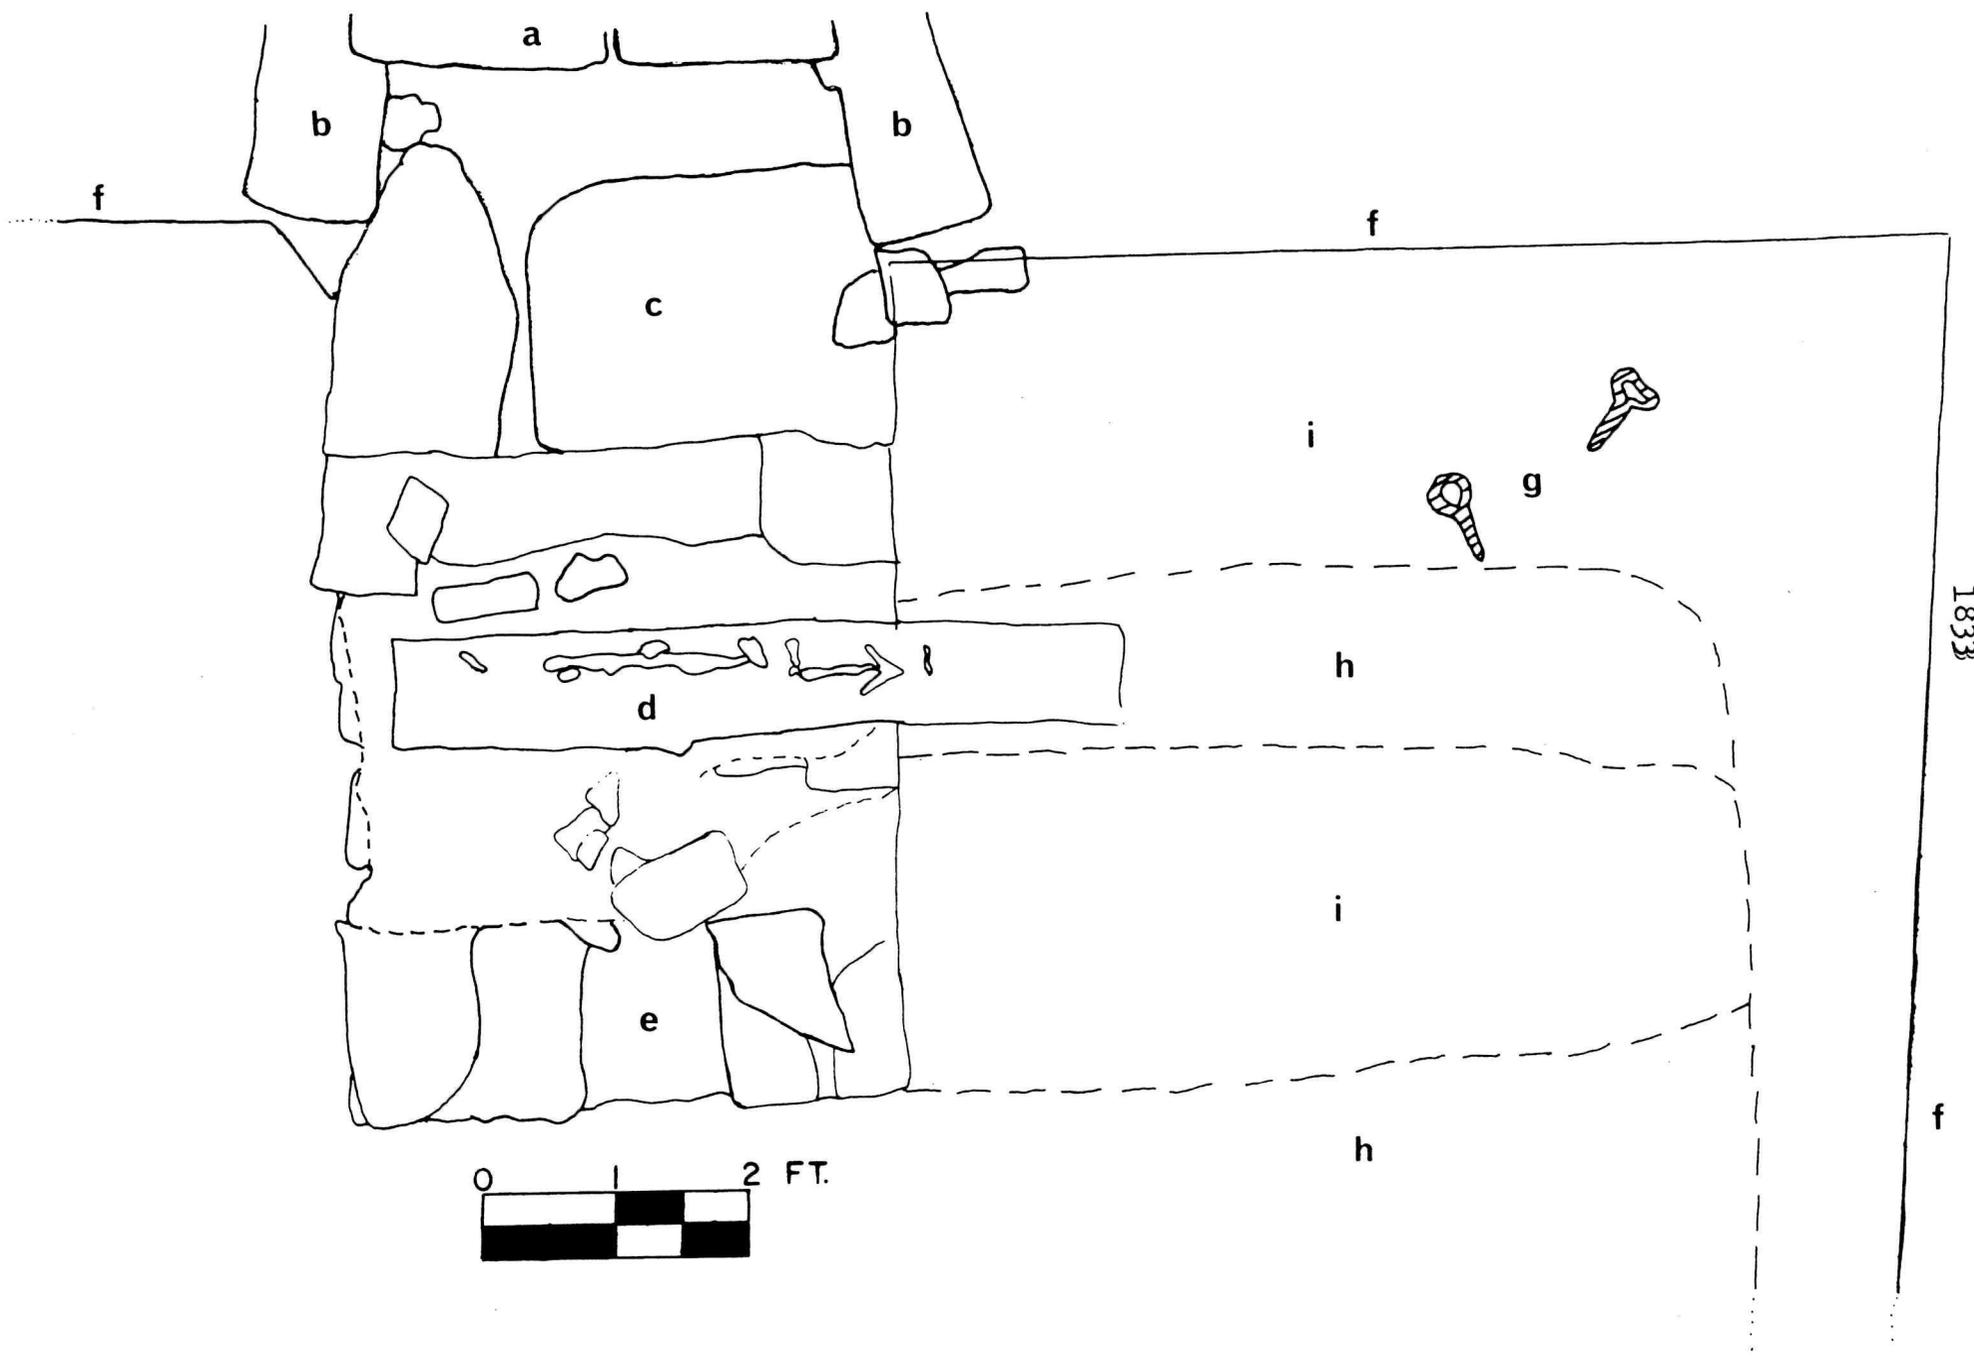
Figure 36. Operation 2. Floor plan of sub-operation 2C showing magazine stairway and door.

Features shown: operation 1 threshold (a), cut stones in doorway (b), threshold at top of stairs inside magazine (c), grey clay and wood stains (d), bottom stair tread (e), line of magazine wall (f), eyebolts on floor level (g), black stained sandy deposit (h), loose tan mortar (i). Scale in ft.

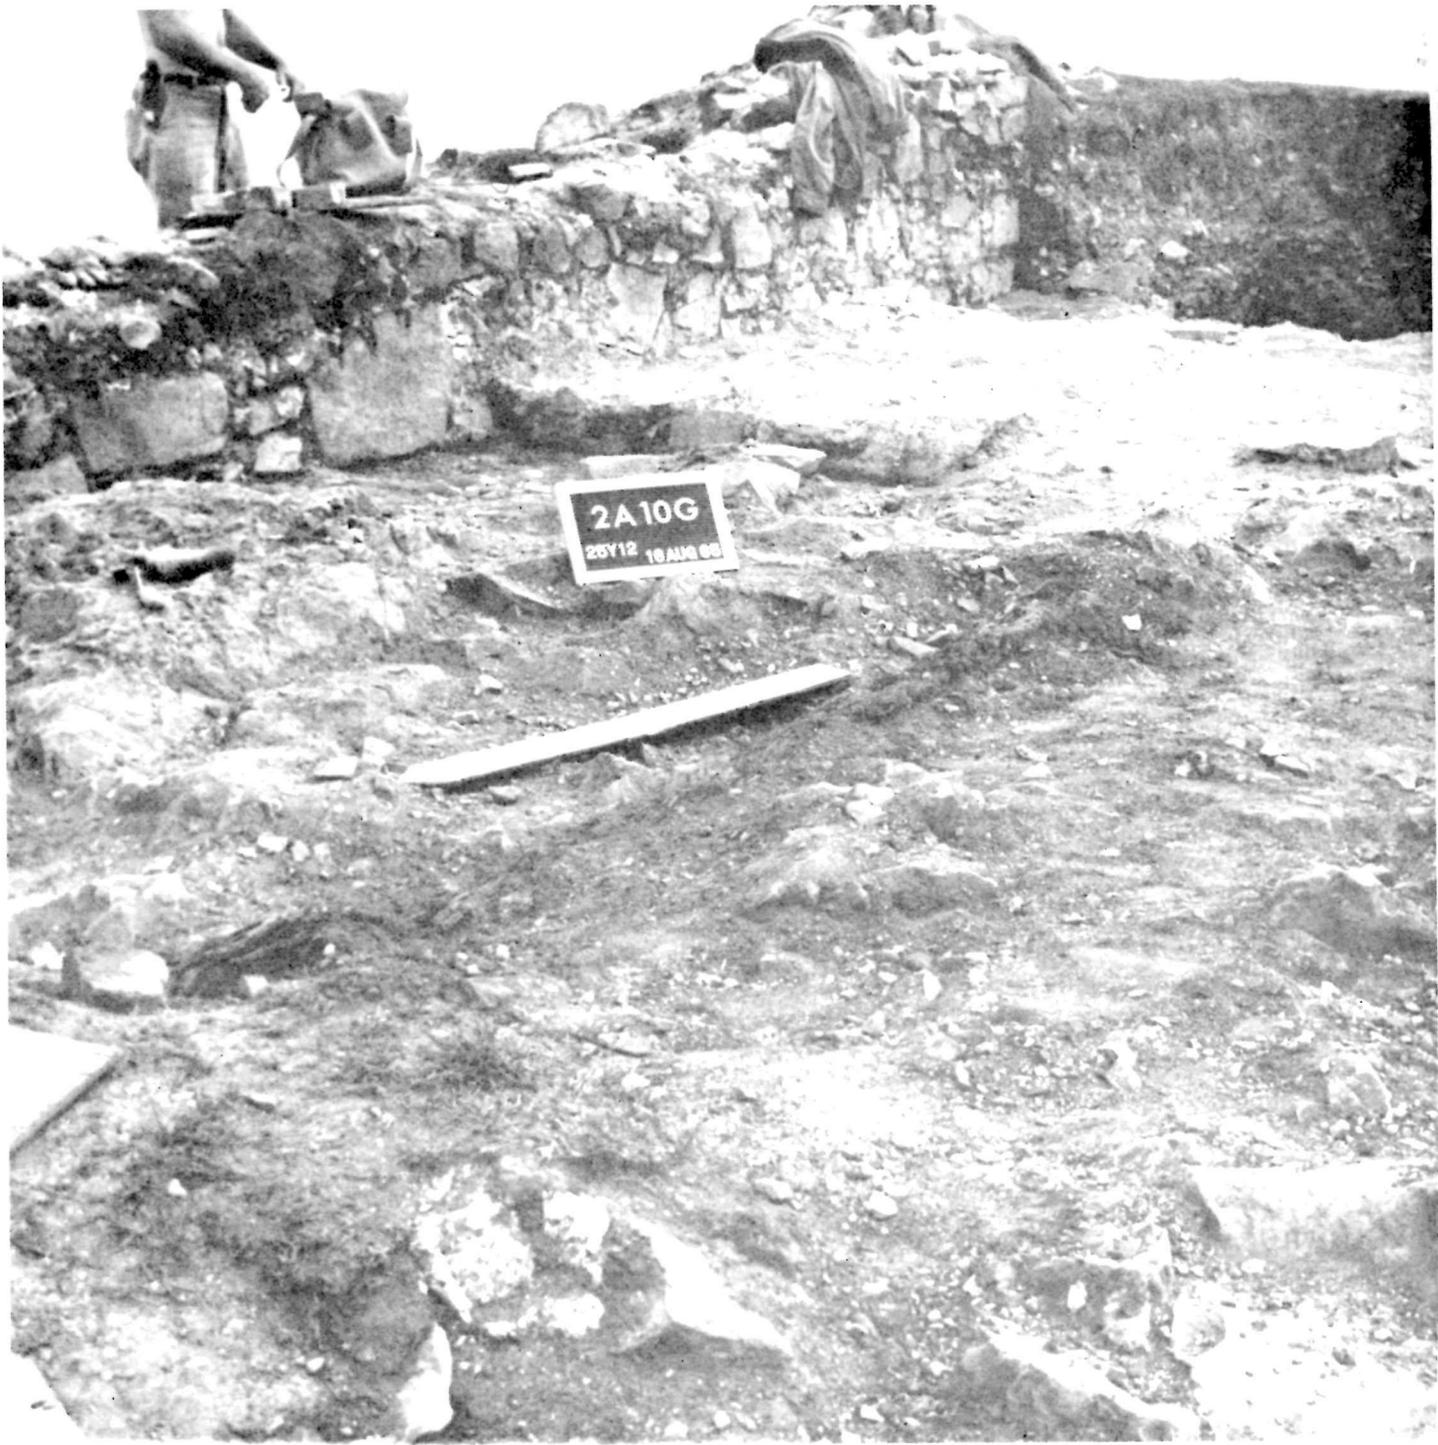
Figure 37a. Operation 10. View looking toward the southeast at sub-operation 10G. Rotted floor sleeper beam in centre near scale, hearth platform adjacent to west wall of operation 7 in background.

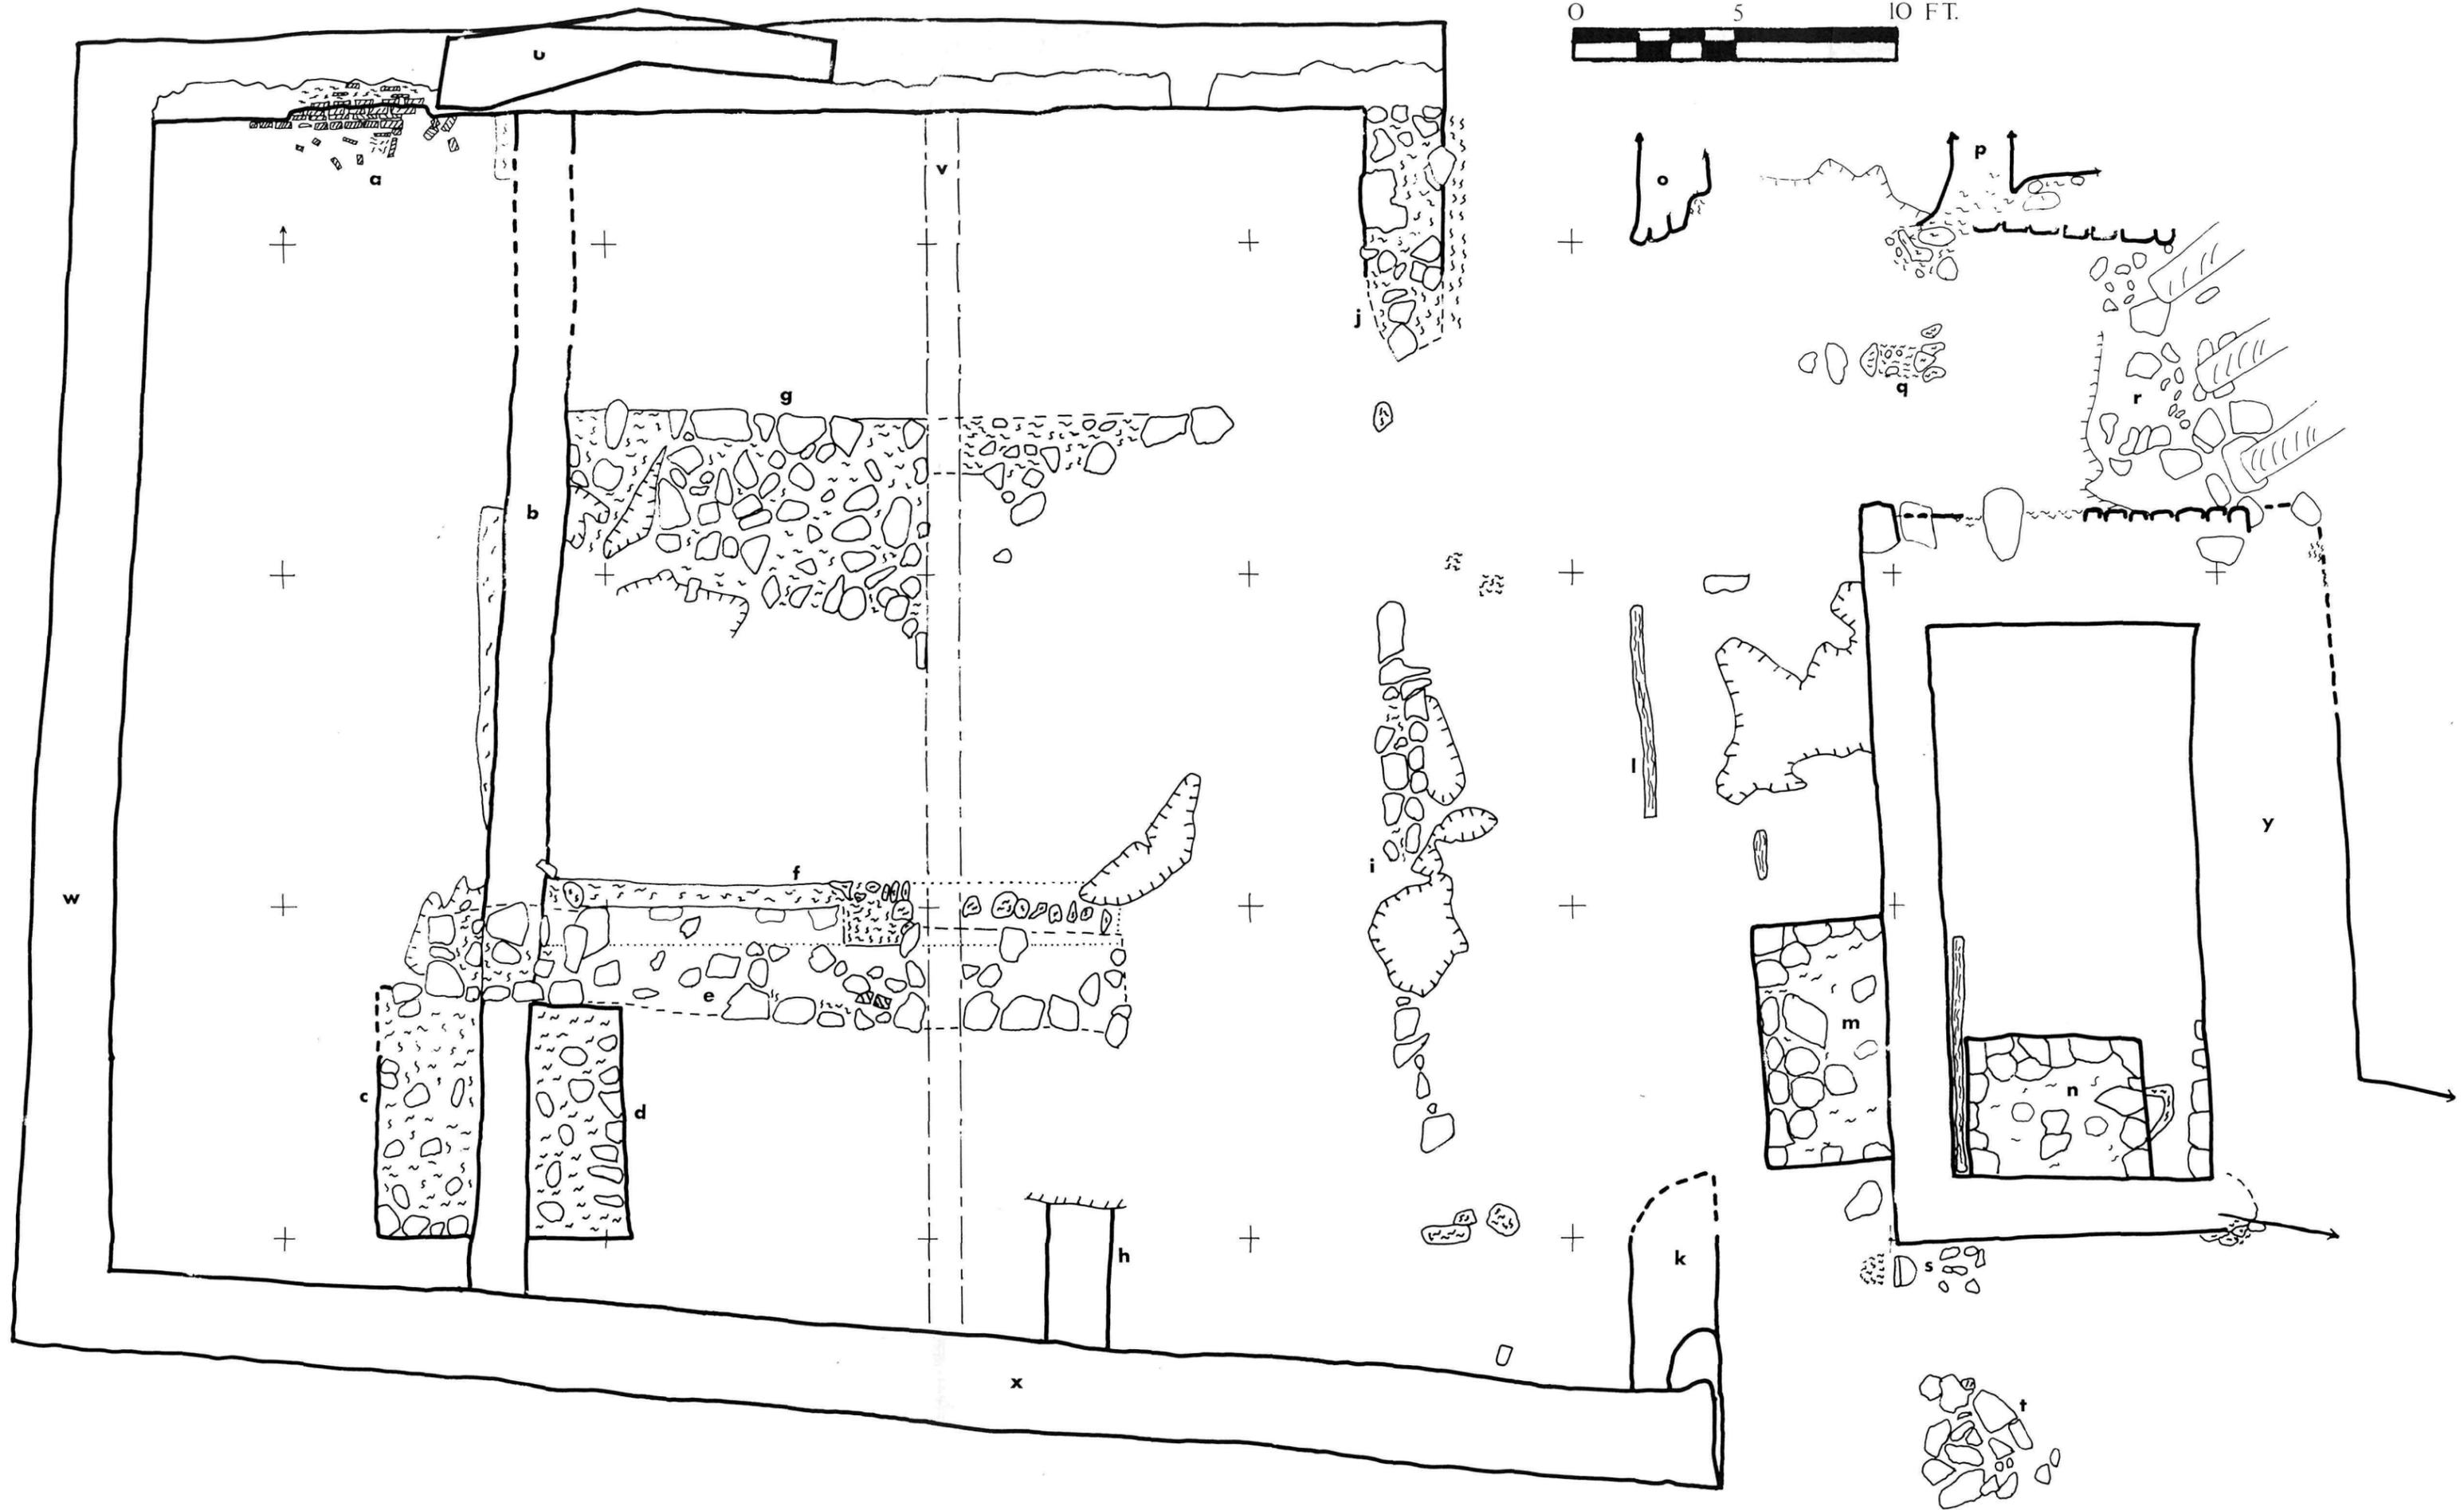
FIGURE 38

Figure 38. Operation 10. Plan of operation 10 area showing various architectural features. Features shown: French brick fireplace (a), French barracks wall (b), French hearth base (c,d), English blockhouse foundation (e), French barracks wall adjacent to and beneath blockhouse foundation (f), English blockhouse hearth base (g), French barracks wall remnant (h), English storehouse foundation remnant (i), northeast revetment wall (j), southeast revetment wall (k), wooden floor beam (l), English hearth platform (m,n), masonry wall between stair area up to gun platform (on left side of wall) and operation 1 ramp down to magazine (on right side of wall) (o), wall between operation 1 and sub-operation 6B (p), mortar stain and rubble on bedrock in entrance area, probably footer for English stair into guardroom (q), pavement in entrance, operation 8, partly obscured by modern footbridge sleepers (r), English stair in 9E (s), rubble revetment (?) in 9E (t), modern monument in north revetment wall (u), unexcavated baulk, line of cross-section of site (v), west revetment wall (w), south revetment wall (x), east curtain wall, part of operation 7 (y).

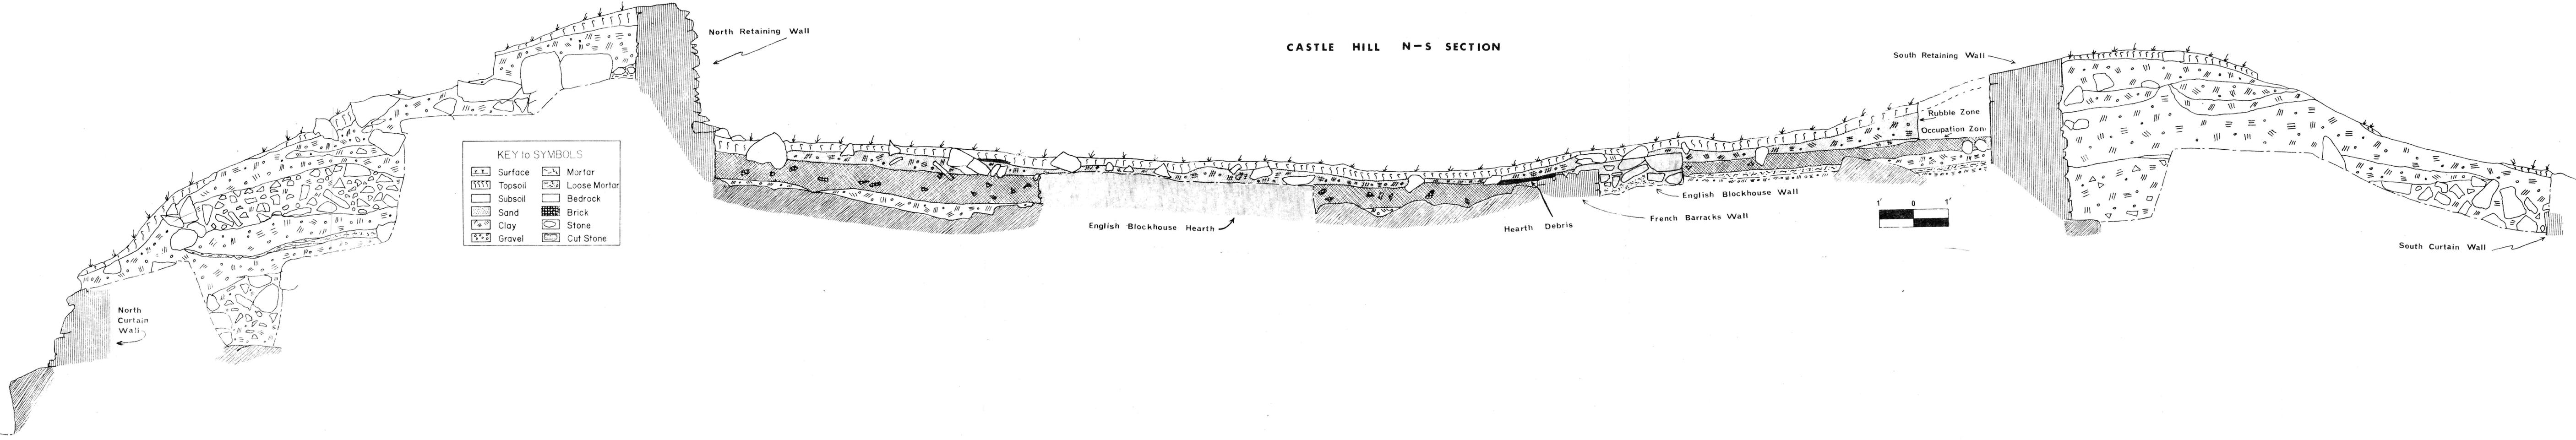
FIGURE 39

Figure 39. Cross-section of the site. Profile, looking east, across centre of site, comprised of profiles in sub-operations 9B, 10D and 9C. Illustrates fill stratigraphy in interior of redoubt and relationship of curtain walls to bedrock knob core of the fort. Stratigraphic elements indicated on drawing. Scale in ft.

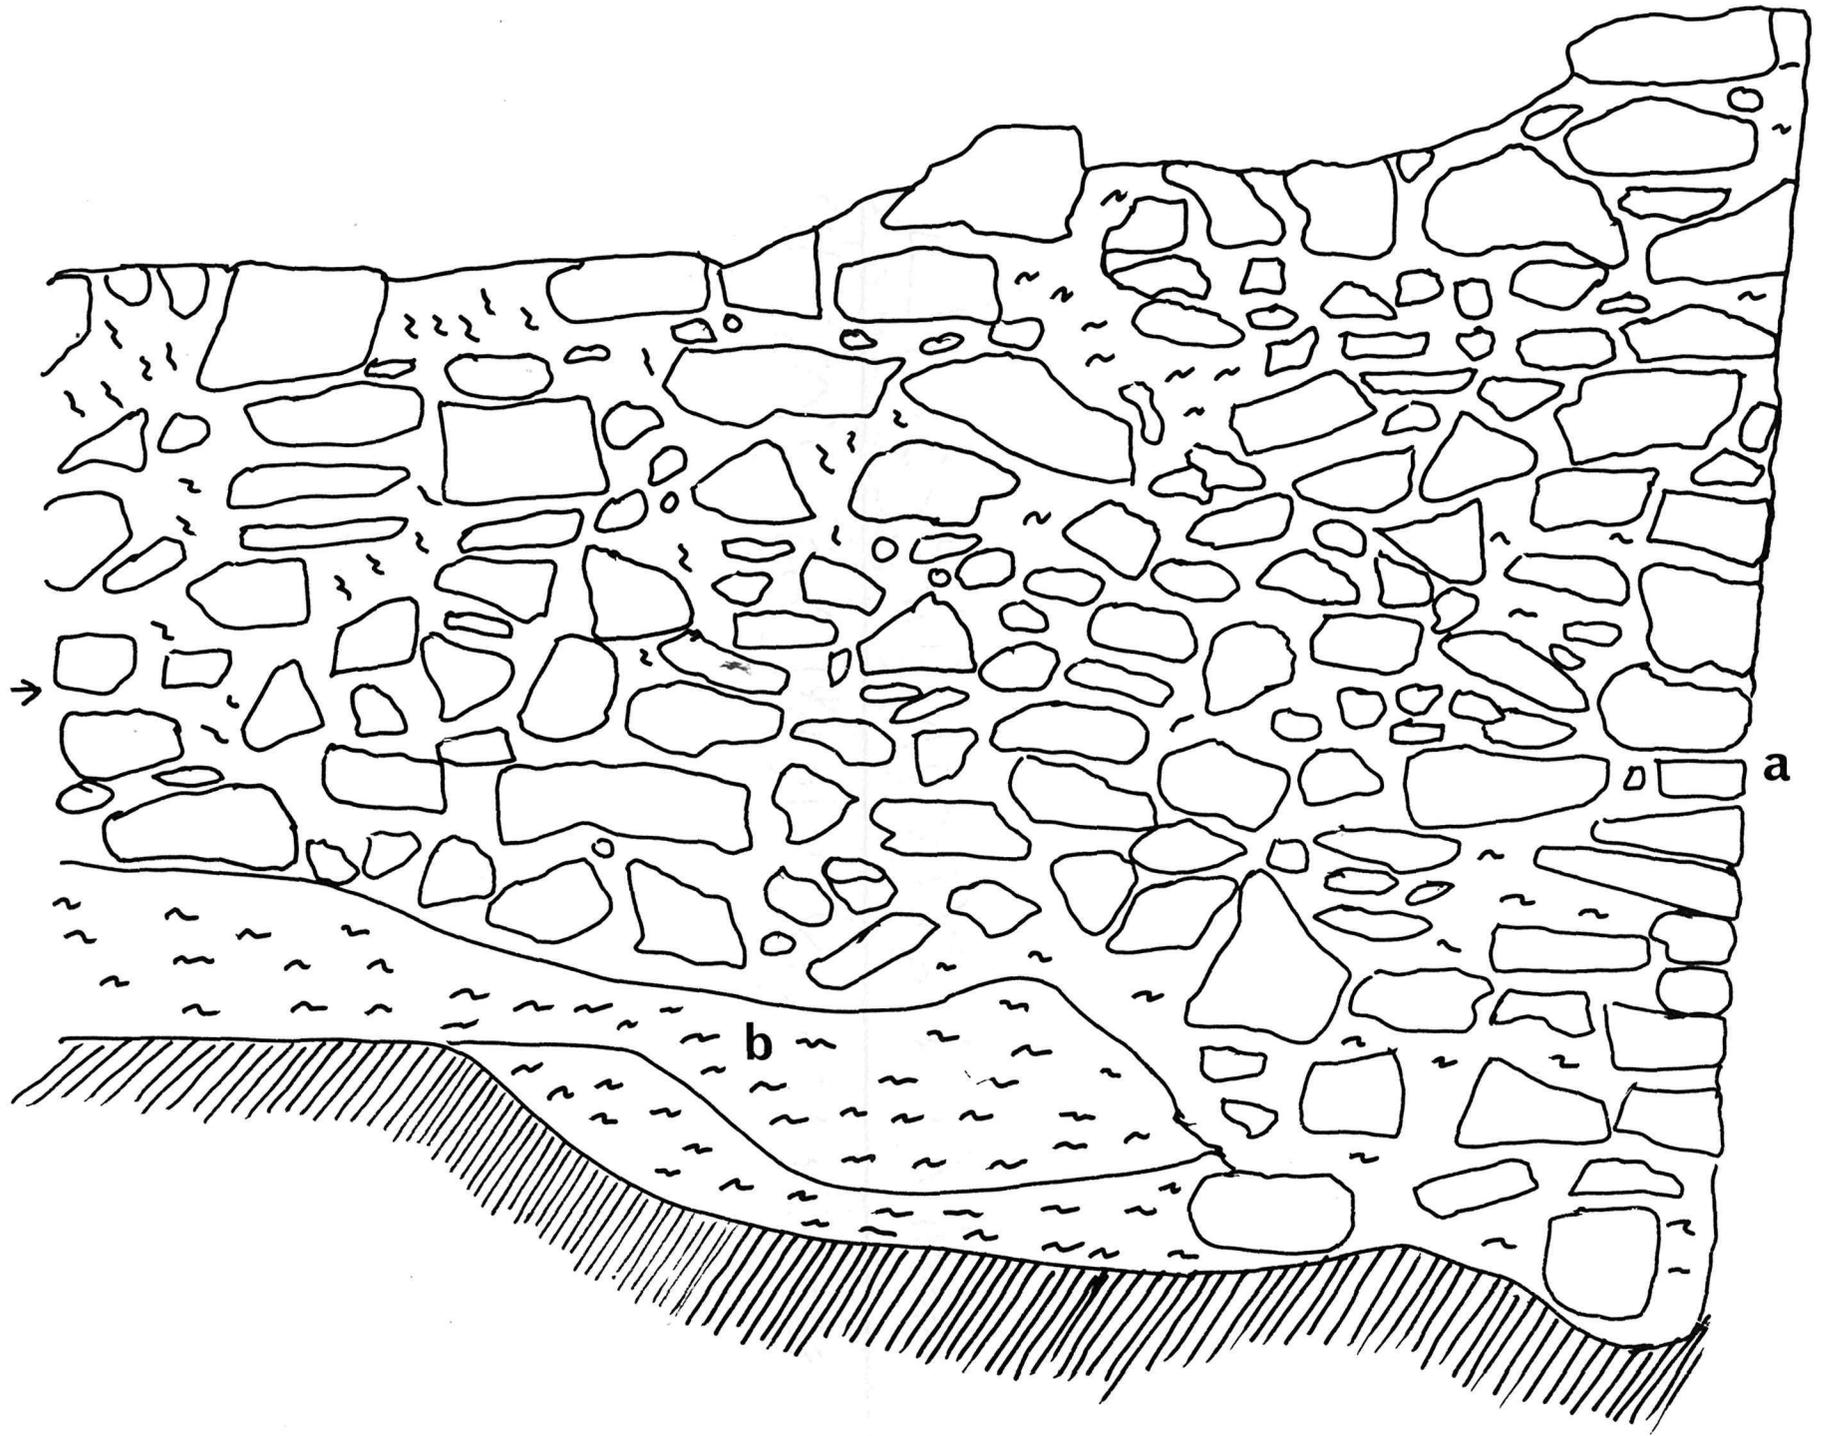
FIGURE 40

Figure 40. Sub-operation 10J. Elevation of the interior side of the south revetment wall at its southwest corner. Line of the west revetment wall (a). Mortar footer (b). Scale in ft.

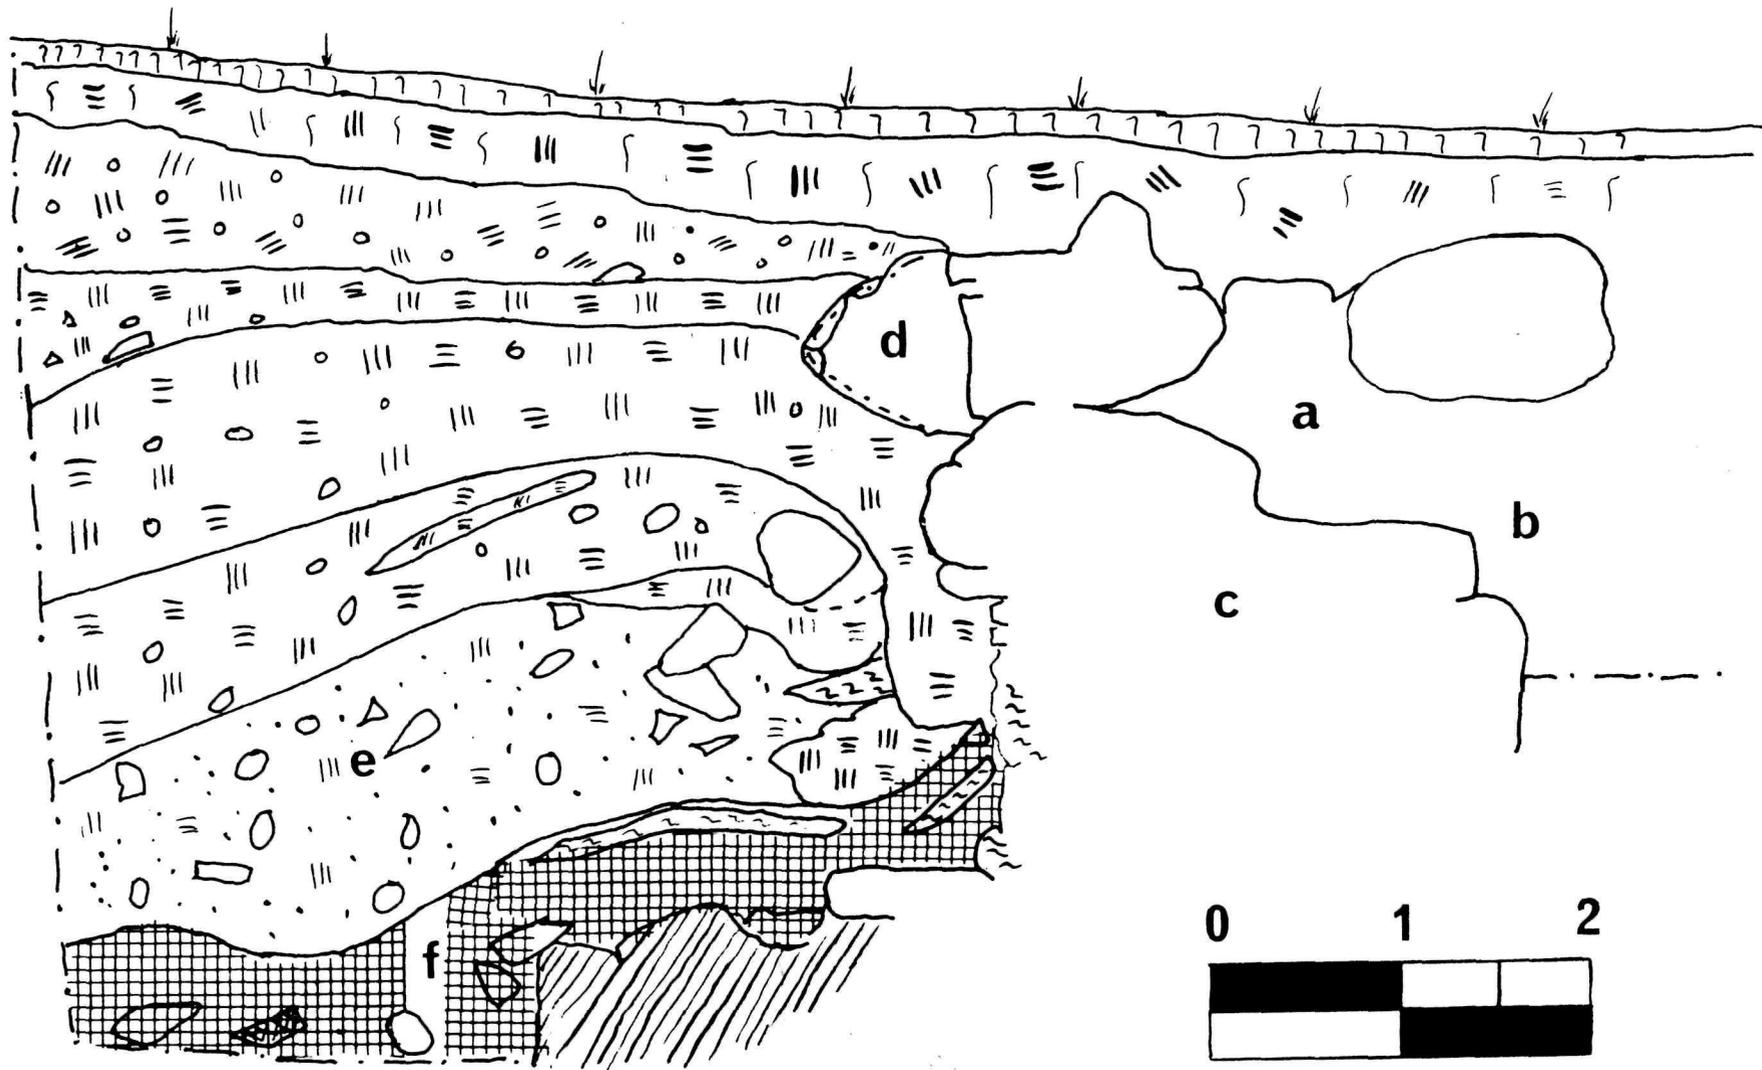
Figure 41. Sub-operation 10B. Looking south at stratigraphic profile at east end of the sub-operation. Features shown: elevation of the south revetment wall (a), line of the revetment corner (b), southeast revetment wall section (c), hollow space in rampart fill (d), refuse deposit (e), and dark stained midden deposit in rampart fill (f). Scale in ft.

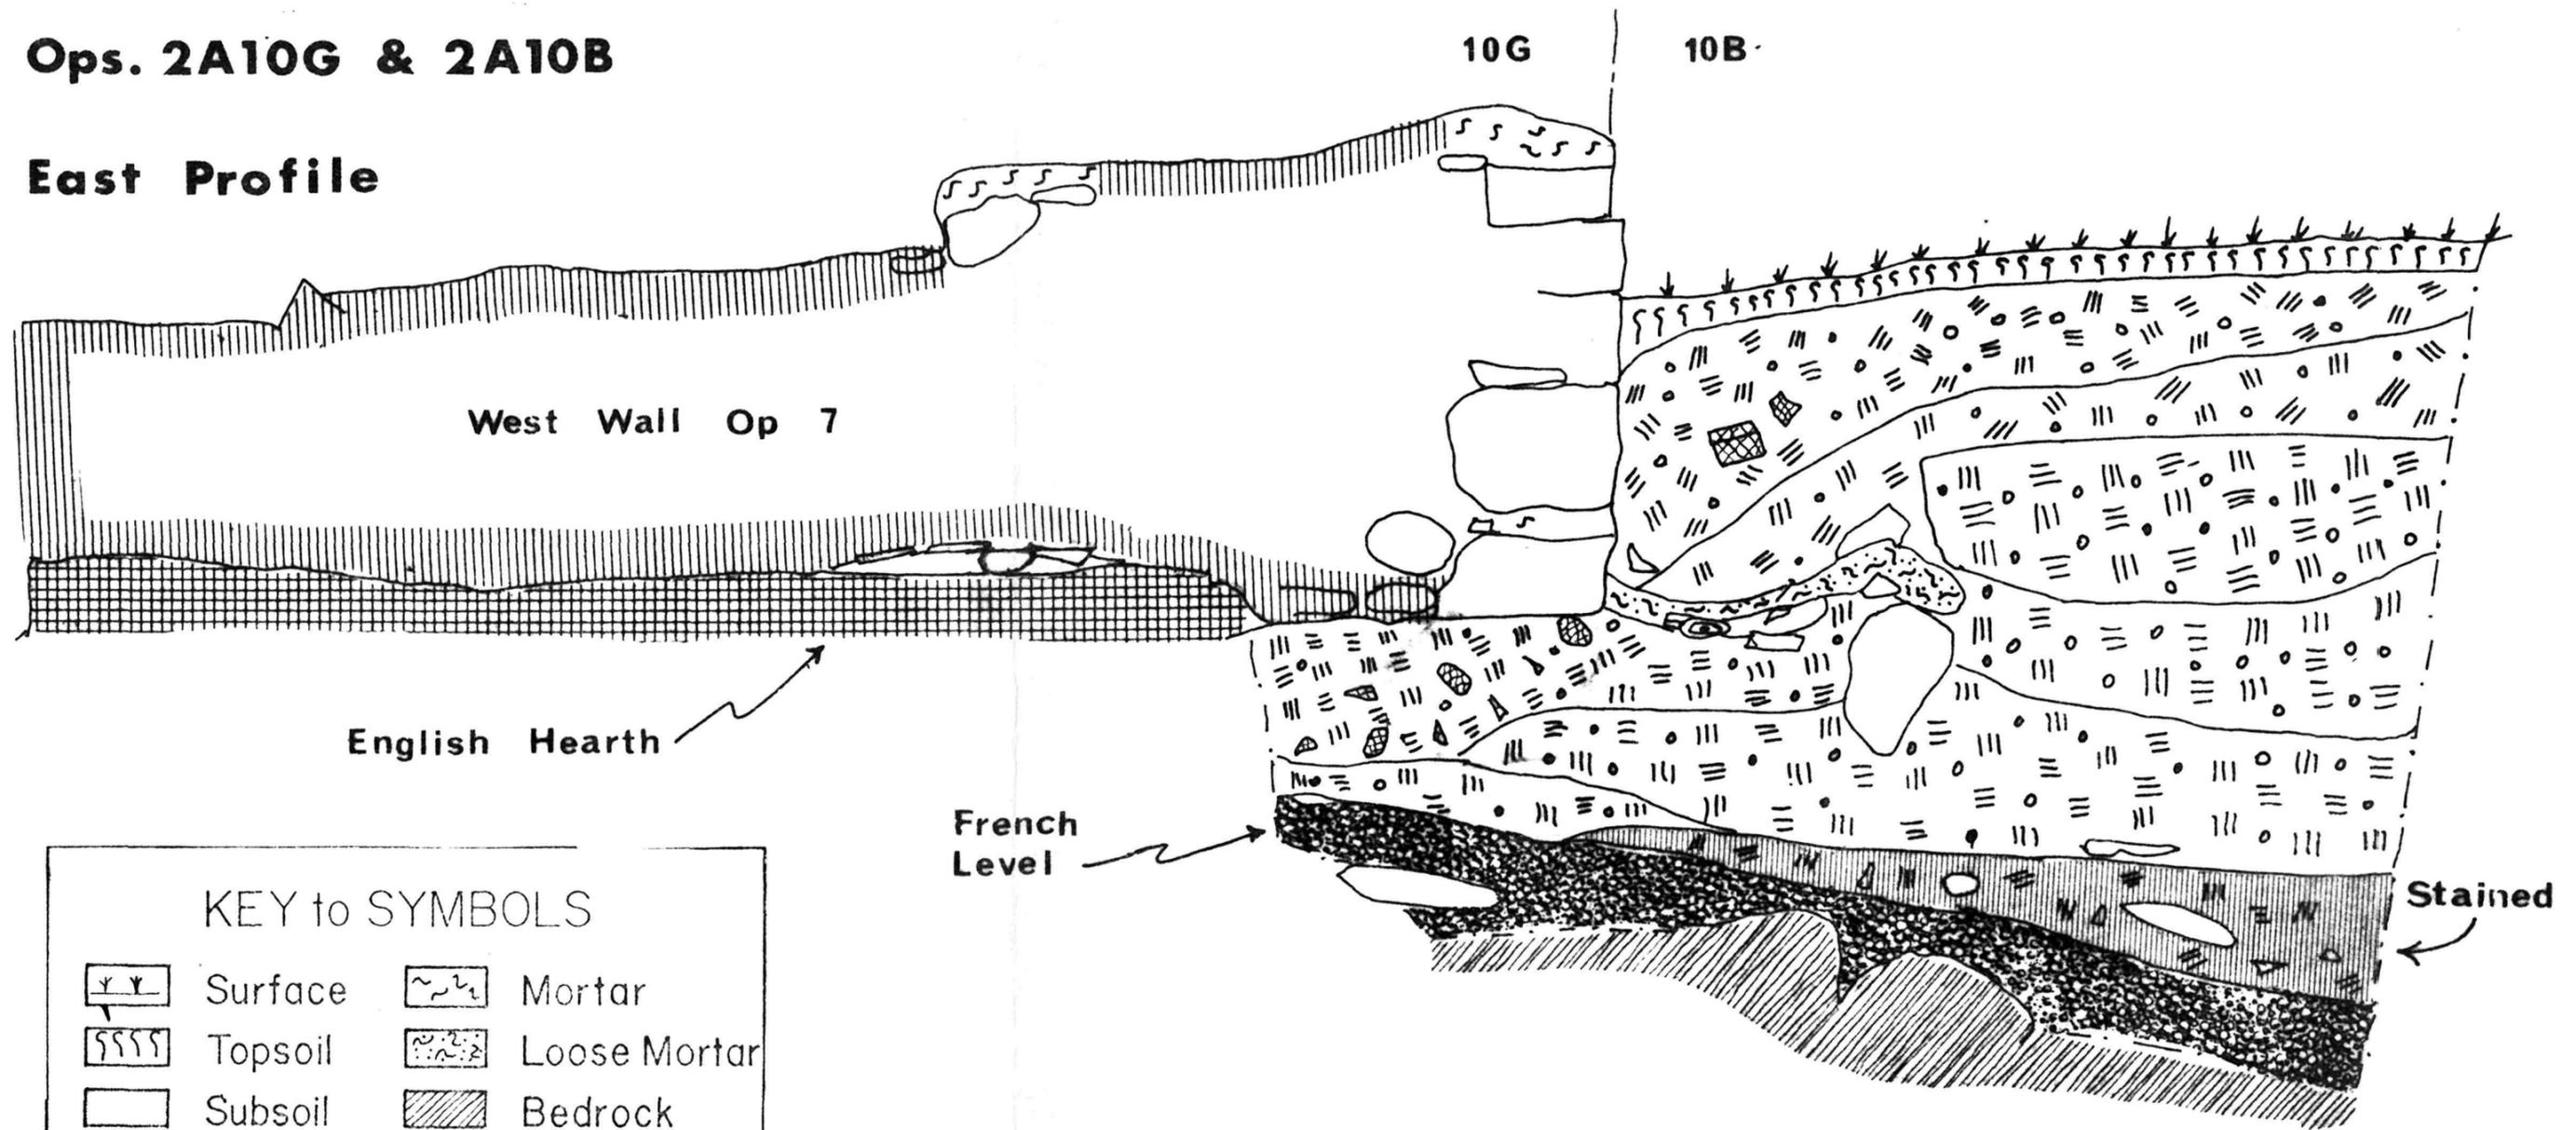
FIGURE 42

Figure 42. Sub-operations 10B and 10G. View toward the east showing wall elevation of operation 7 (wall footer masked by refuse deposits). English hearth platform above the French refuse deposit is in operation 10G and intrusive English stairs in operation 10B also continue into 9E. Scale in ft.

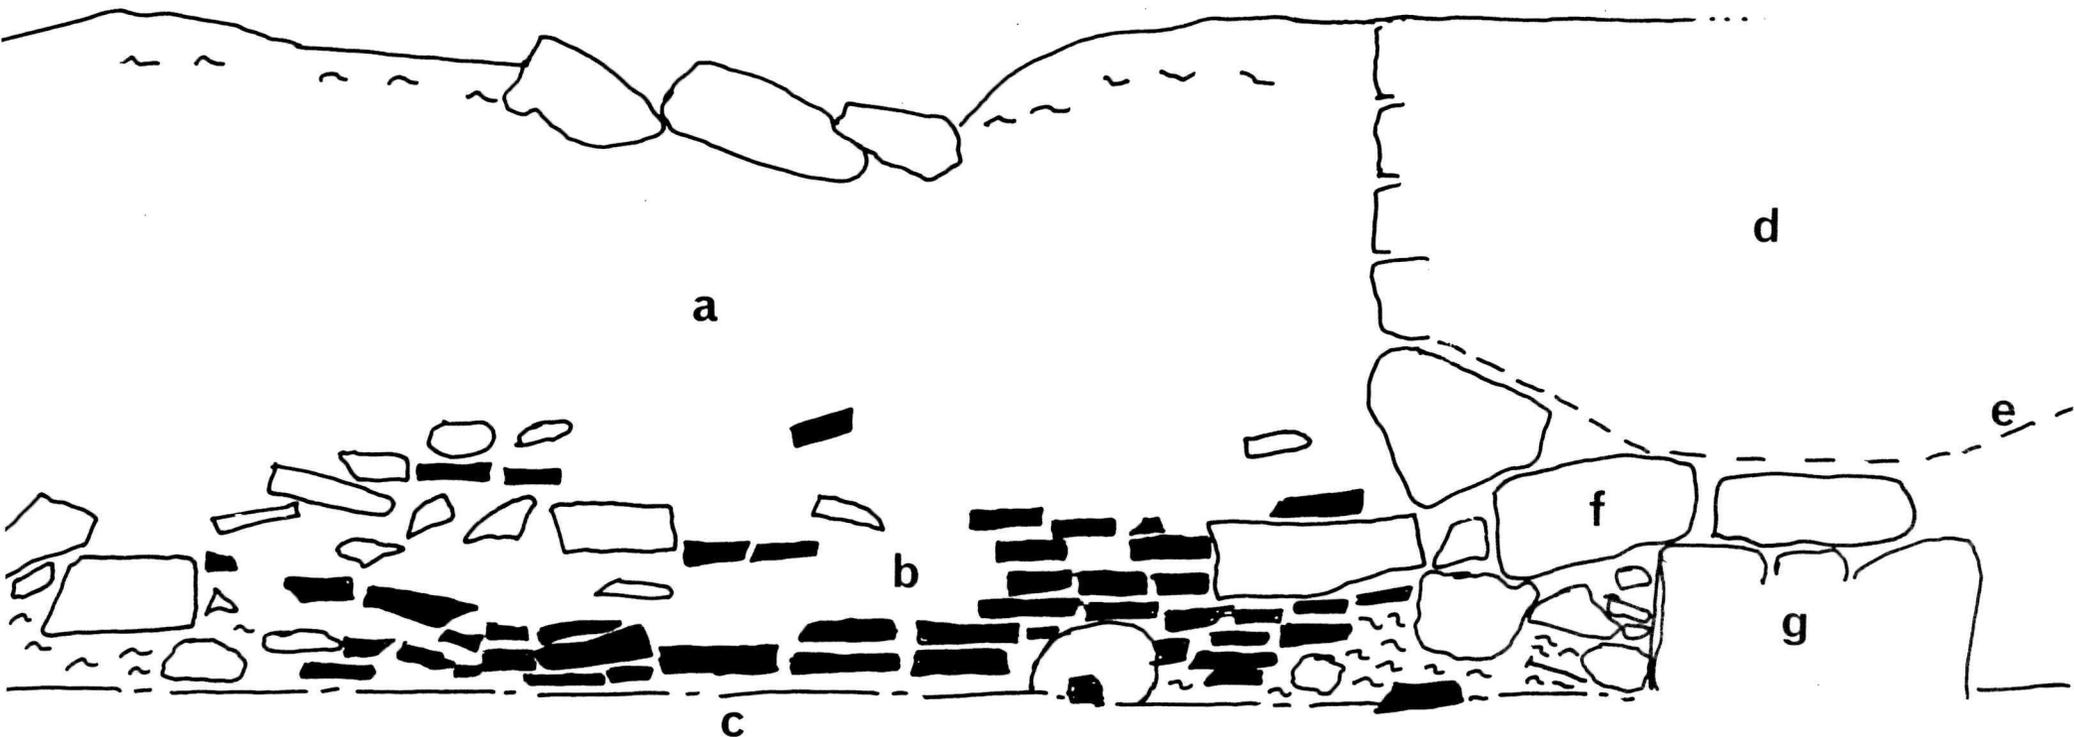
Figure 43. Sub-operation 10C. Elevation showing French brick fireplace in north revetment wall. Features shown: core of north revetment wall (face missing) (a), fireplace bricks mortared into wall, in situ (b), fireplace brick extends horizontally into occupation zone at this level (c), modern monument built into revetment wall (d), line of tuckpointing related to modern monument (e), face stones of north revetment wall (f), **French** barracks wall in section (g), limit of the brick debris in occupation zone (h). Scale in ft.

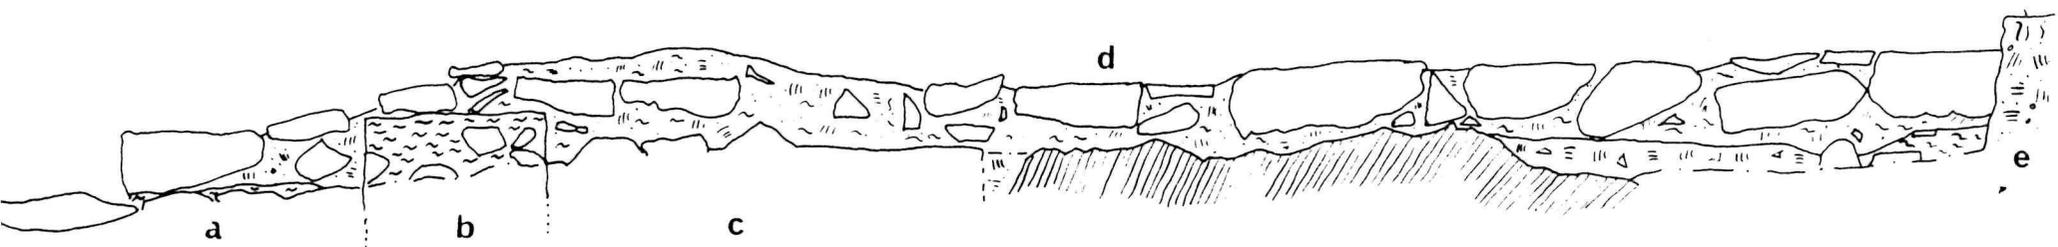
Figure 44. Sub-operation 10C and 10D. View toward the north showing elevation of English blockhouse foundation stratigraphically above French barracks wall. Features shown: French hearth base (a), French barracks wall (b), French hearth base (c), English blockhouse foundation (d), unexcavated baulk (e). Scale in ft.
