NATIONAL HISTORIC SITES SERVICE

MANUSCRIPT REPORT NUMBER 46

EXCAVATIONS AT CASTLE HILL

September 1971

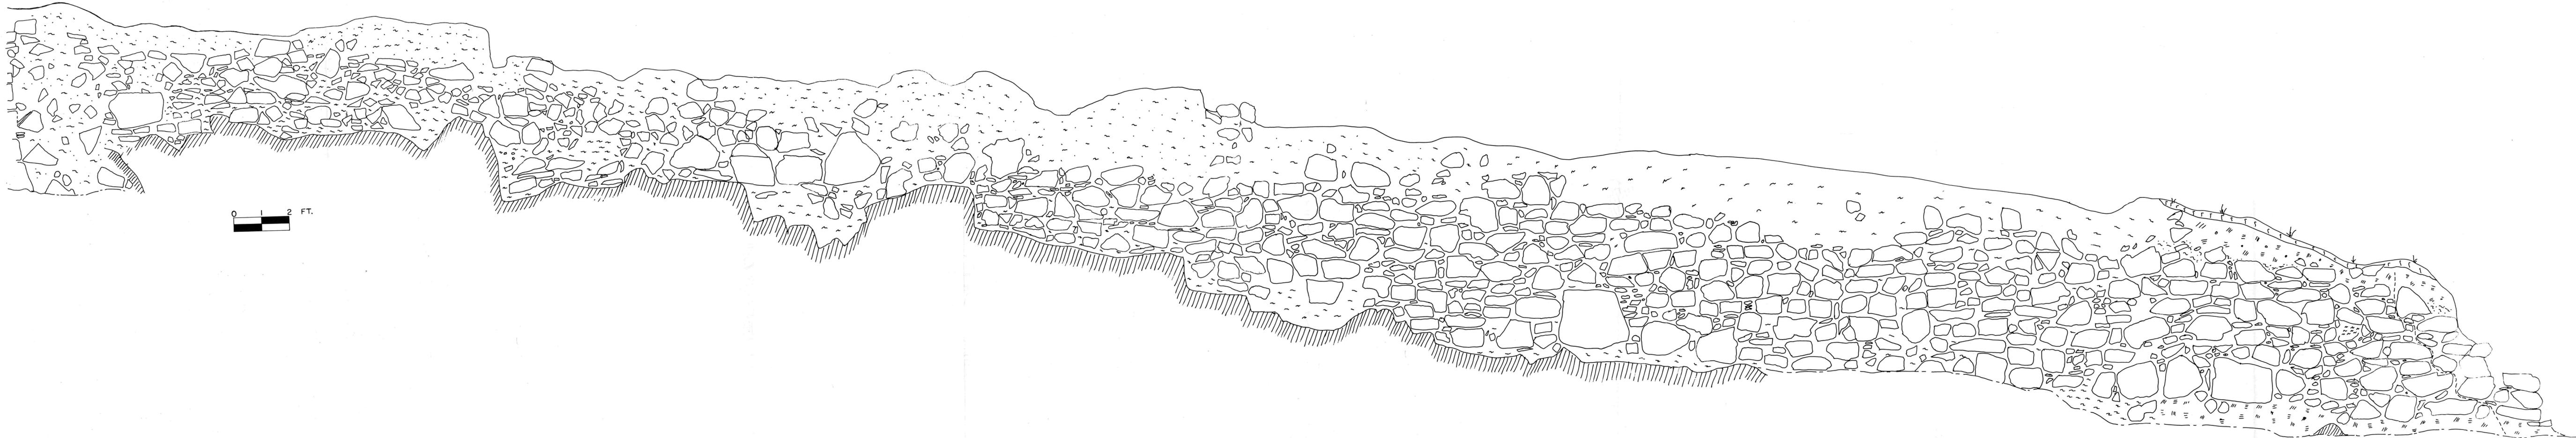
FIGURE 47

Figure 47. Sub-operation 3A. Elevation of north
curtain wall from re-entrant to salient angle.
Scale in ft.

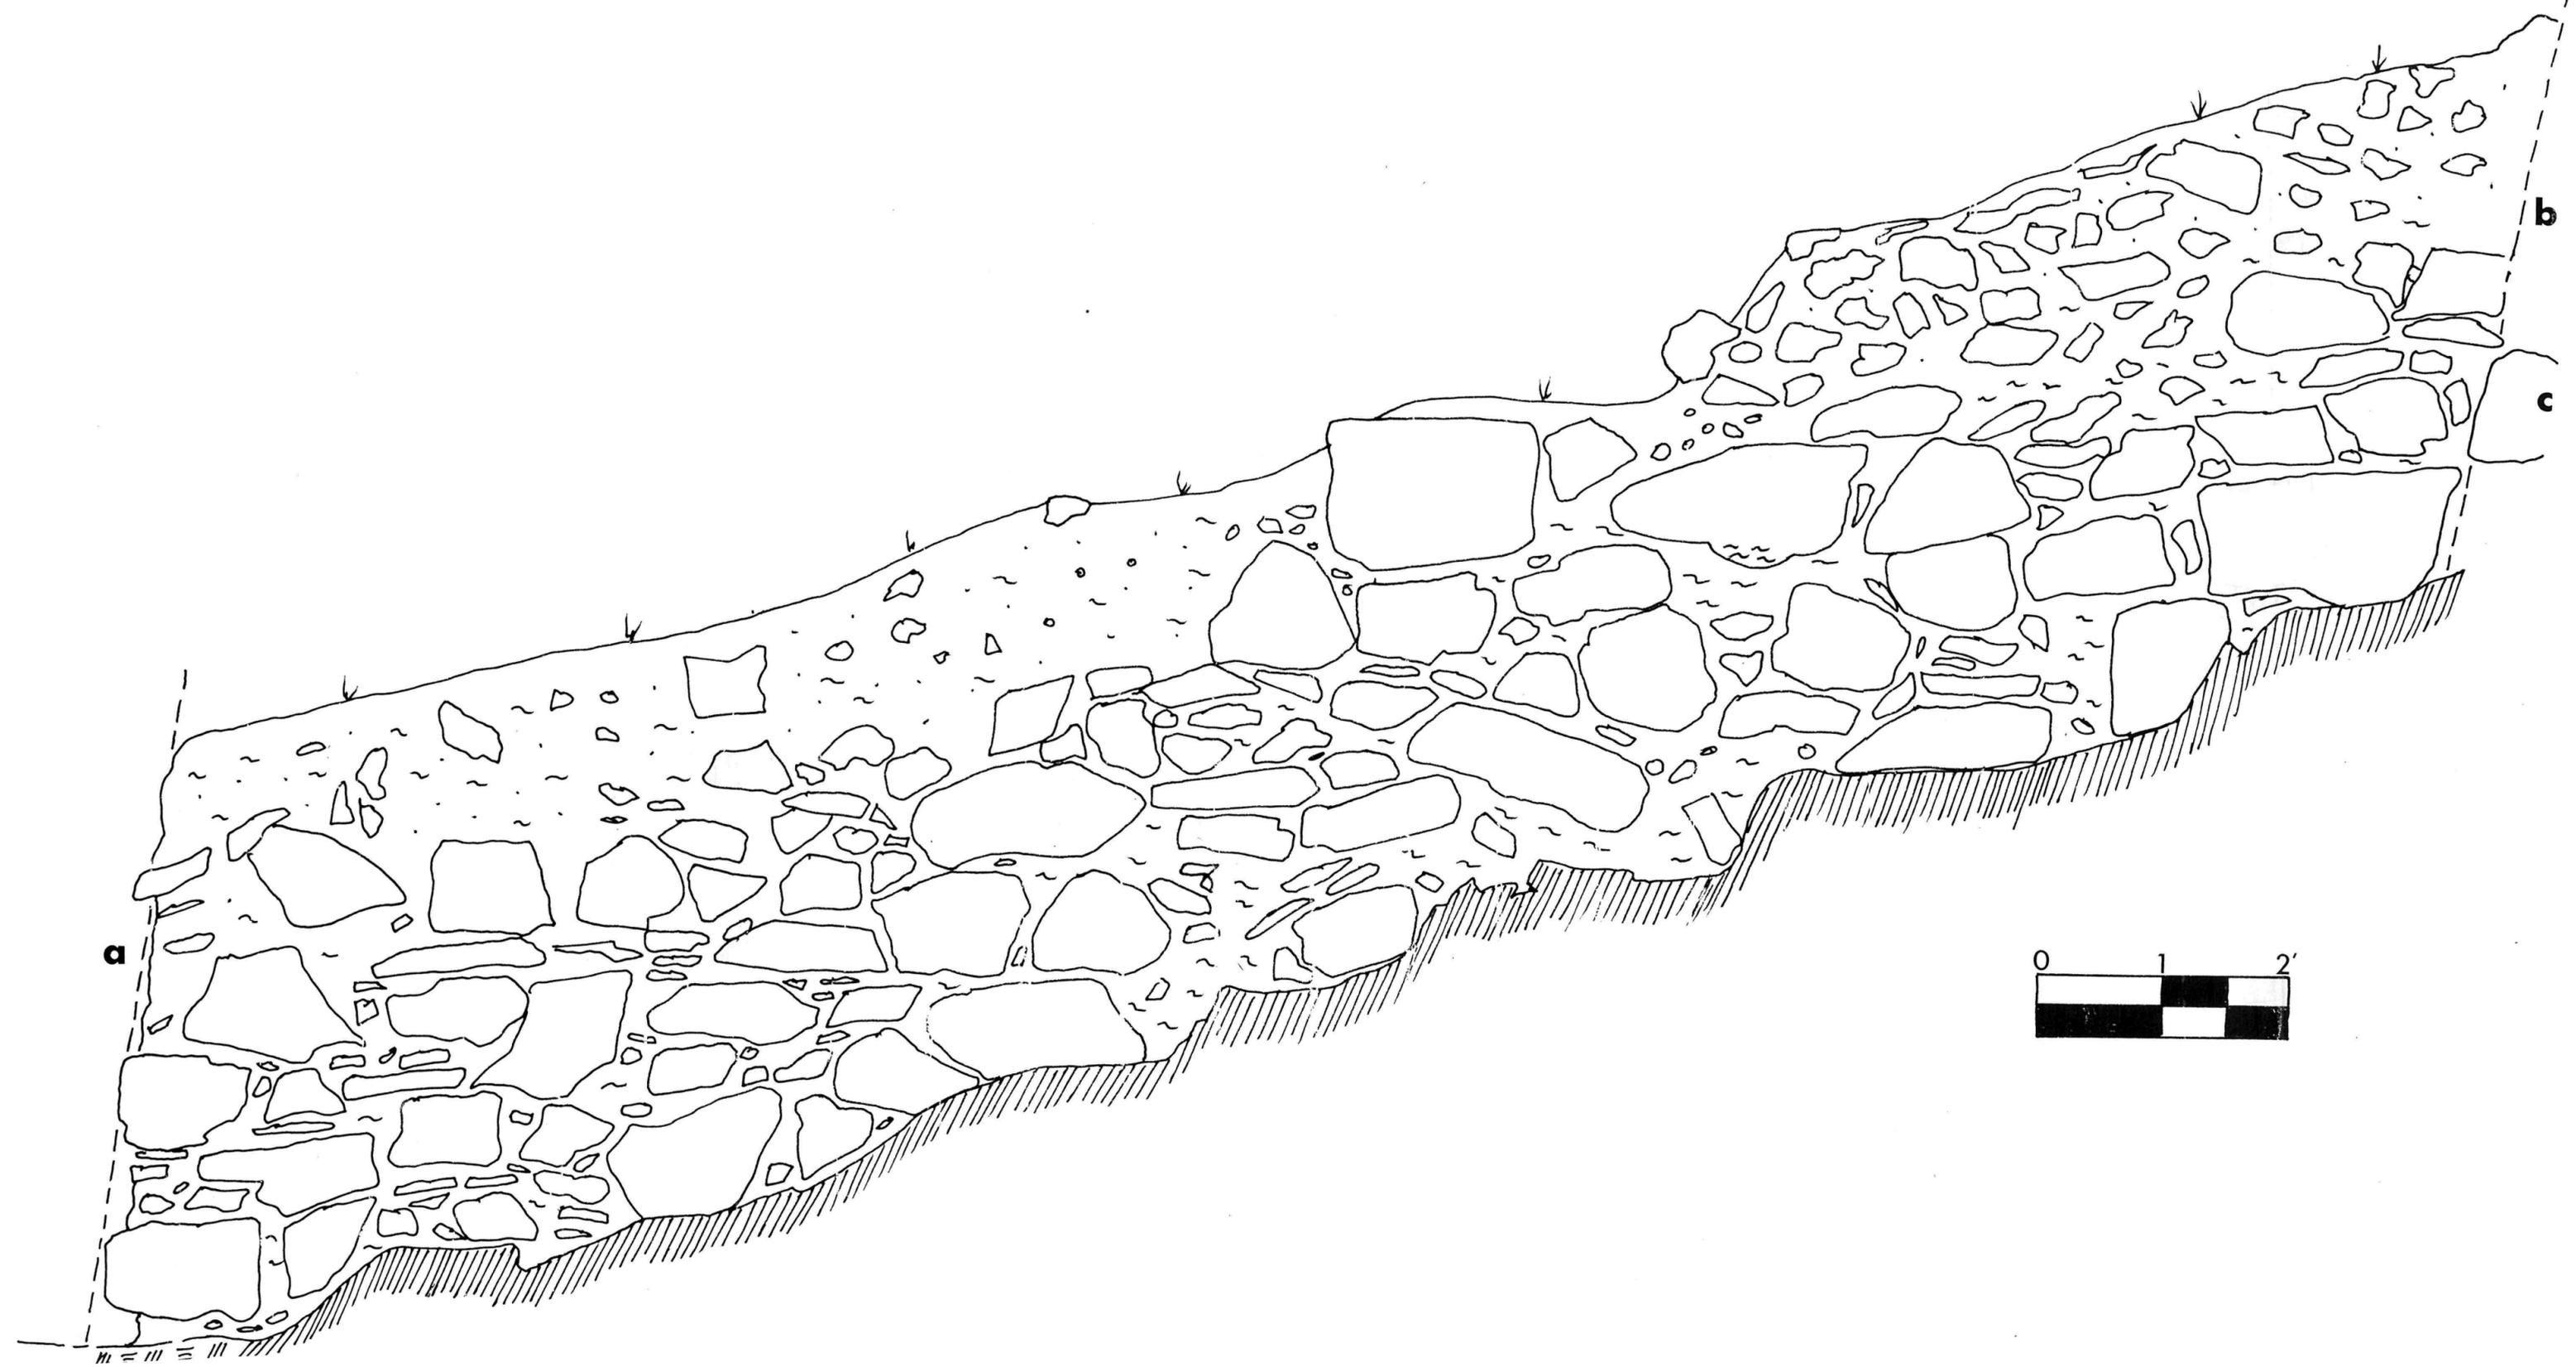
FIGURE 48

Figure 48. Sub-operation 3B. Elevation of the west flank of the northeast bastion. Features shown: Shoulder angle (a), line of re-entrant angle (b), stone in north curtain wall at re-entrant angle, in situ (c). Scale in ft.

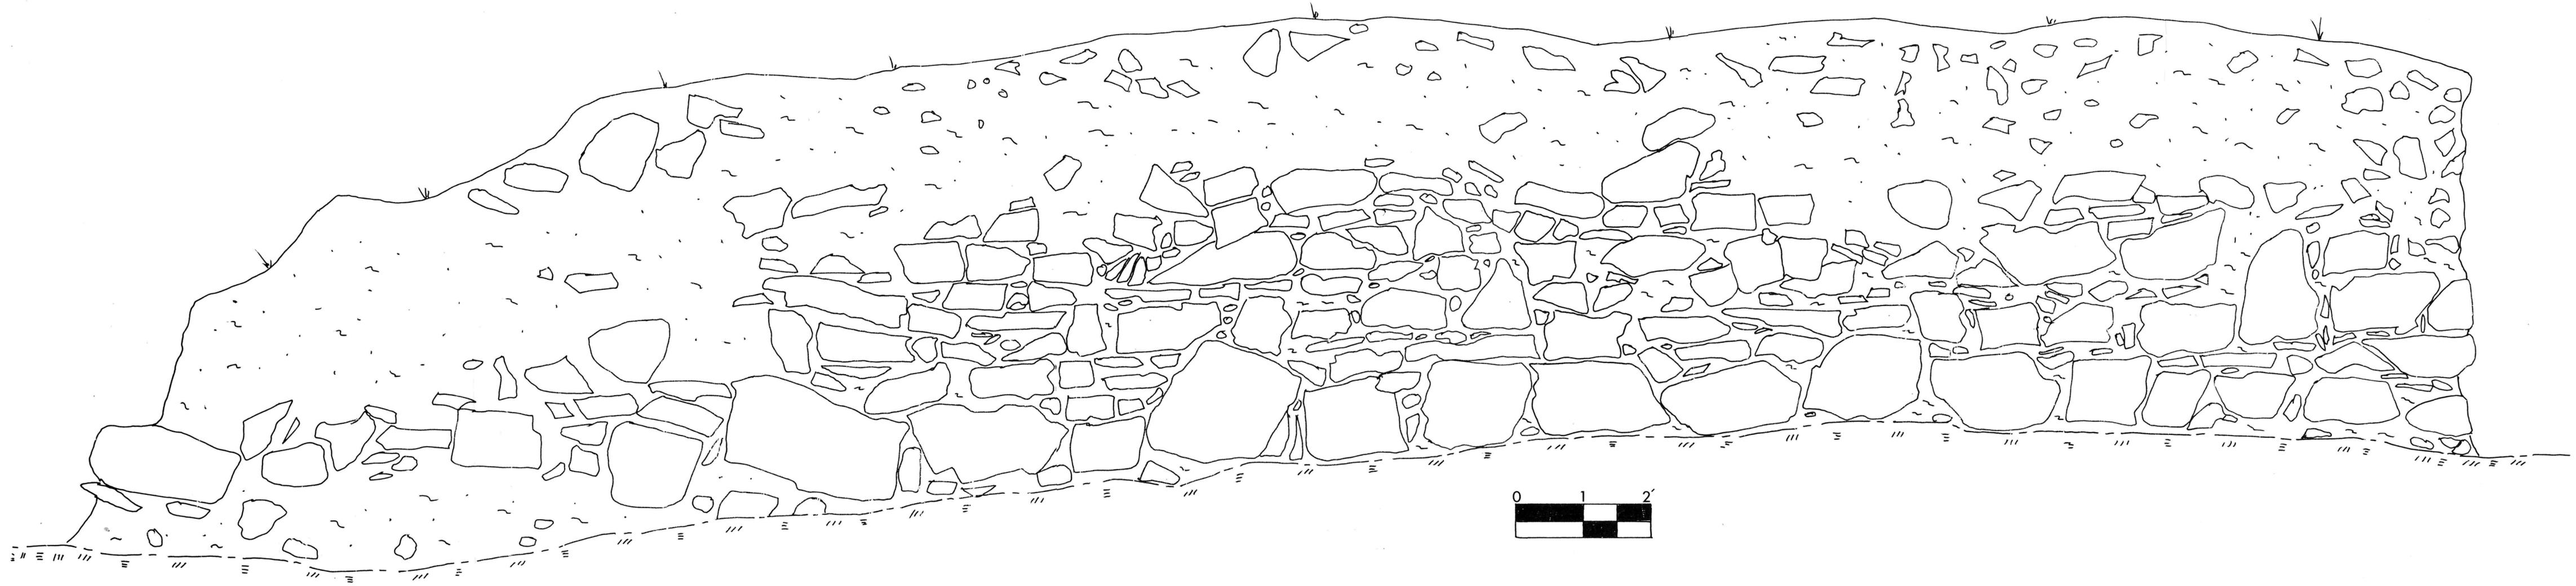
FIGURE 49

Figure 49. Sub-operation 3C. Elevation of north face of the northeast bastion from shoulder angle to salient. Shoulder angle at right, salient angle at left, partly collapsed and slightly out of original position. Scale in ft.

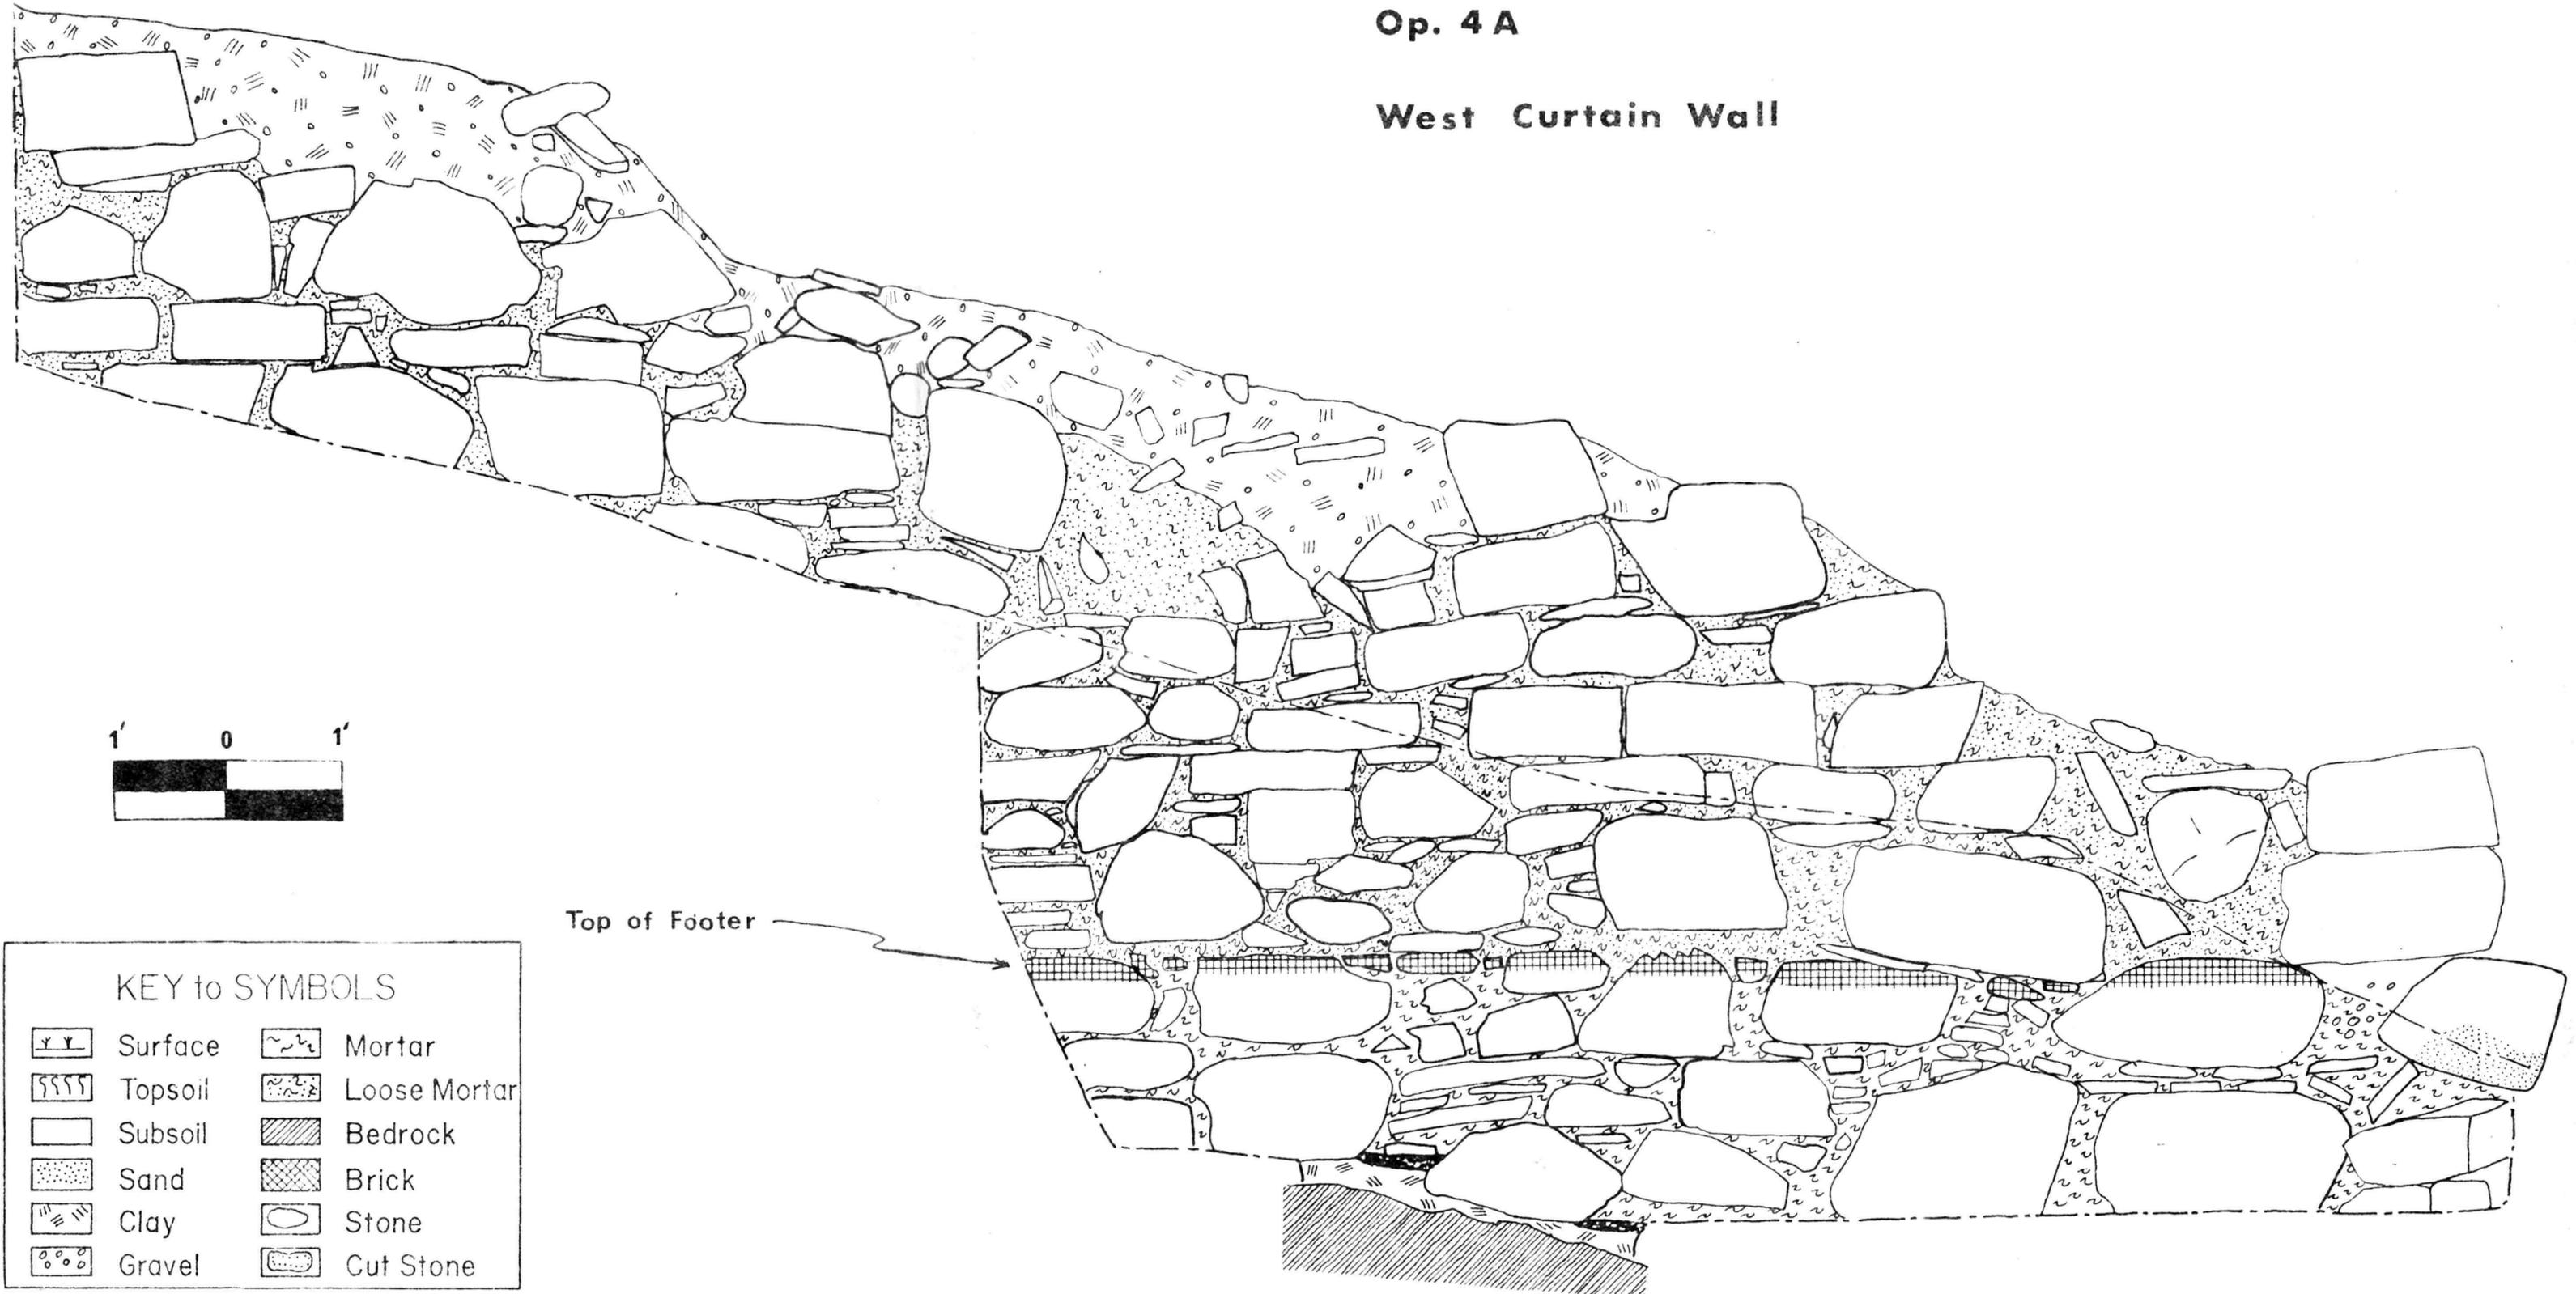
FIGURE 50

Figure 50. Sub-operation 4A. Elevation of the west curtain wall at the salient angle of the southwest demi-bastion, showing wall footer. Scale in ft.

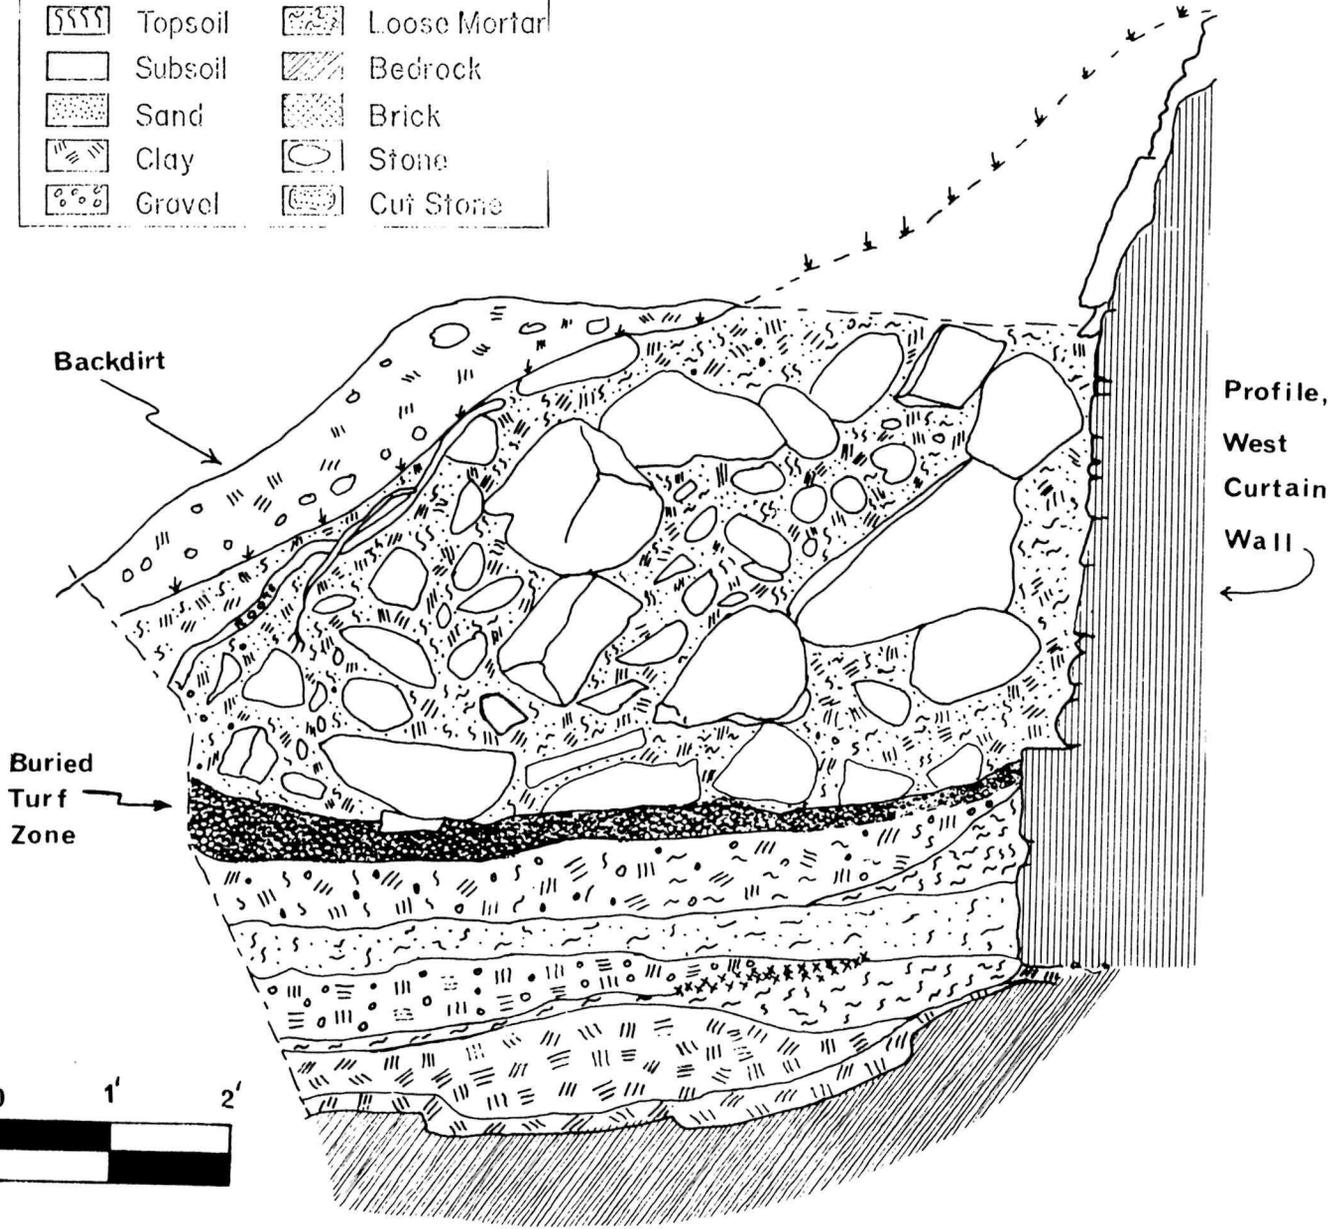
Figure 51. Sub-operation 4A. View toward the north showing the profile of stratigraphic deposits along the west curtain wall at the salient angle. Scale in ft.

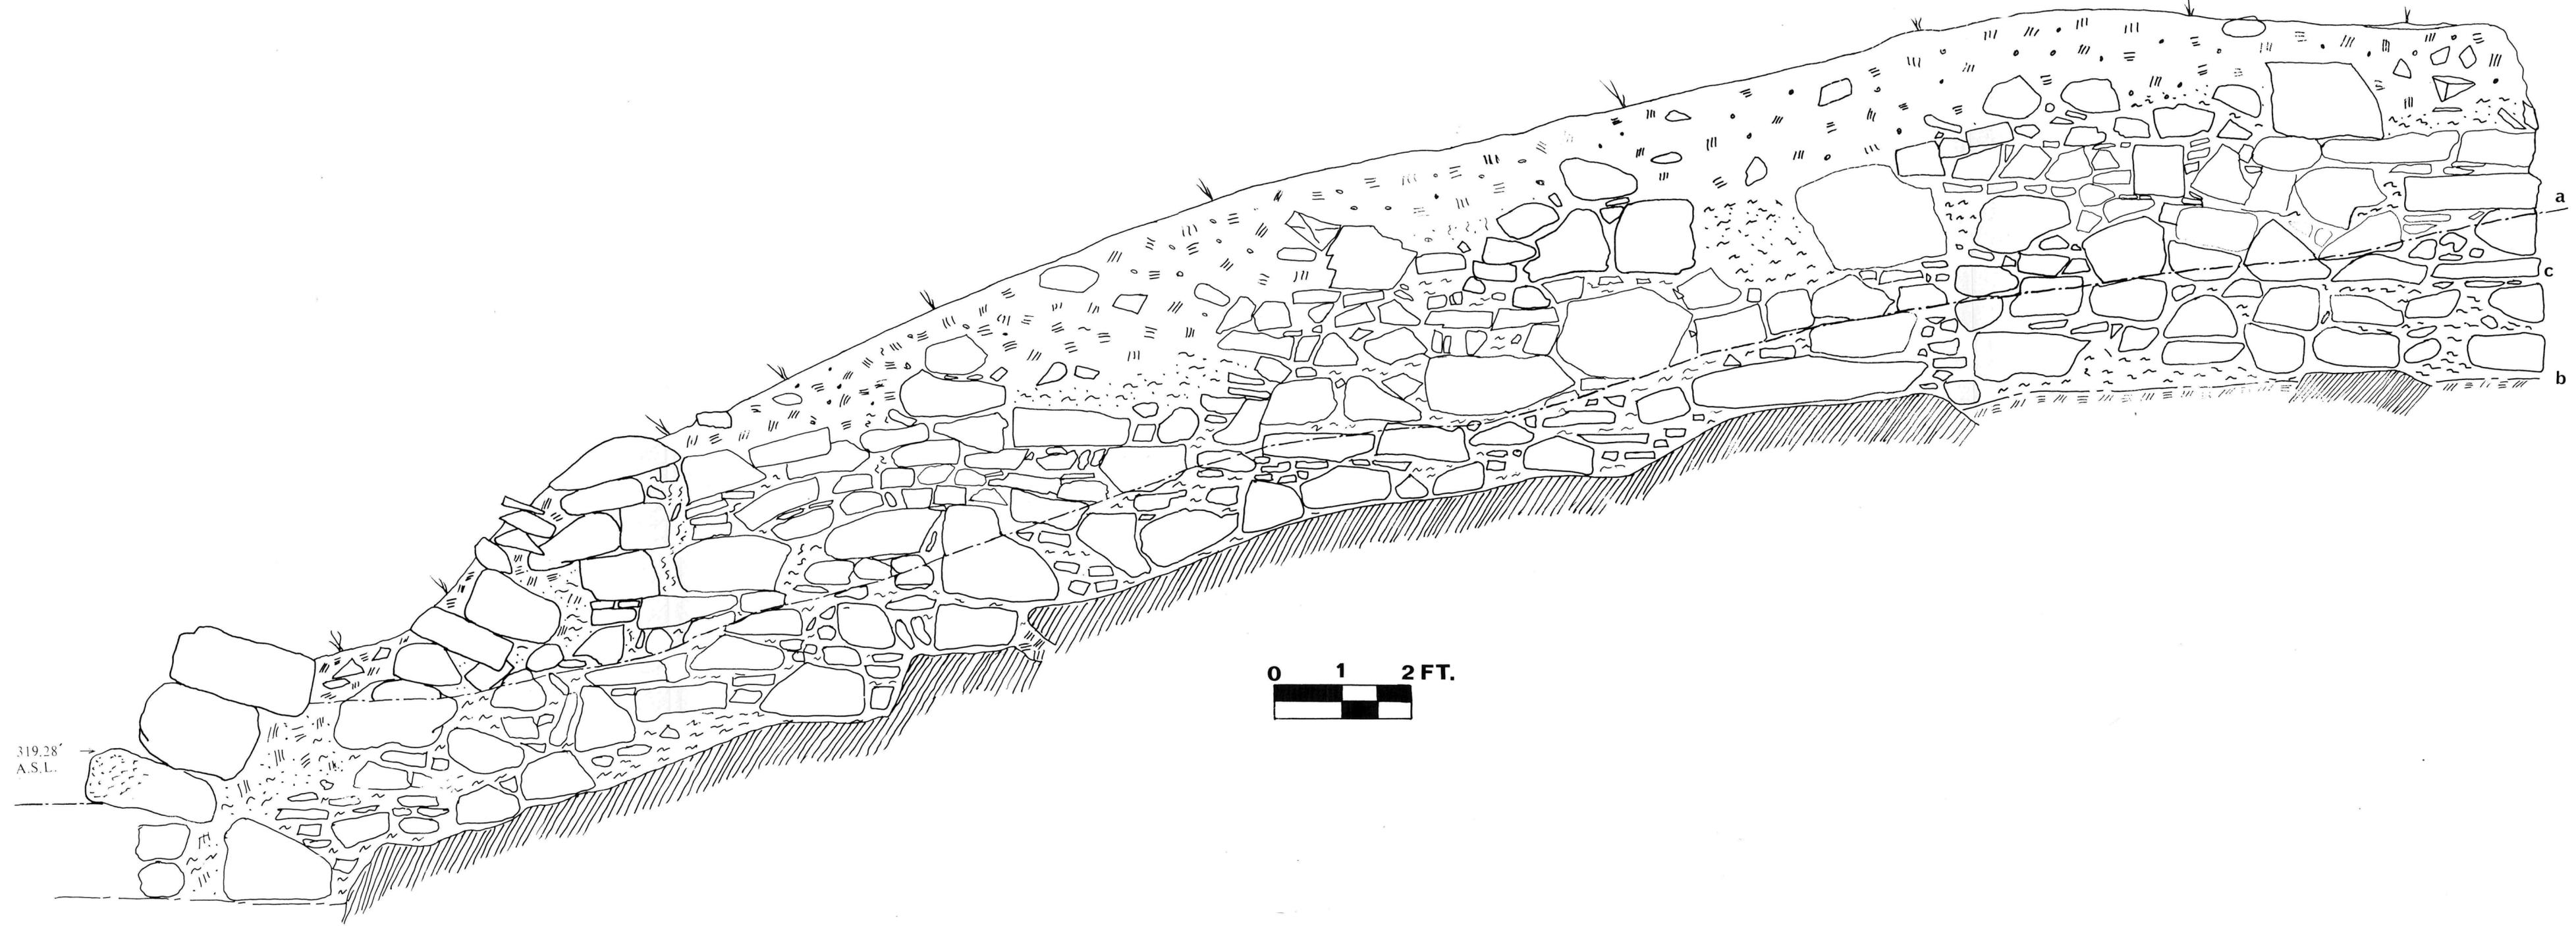
FIGURE 52

Figure 52. Sub-operation 5A. Elevation of the south face of the southwest demi-bastion from salient to shoulder angles. Features shown: limit of 1965 excavation (a), shoulder angle foundation on clay above bedrock (b), line of the shoulder angle (c). Scale in ft.

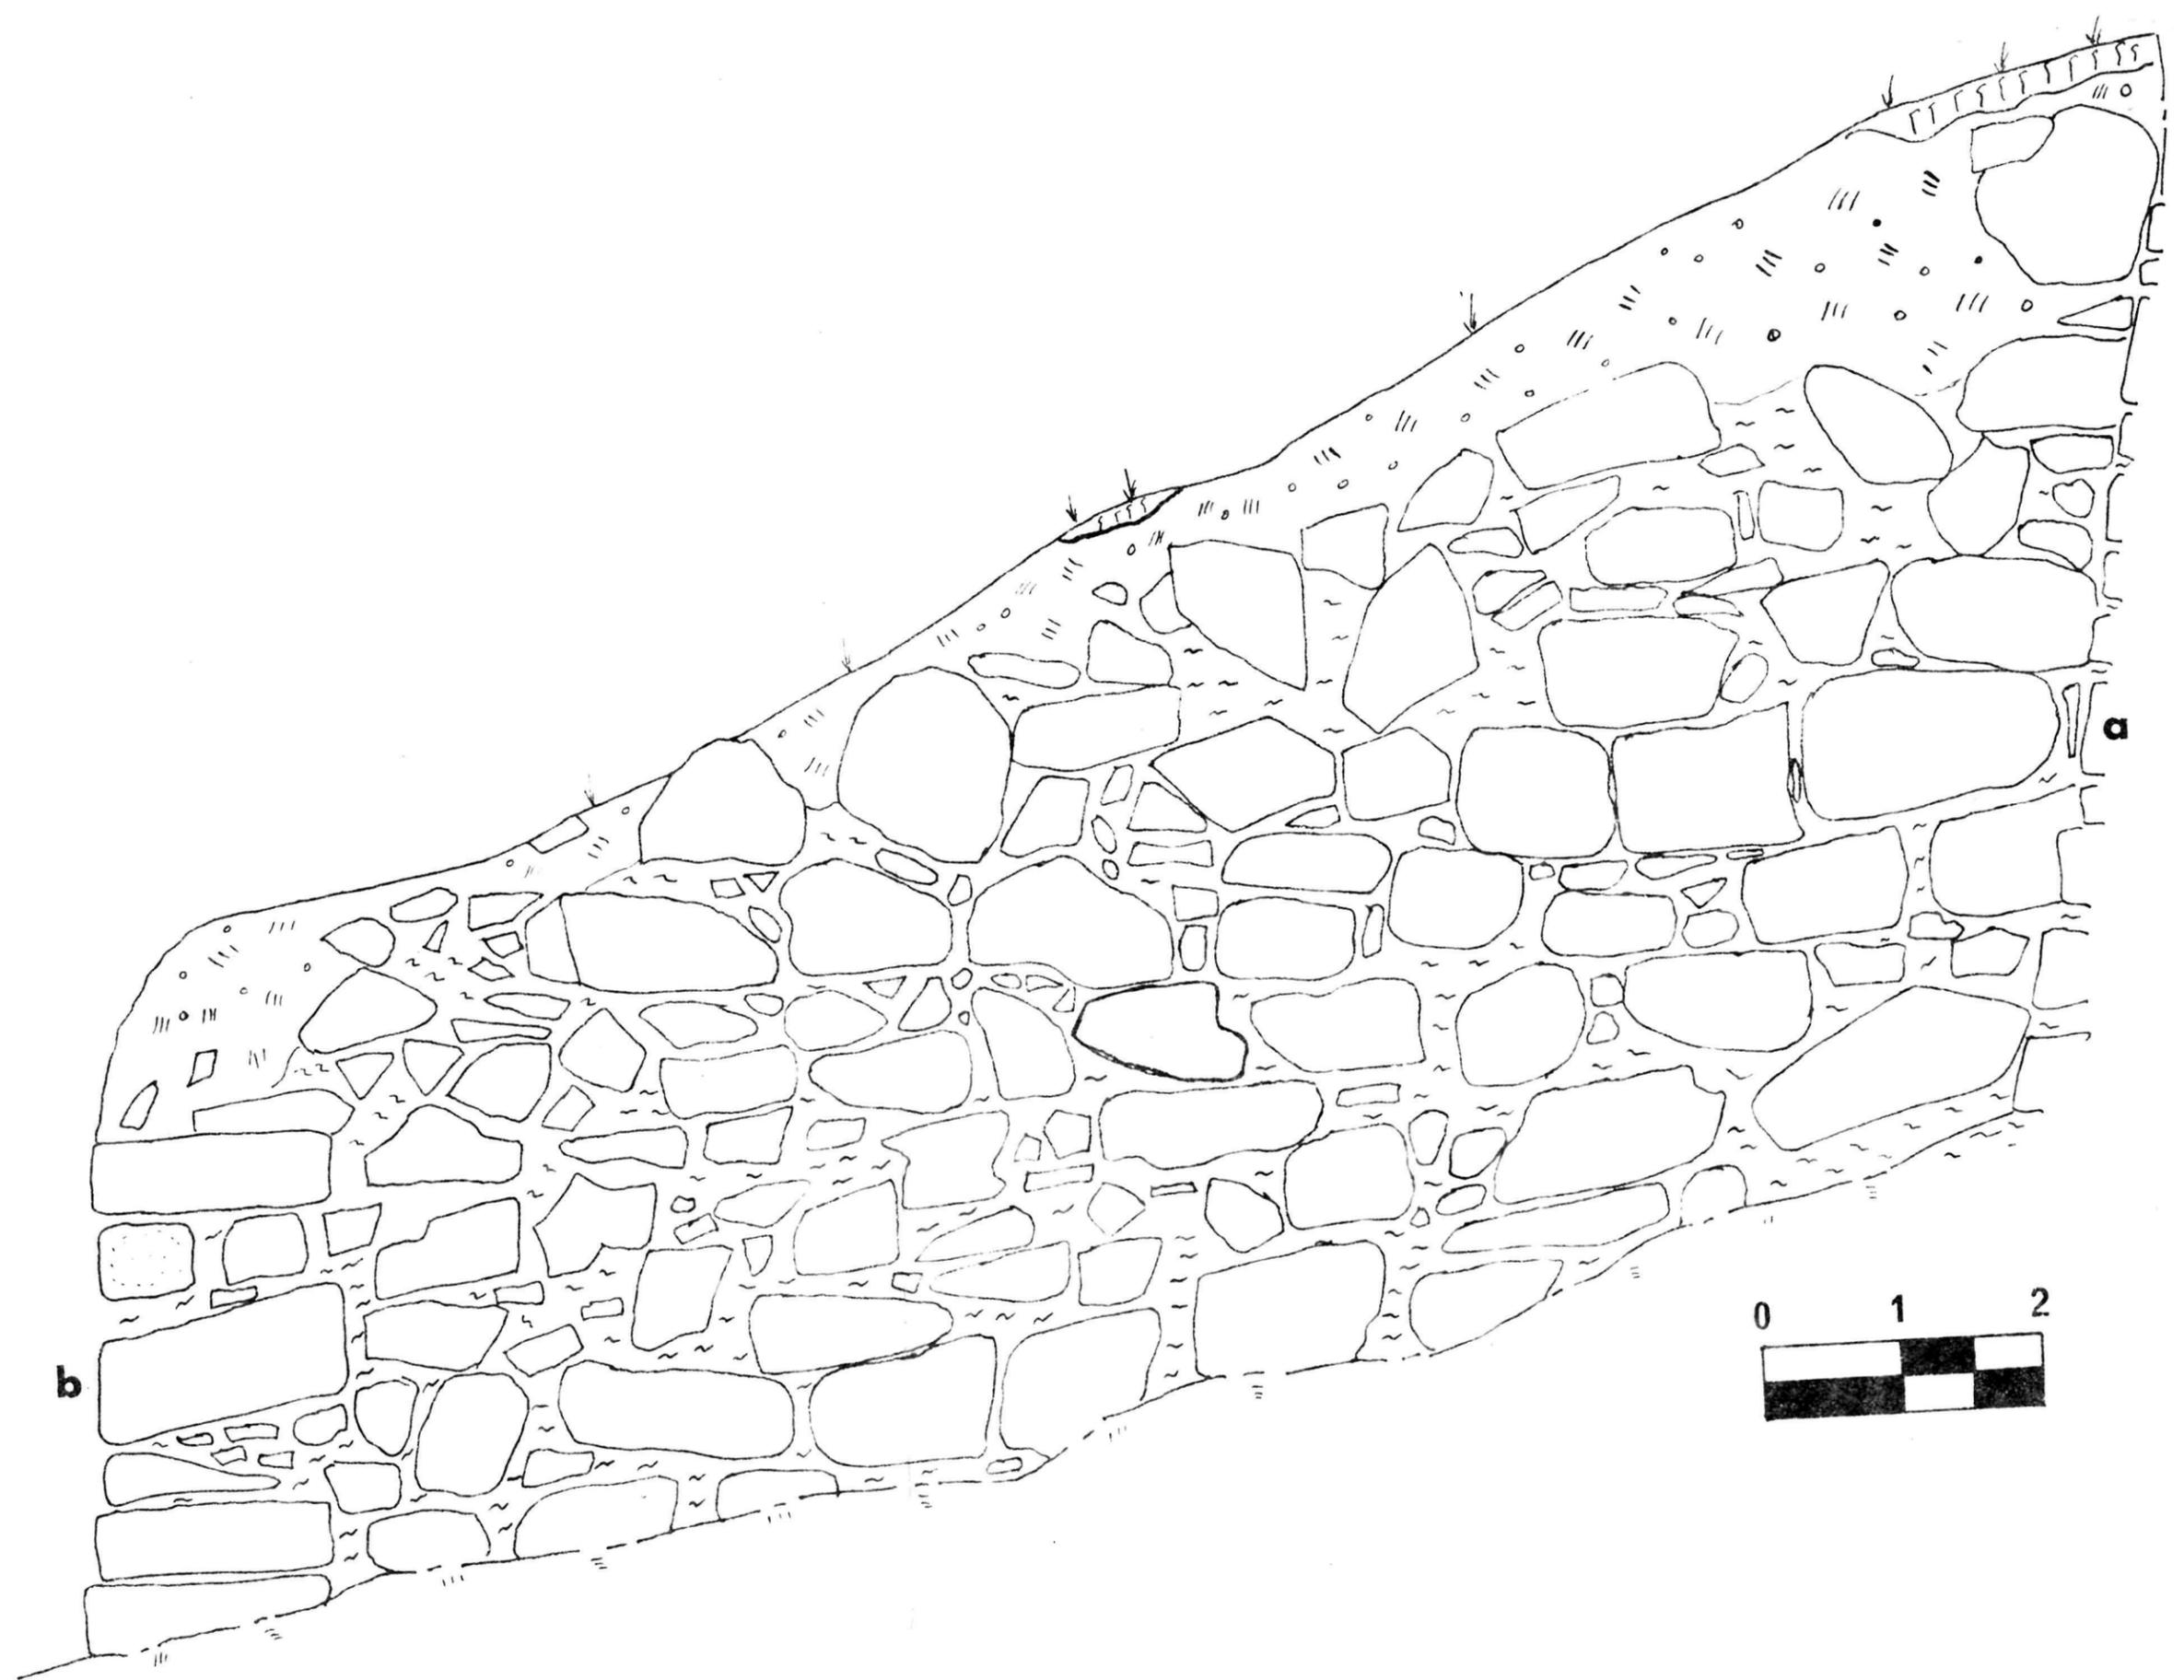
FIGURE 53

Figure 53. Sub-operation 5B. Elevation of the east flank of the southwest demi-bastion. Features shown: line of the south curtain wall at the re-entrant angle (a), shoulder angle (b). Scale in ft.

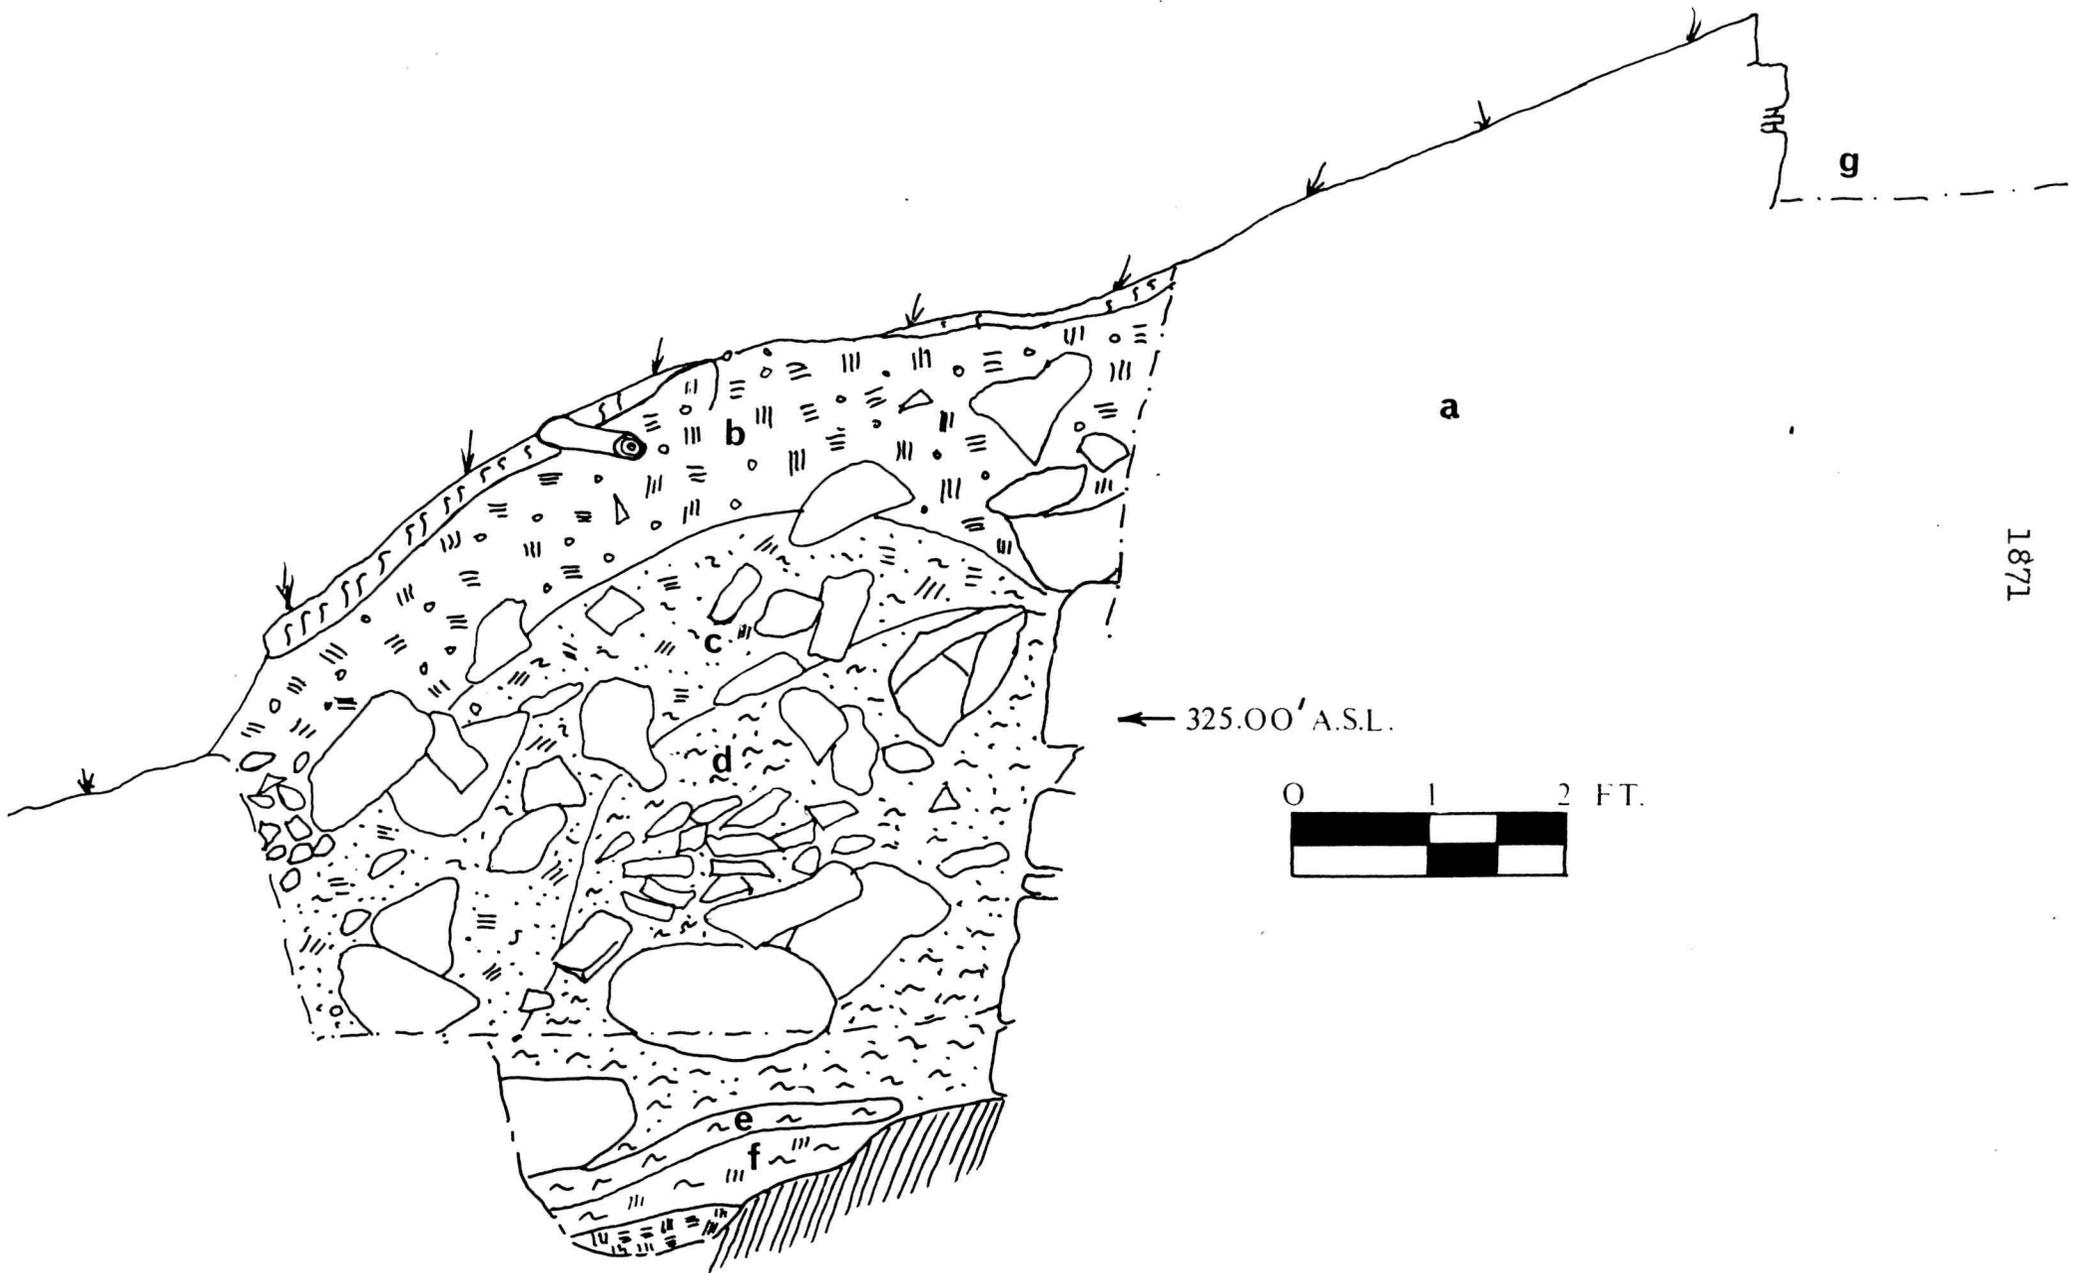
Figure 54. Sub-operation 5C. Profile of talus rubble along the south curtain wall; looking west, near the salient angle. Features shown: south curtain wall in profile (a), 5C1 (b), 5C2 (c), 5C4 (d), 5C6 (e), 5C7 (f), operation 9A (g). Scale in ft.

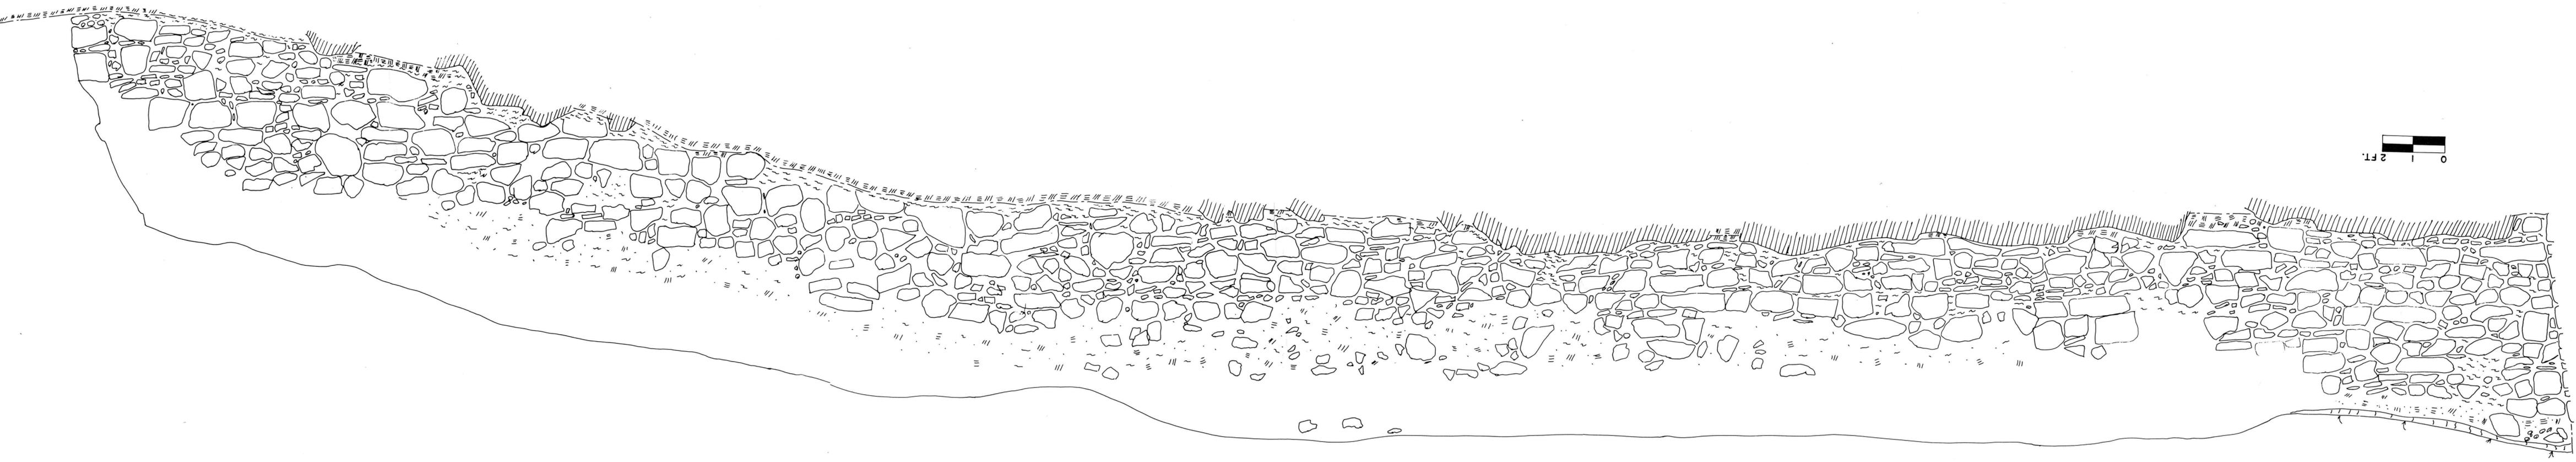
Figure 55. Sub-operation 5C. Elevation of the south curtain wall from the re-entrant to the salient angle. Scale in ft.
