NATIONAL HISTORIC SITES SERVICE

MANUSCRIPT REPORT NUMBER 46

EXCAVATIONS AT CASTLE HILL

September 1971

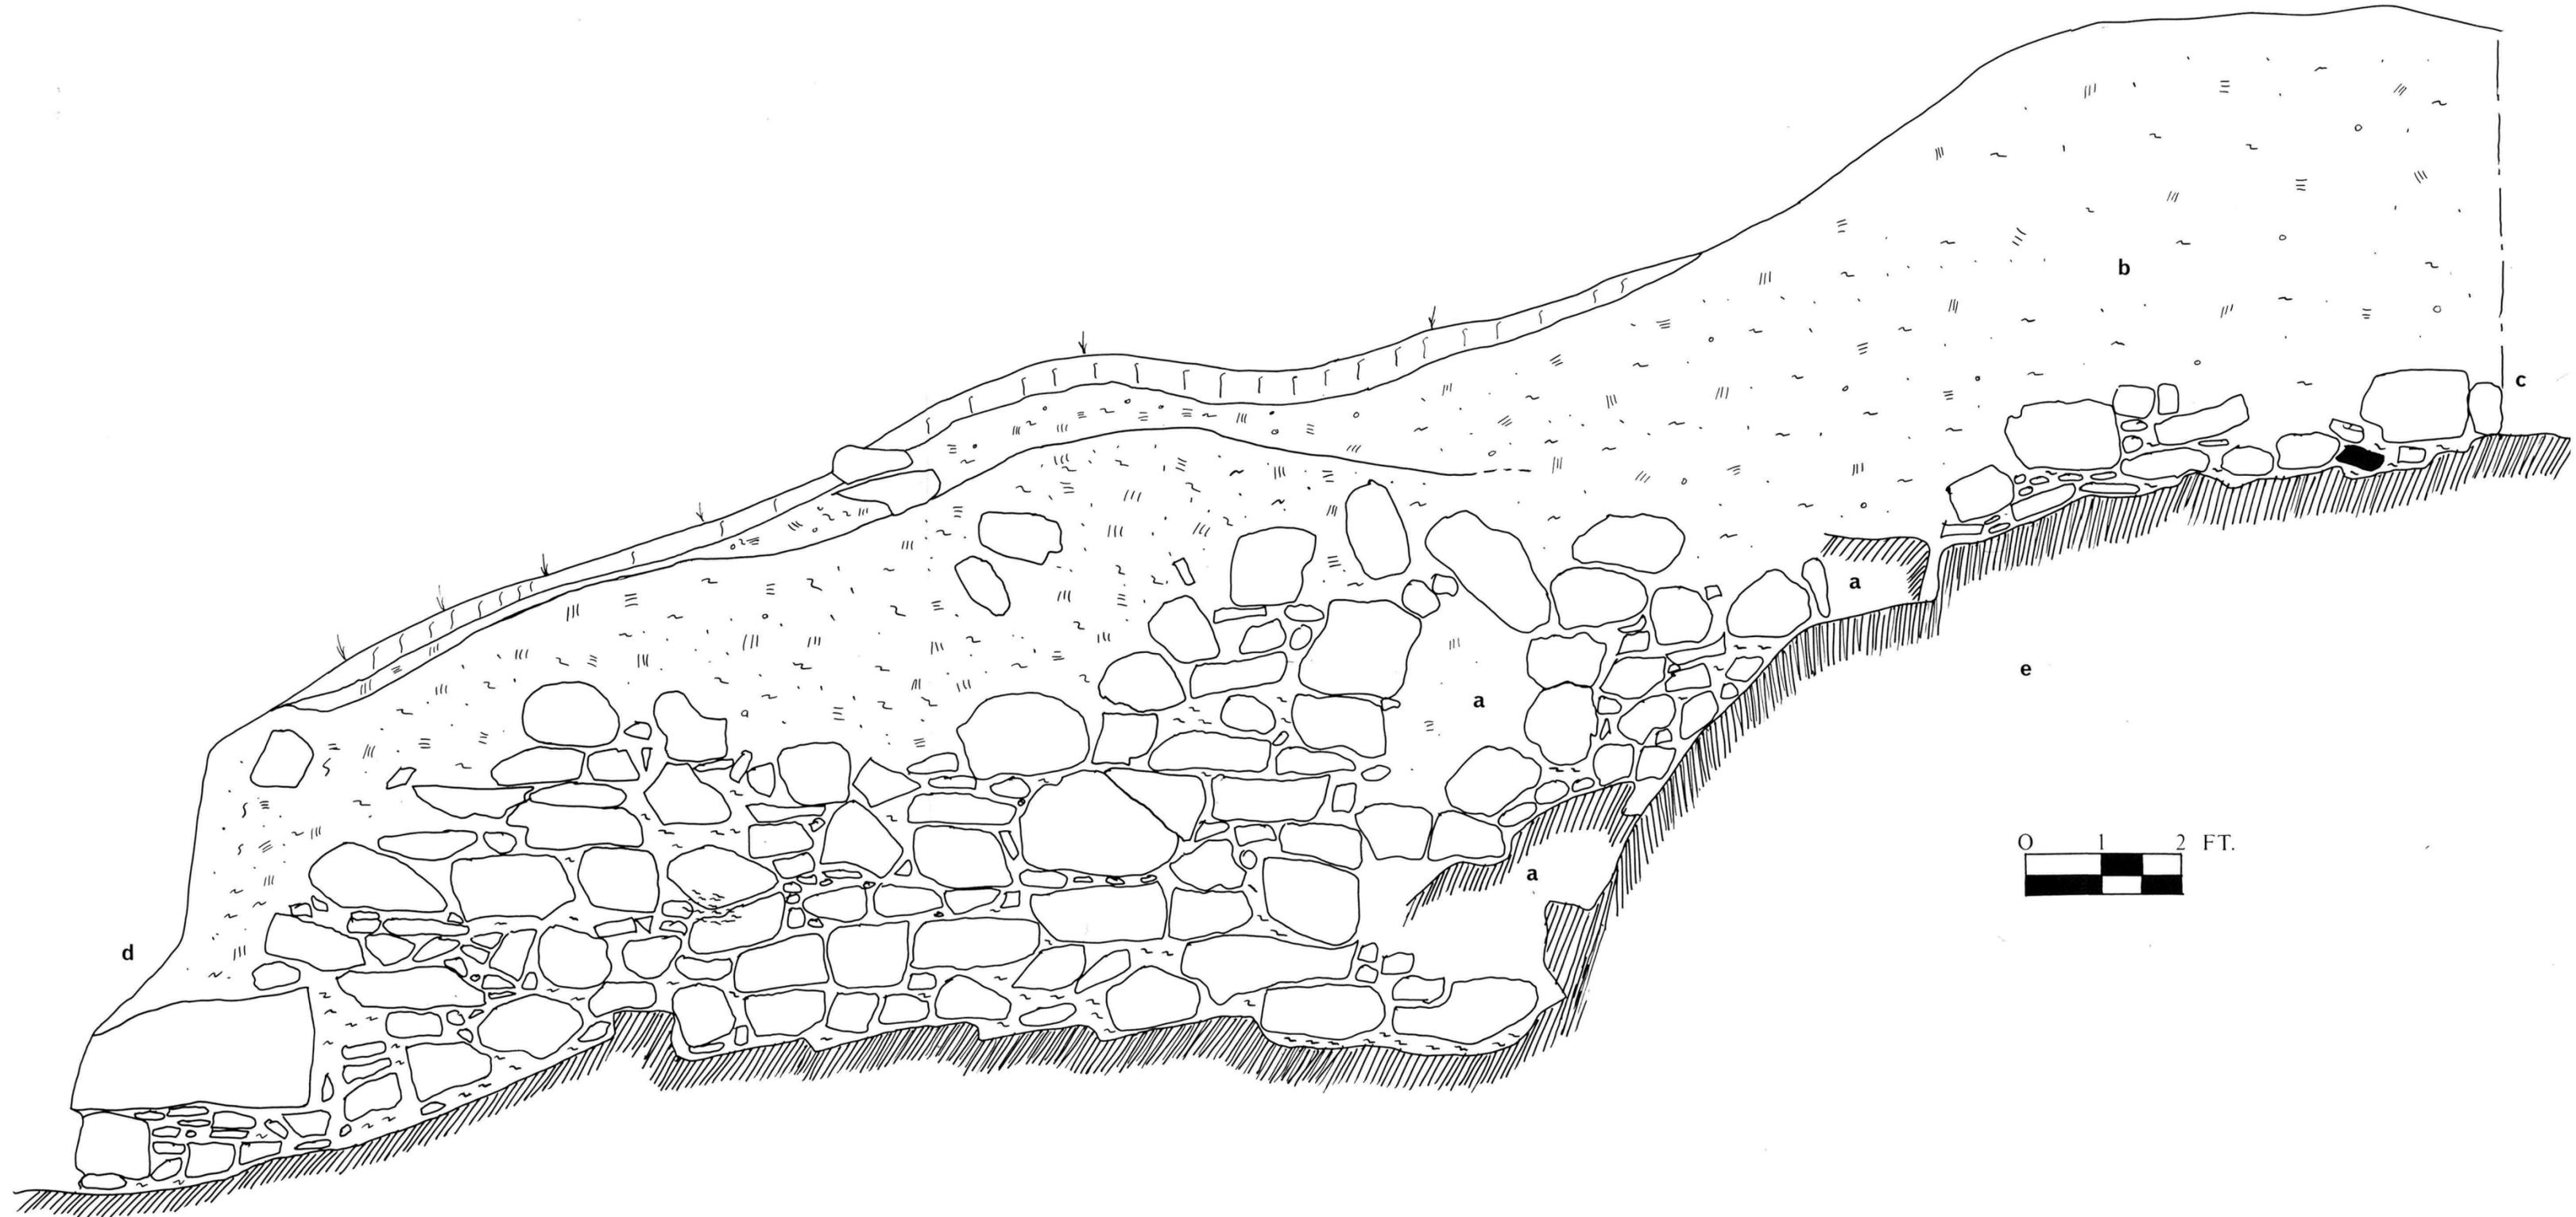
FIGURE 56

Figure 56. Sub-operation 6A. Elevation of the east face of the southeast demi-bastion. Features shown: bedrock core with face stones missing (a), eroded core of wall (b), approximate shoulder angle line (c), salient angle and line of the south curtain wall (d). Scale in ft.

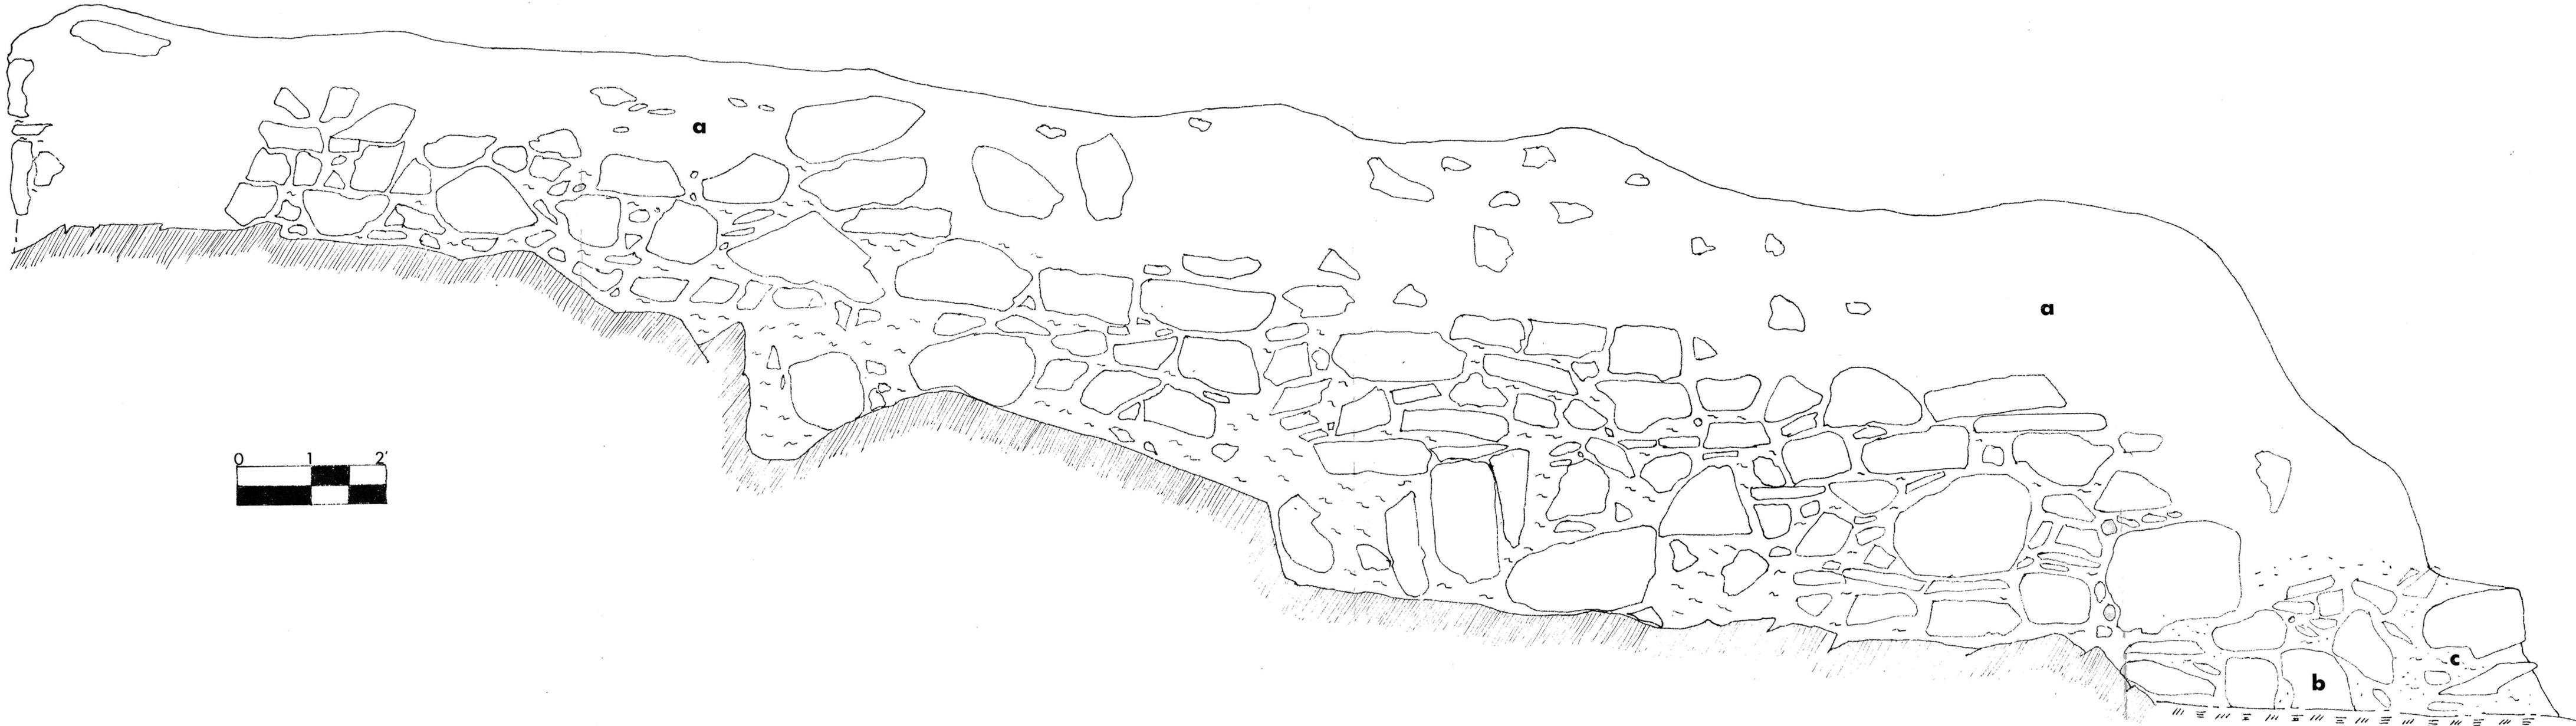
FIGURE 57

Figure 57. Sub-operation 6E. Elevation of the east face of the northeast bastion. Features shown: eroded wall core (a), limestone block in wall (unique case) (b), collapsed salient angle slightly out of original position (c). Scale in ft.

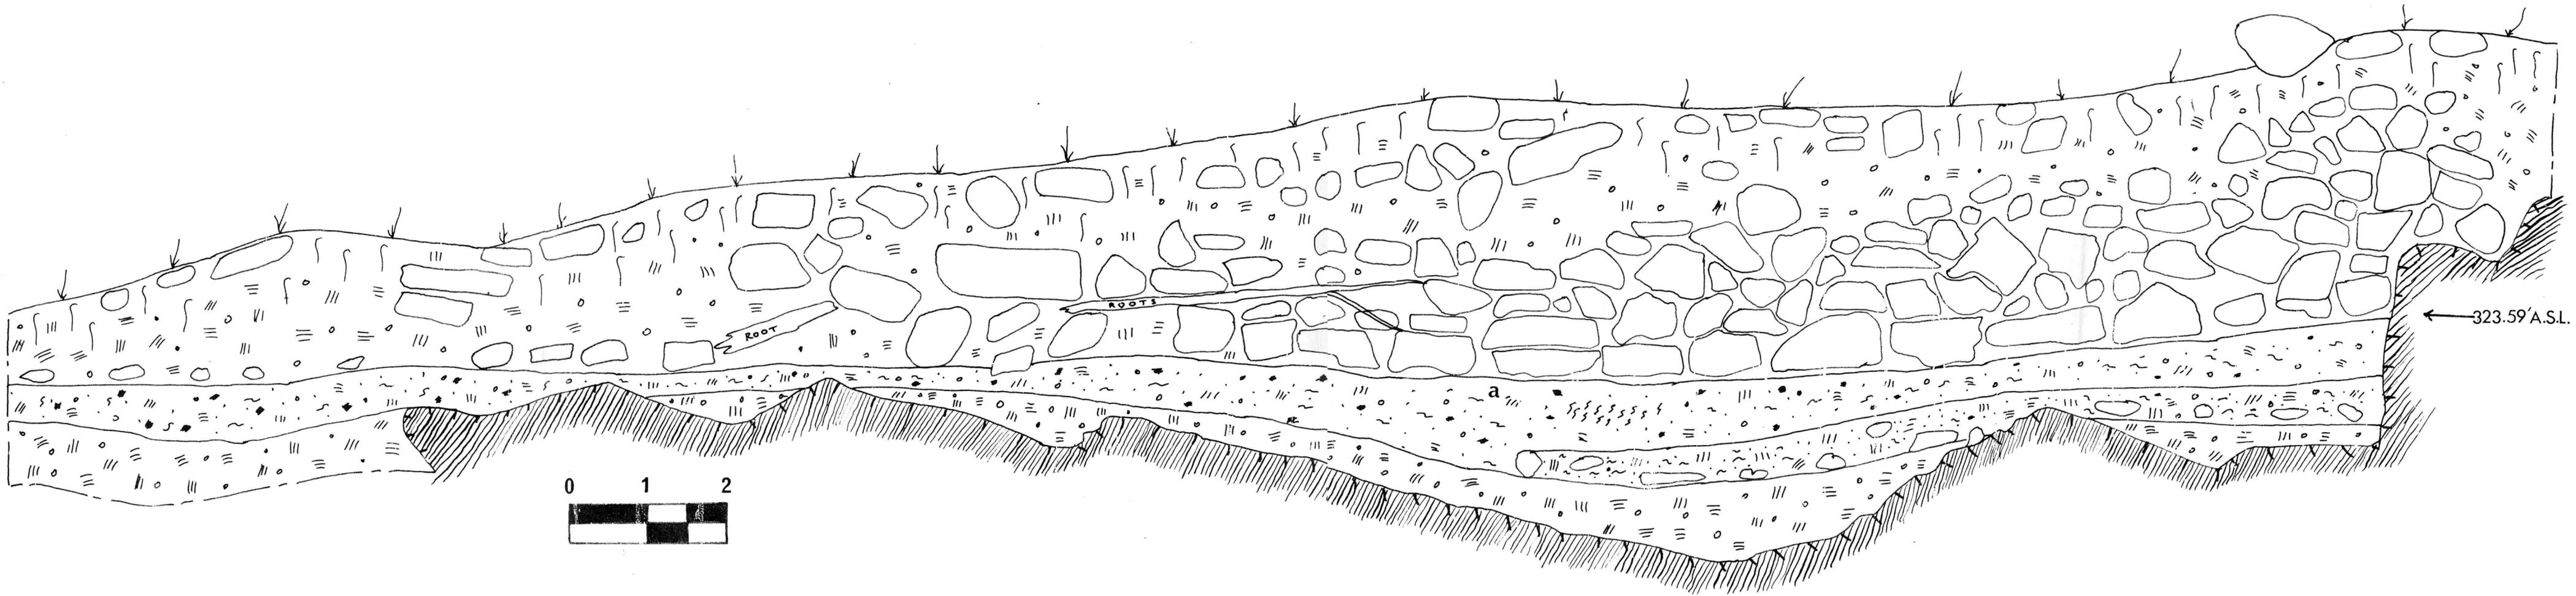
FIGURE 58

Figure 58. Sub-operation 6E. East profile and elevation of the dry-wall counterscarp. Scale in ft.

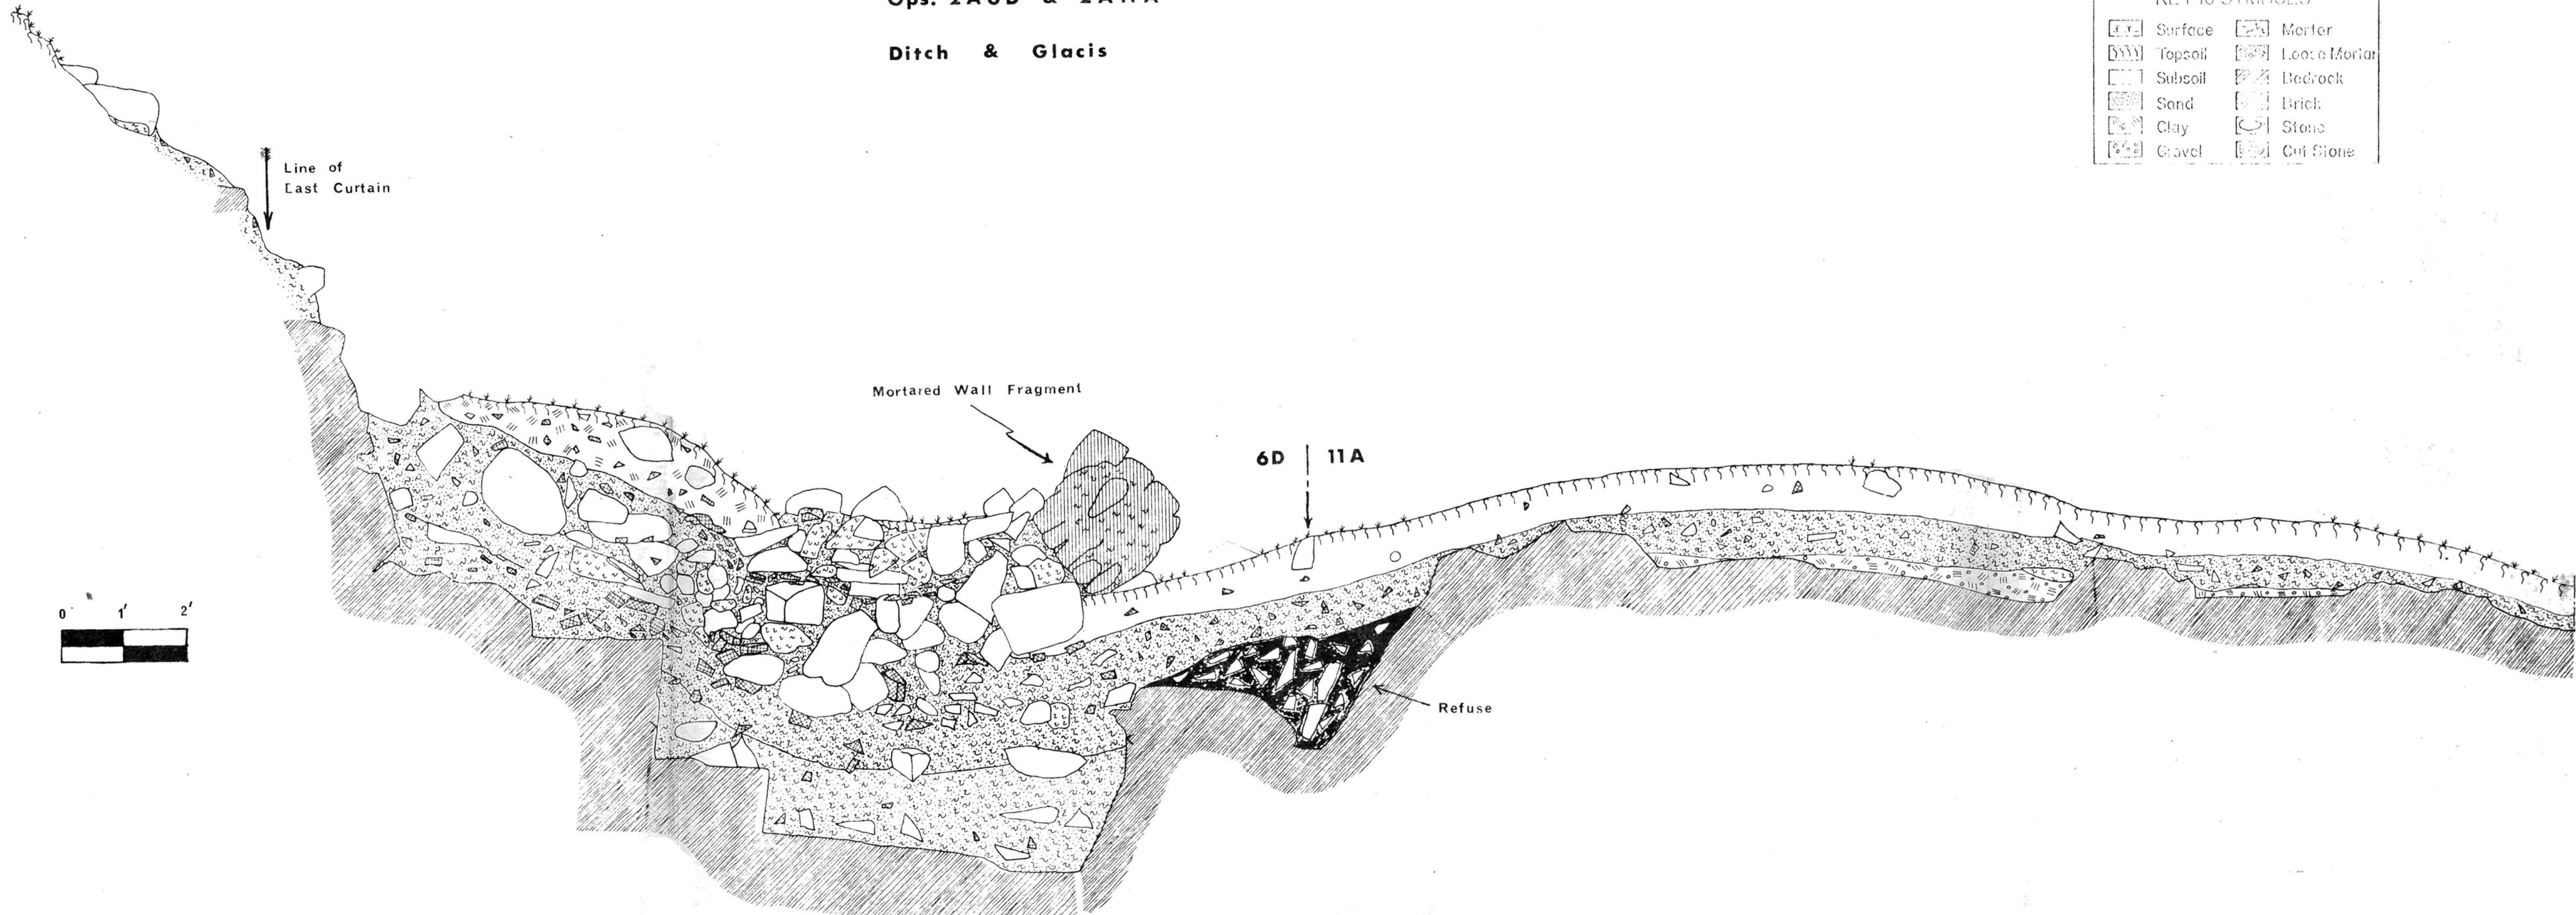
FIGURE 59

Figure 59. Sub-operation 6D and operation 11.
East-west cross-section showing the east curtain
wall, ditch fill stratigraphy (6D) and the glacis
(11). Stratigraphic elements identified on drawing.
Scale in ft.

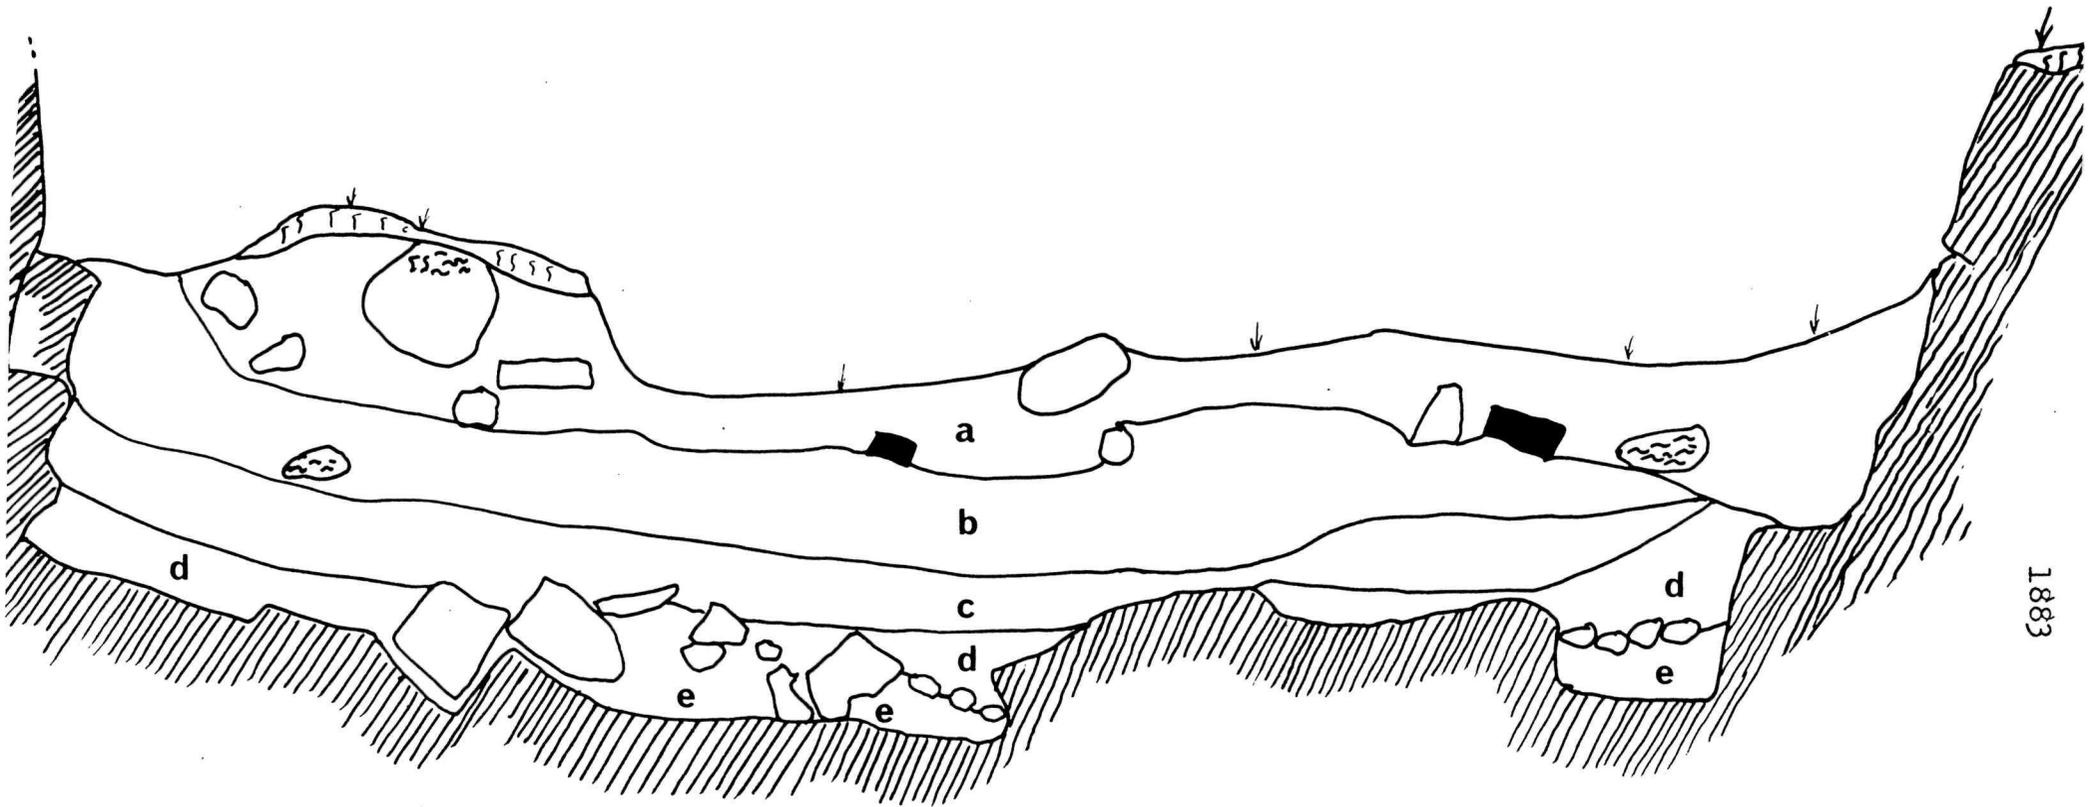
Figure 60. Sub-operation 6D. Profile showing the stratigraphic sequence of strata block A, north profile after excavation (e.g., the face of strata block B). Features shown: 2A6D5 (a), 2A6D6 (b), 2A6D7 (c), 2A6D8 (d), 2A6D9 (e). Scale in ft.

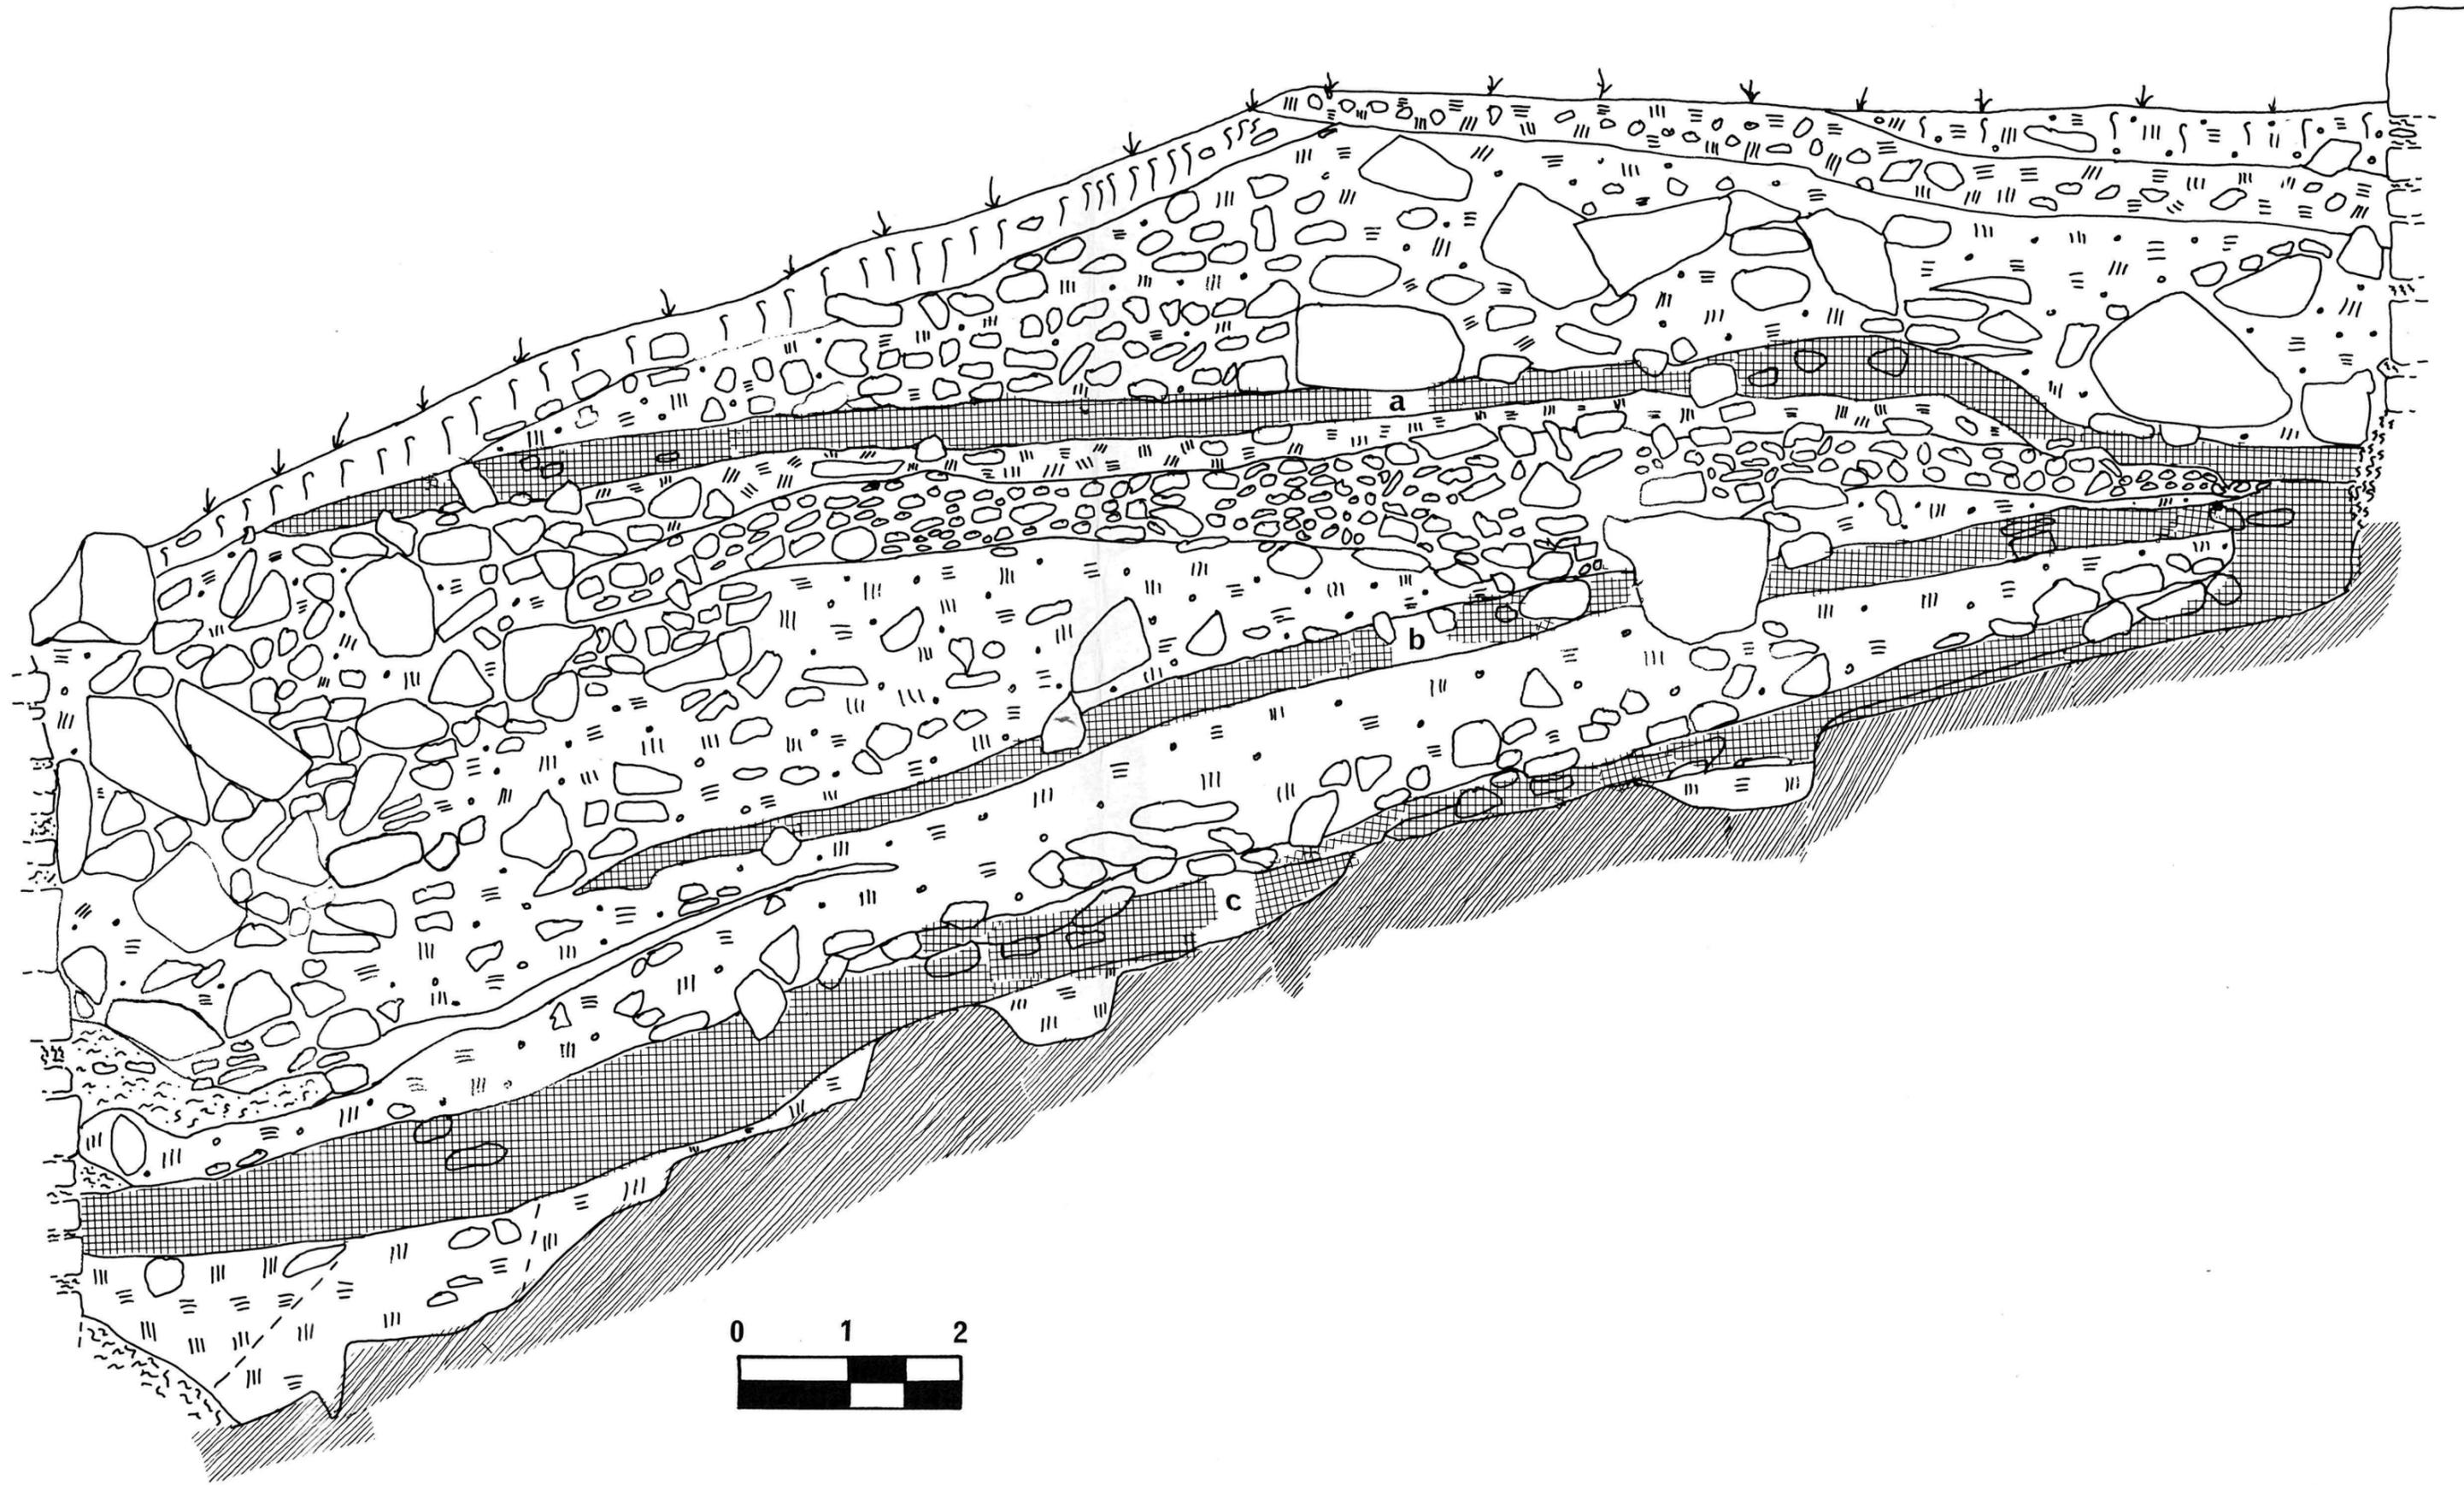
FIGURE 61

Figure 61. Sub-operation 9E. West profile of sub-operation 9E showing rampart fill stratigraphy. 2A9E2 (a), 2A9E11 (b), 2A9E15 (c); three major layers of midden debris in the fill. Scale in ft.

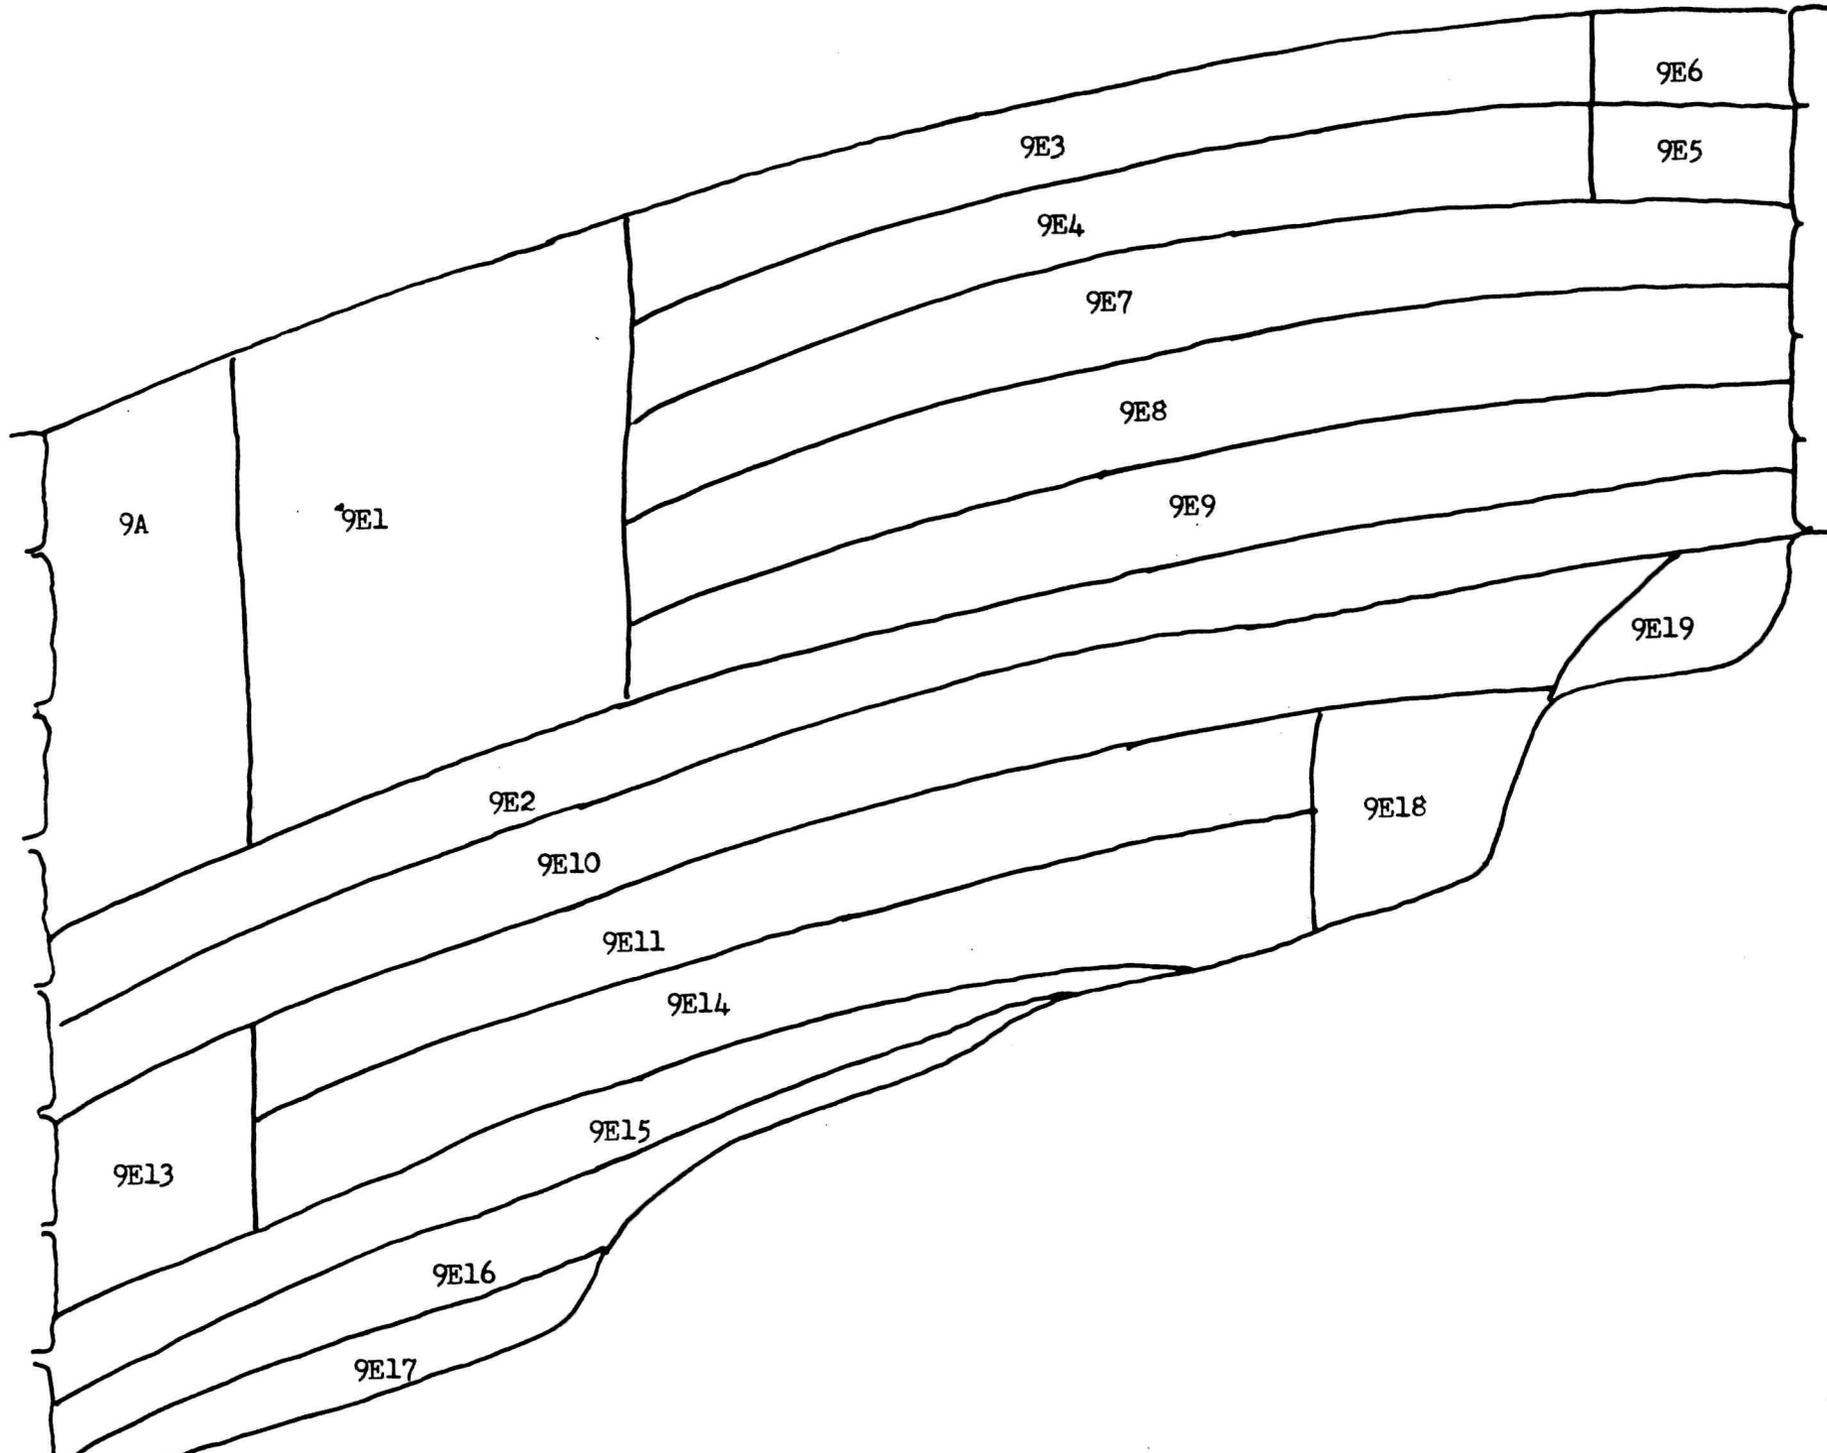
Figure 62. Diagram showing lot sequence in sub-
operation 9E.

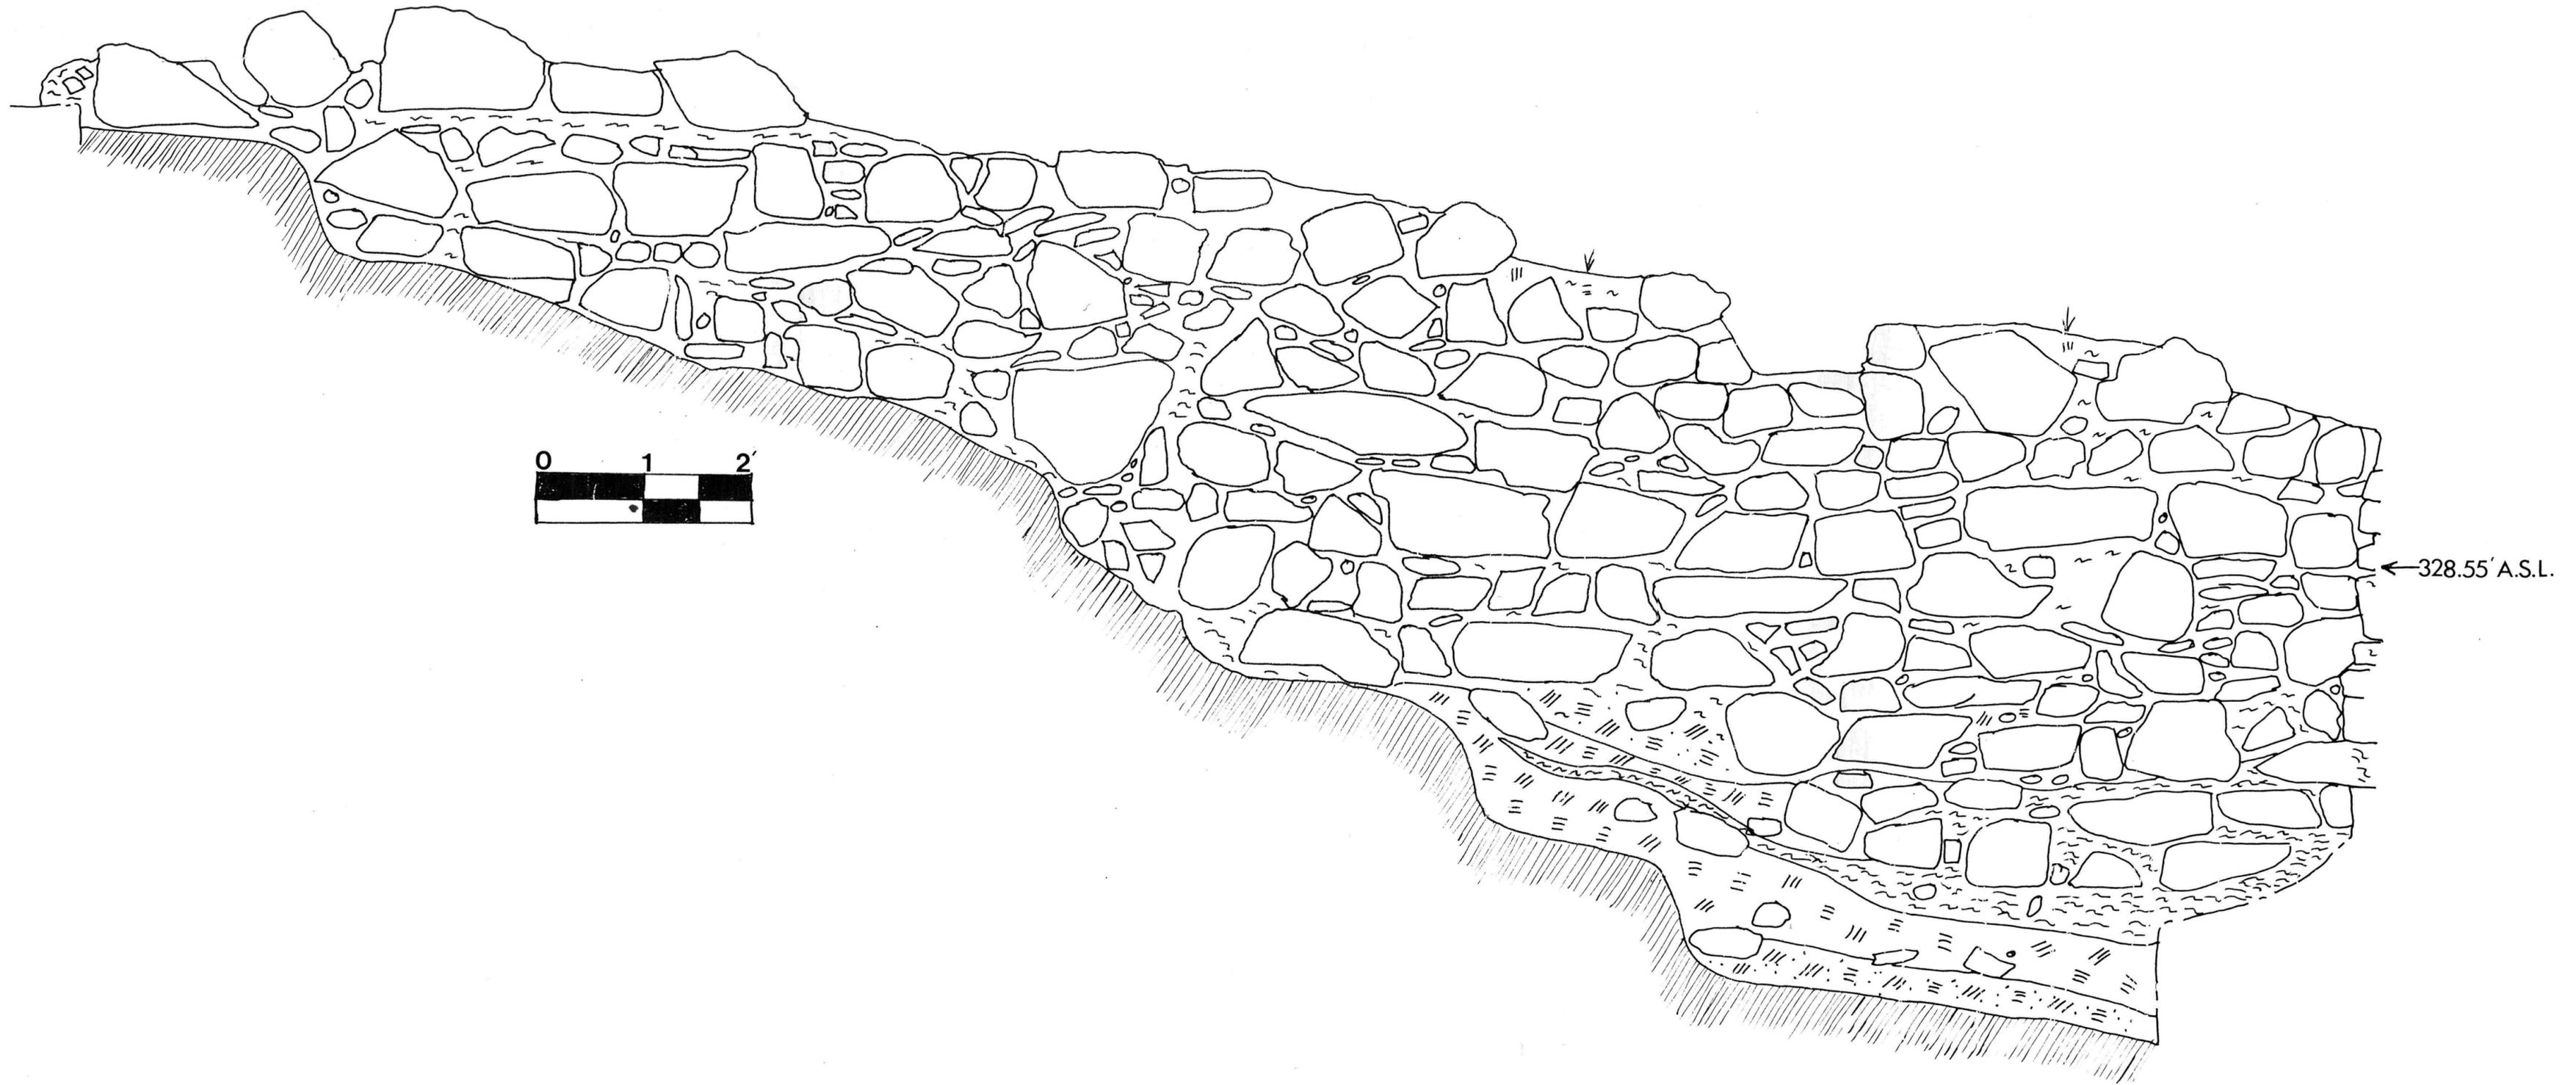
FIGURE 63

Figure 63, Sub-operation 9E. Elevation of the interior side of the east face of the southeast demi-bastion. Shoulder angle on the left, salient angle on the right. Scale in ft.

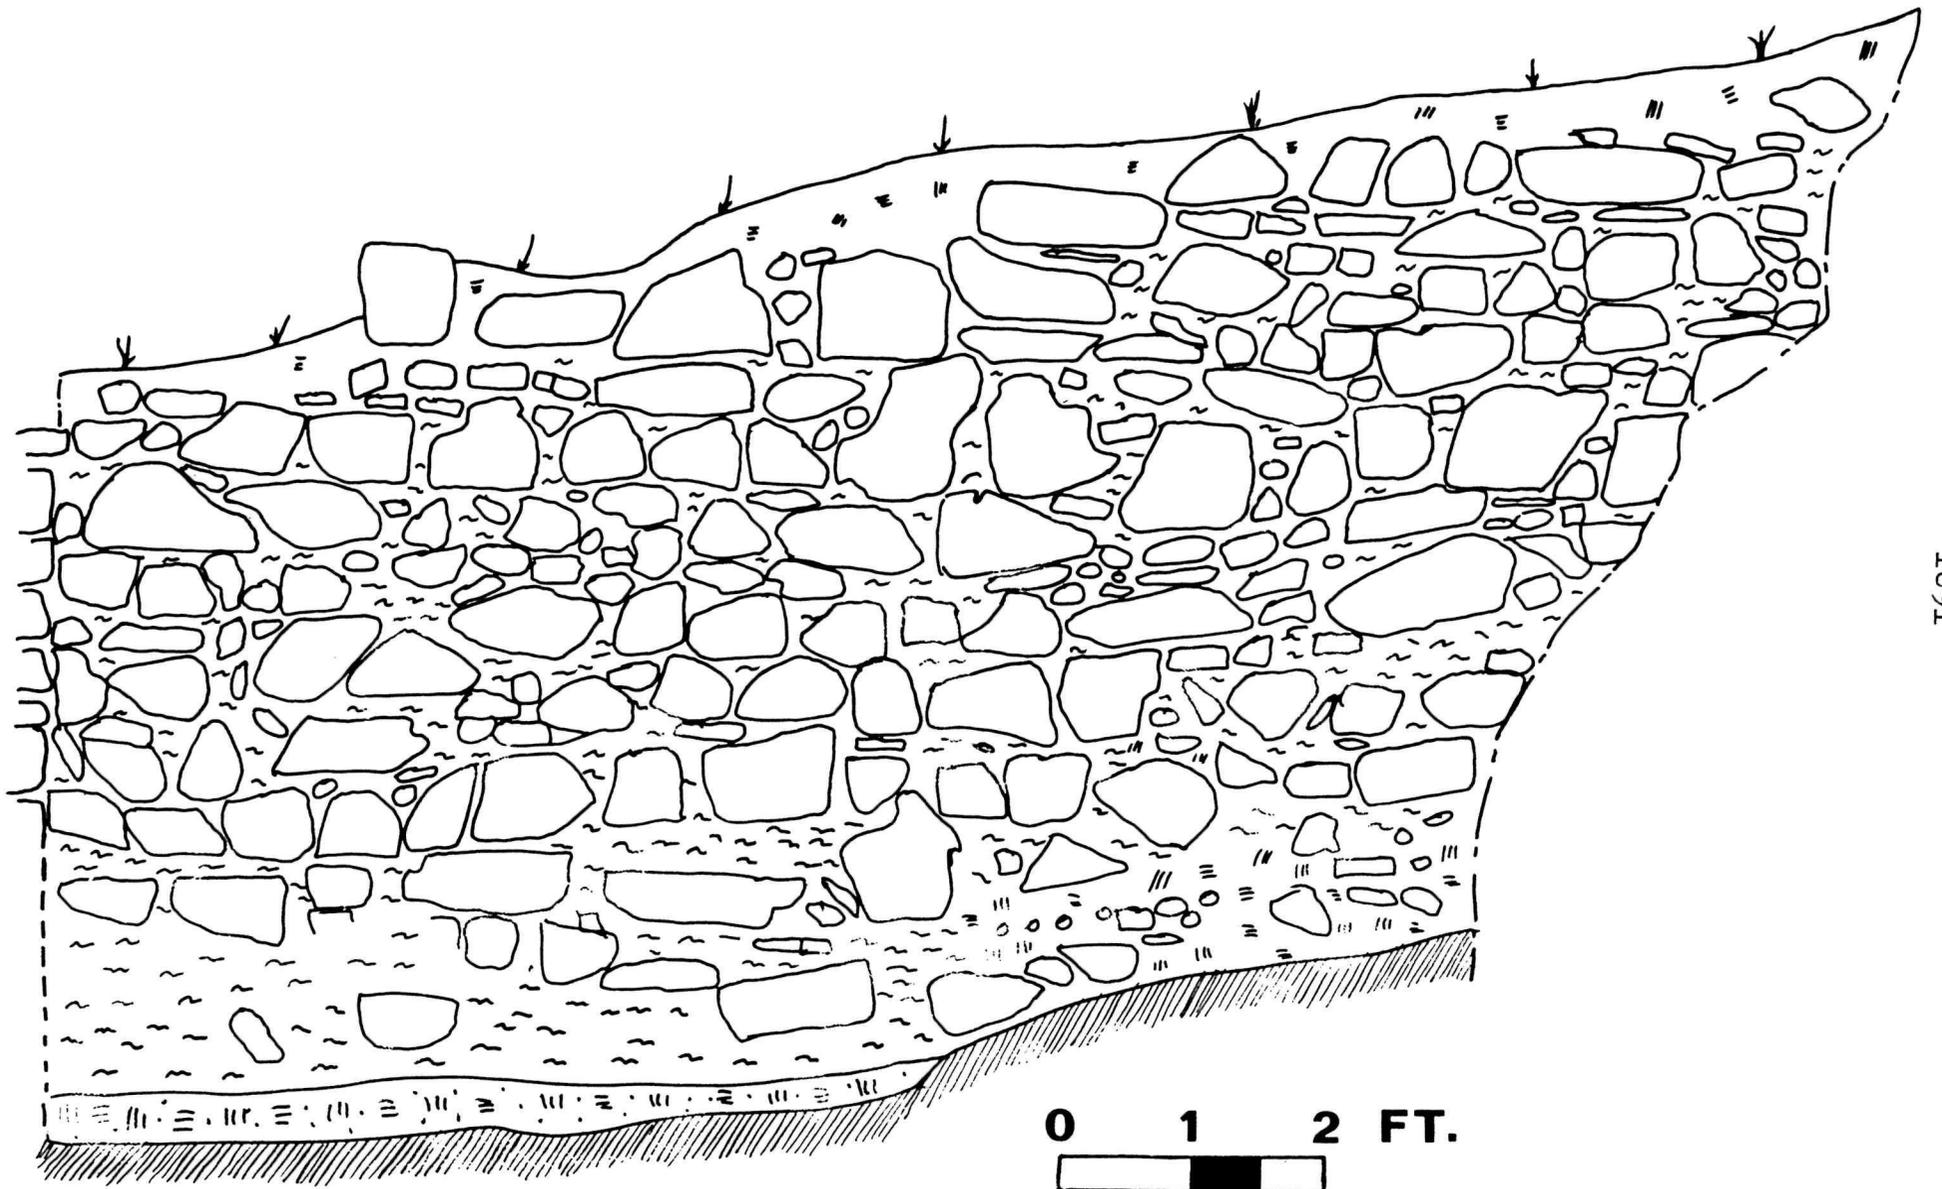
Figure 64. Sub-operation 9E. View to the south showing the elevation of the interior side of the south curtain wall at the interior corner of the southeast demi-bastion. Line of the east face wall is on the left; unexcavated rampart fill on the right. Scale in ft.
