NATIONAL HISTORIC SITES SERVICE

MANUSCRIPT REPORT NUMBER 46

EXCAVATIONS AT CASTLE HILL

September 1971

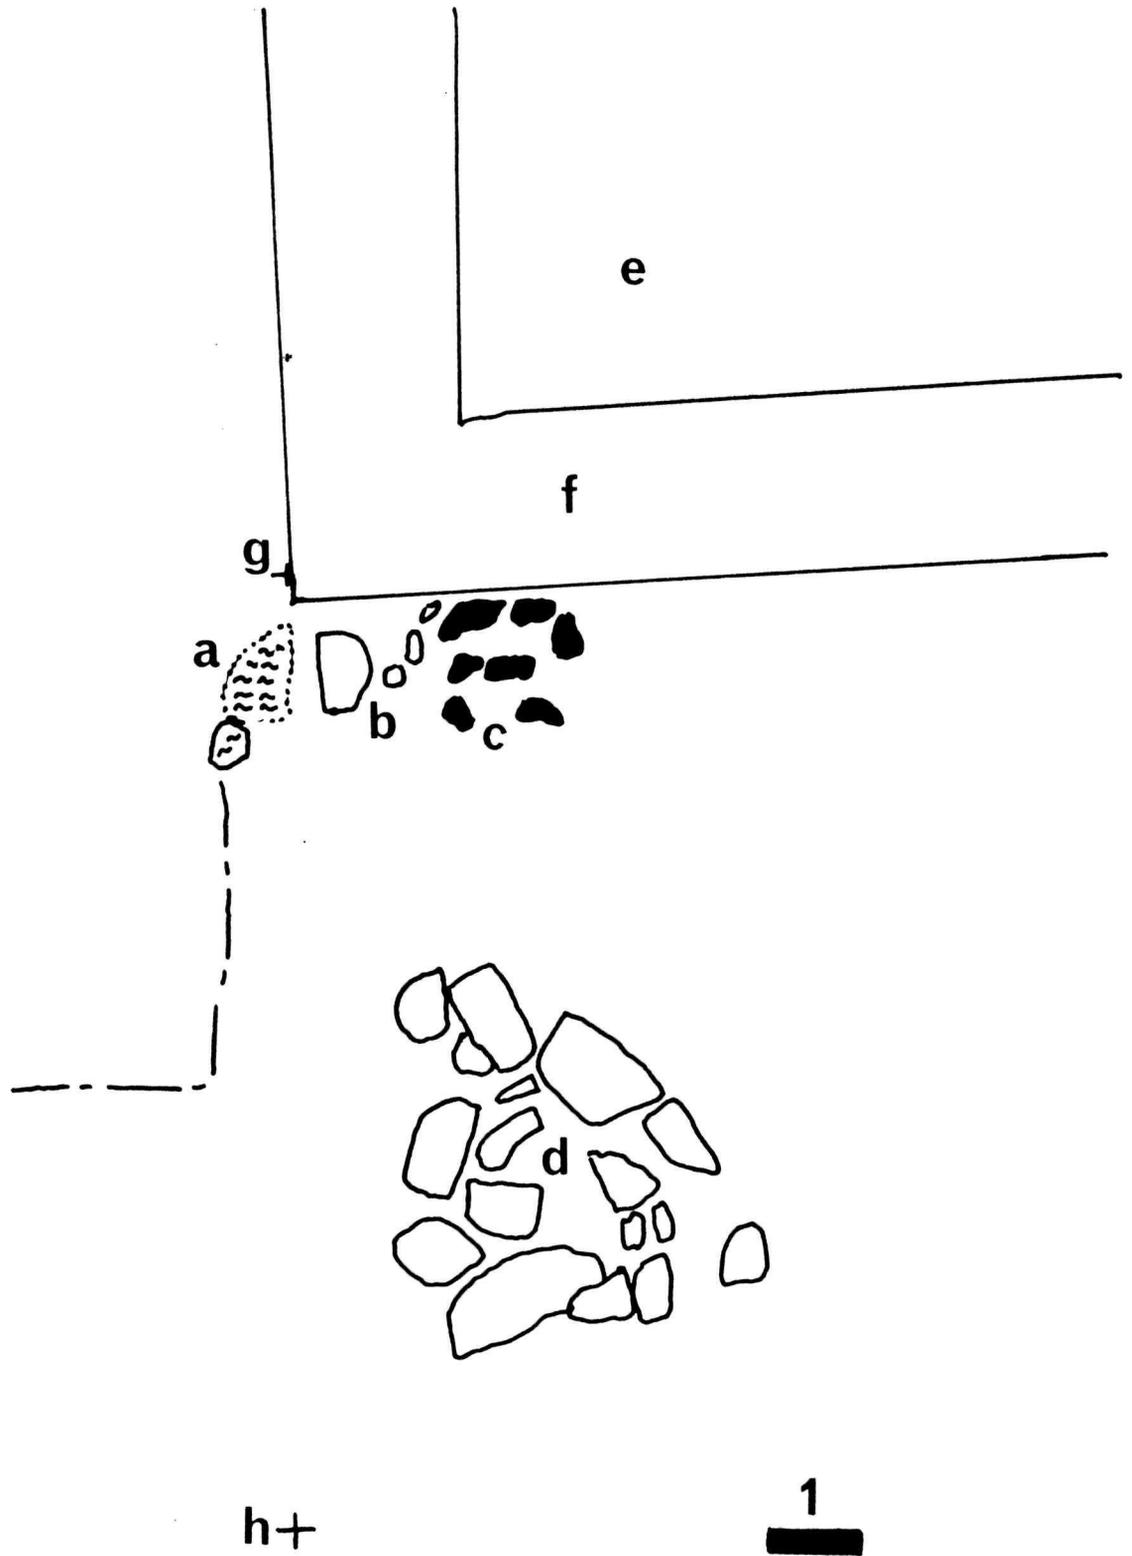
Figure 65. Sub-operation 9E. Plan showing the English stairs in sub-operation 9E. Features shown: mortar path, lowest step (a), stones in situ, 9E5 step (b), stones in situ 9E6 step (c), rock rubble and mortar traces, possible revetment (d), interior of operation 7 (e), masonry wall of operation 7(f). Scale in ft.

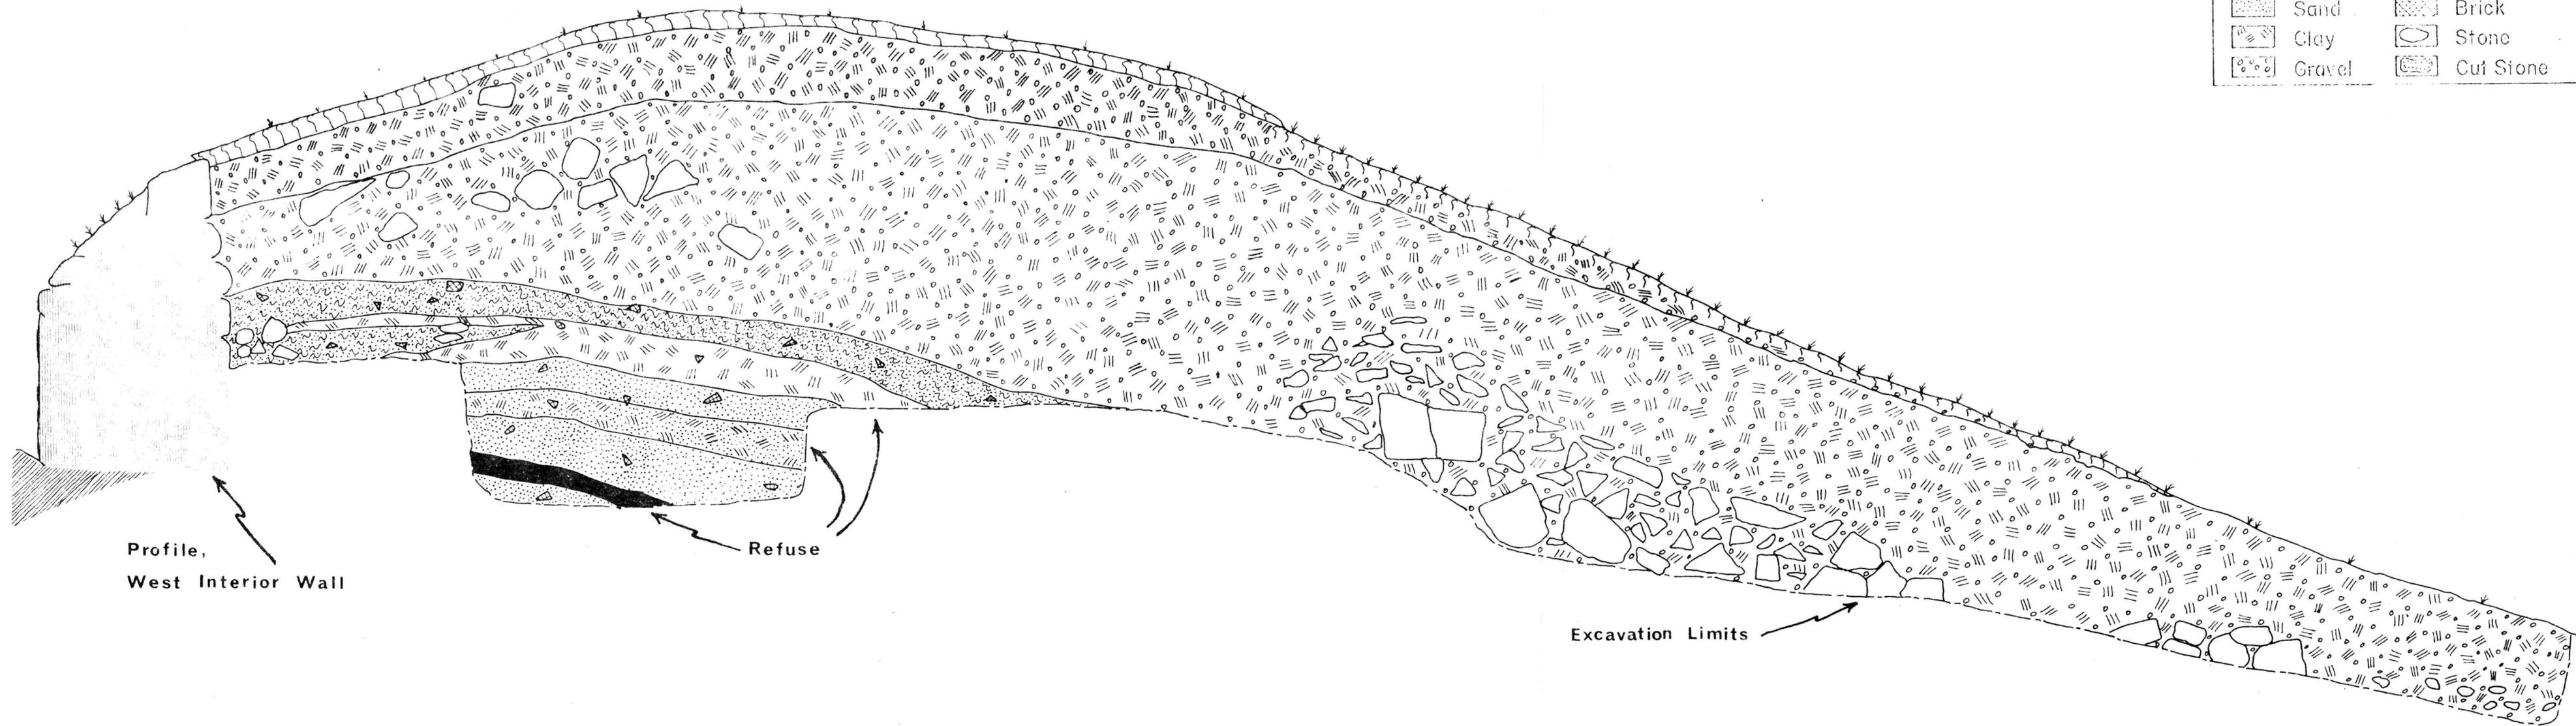
FIGURE 66

Figure 66. Sub-operation 9D. Looking south at the profile of the trench showing stratified deposits in the fill of the west gun platform. Scale in ft.

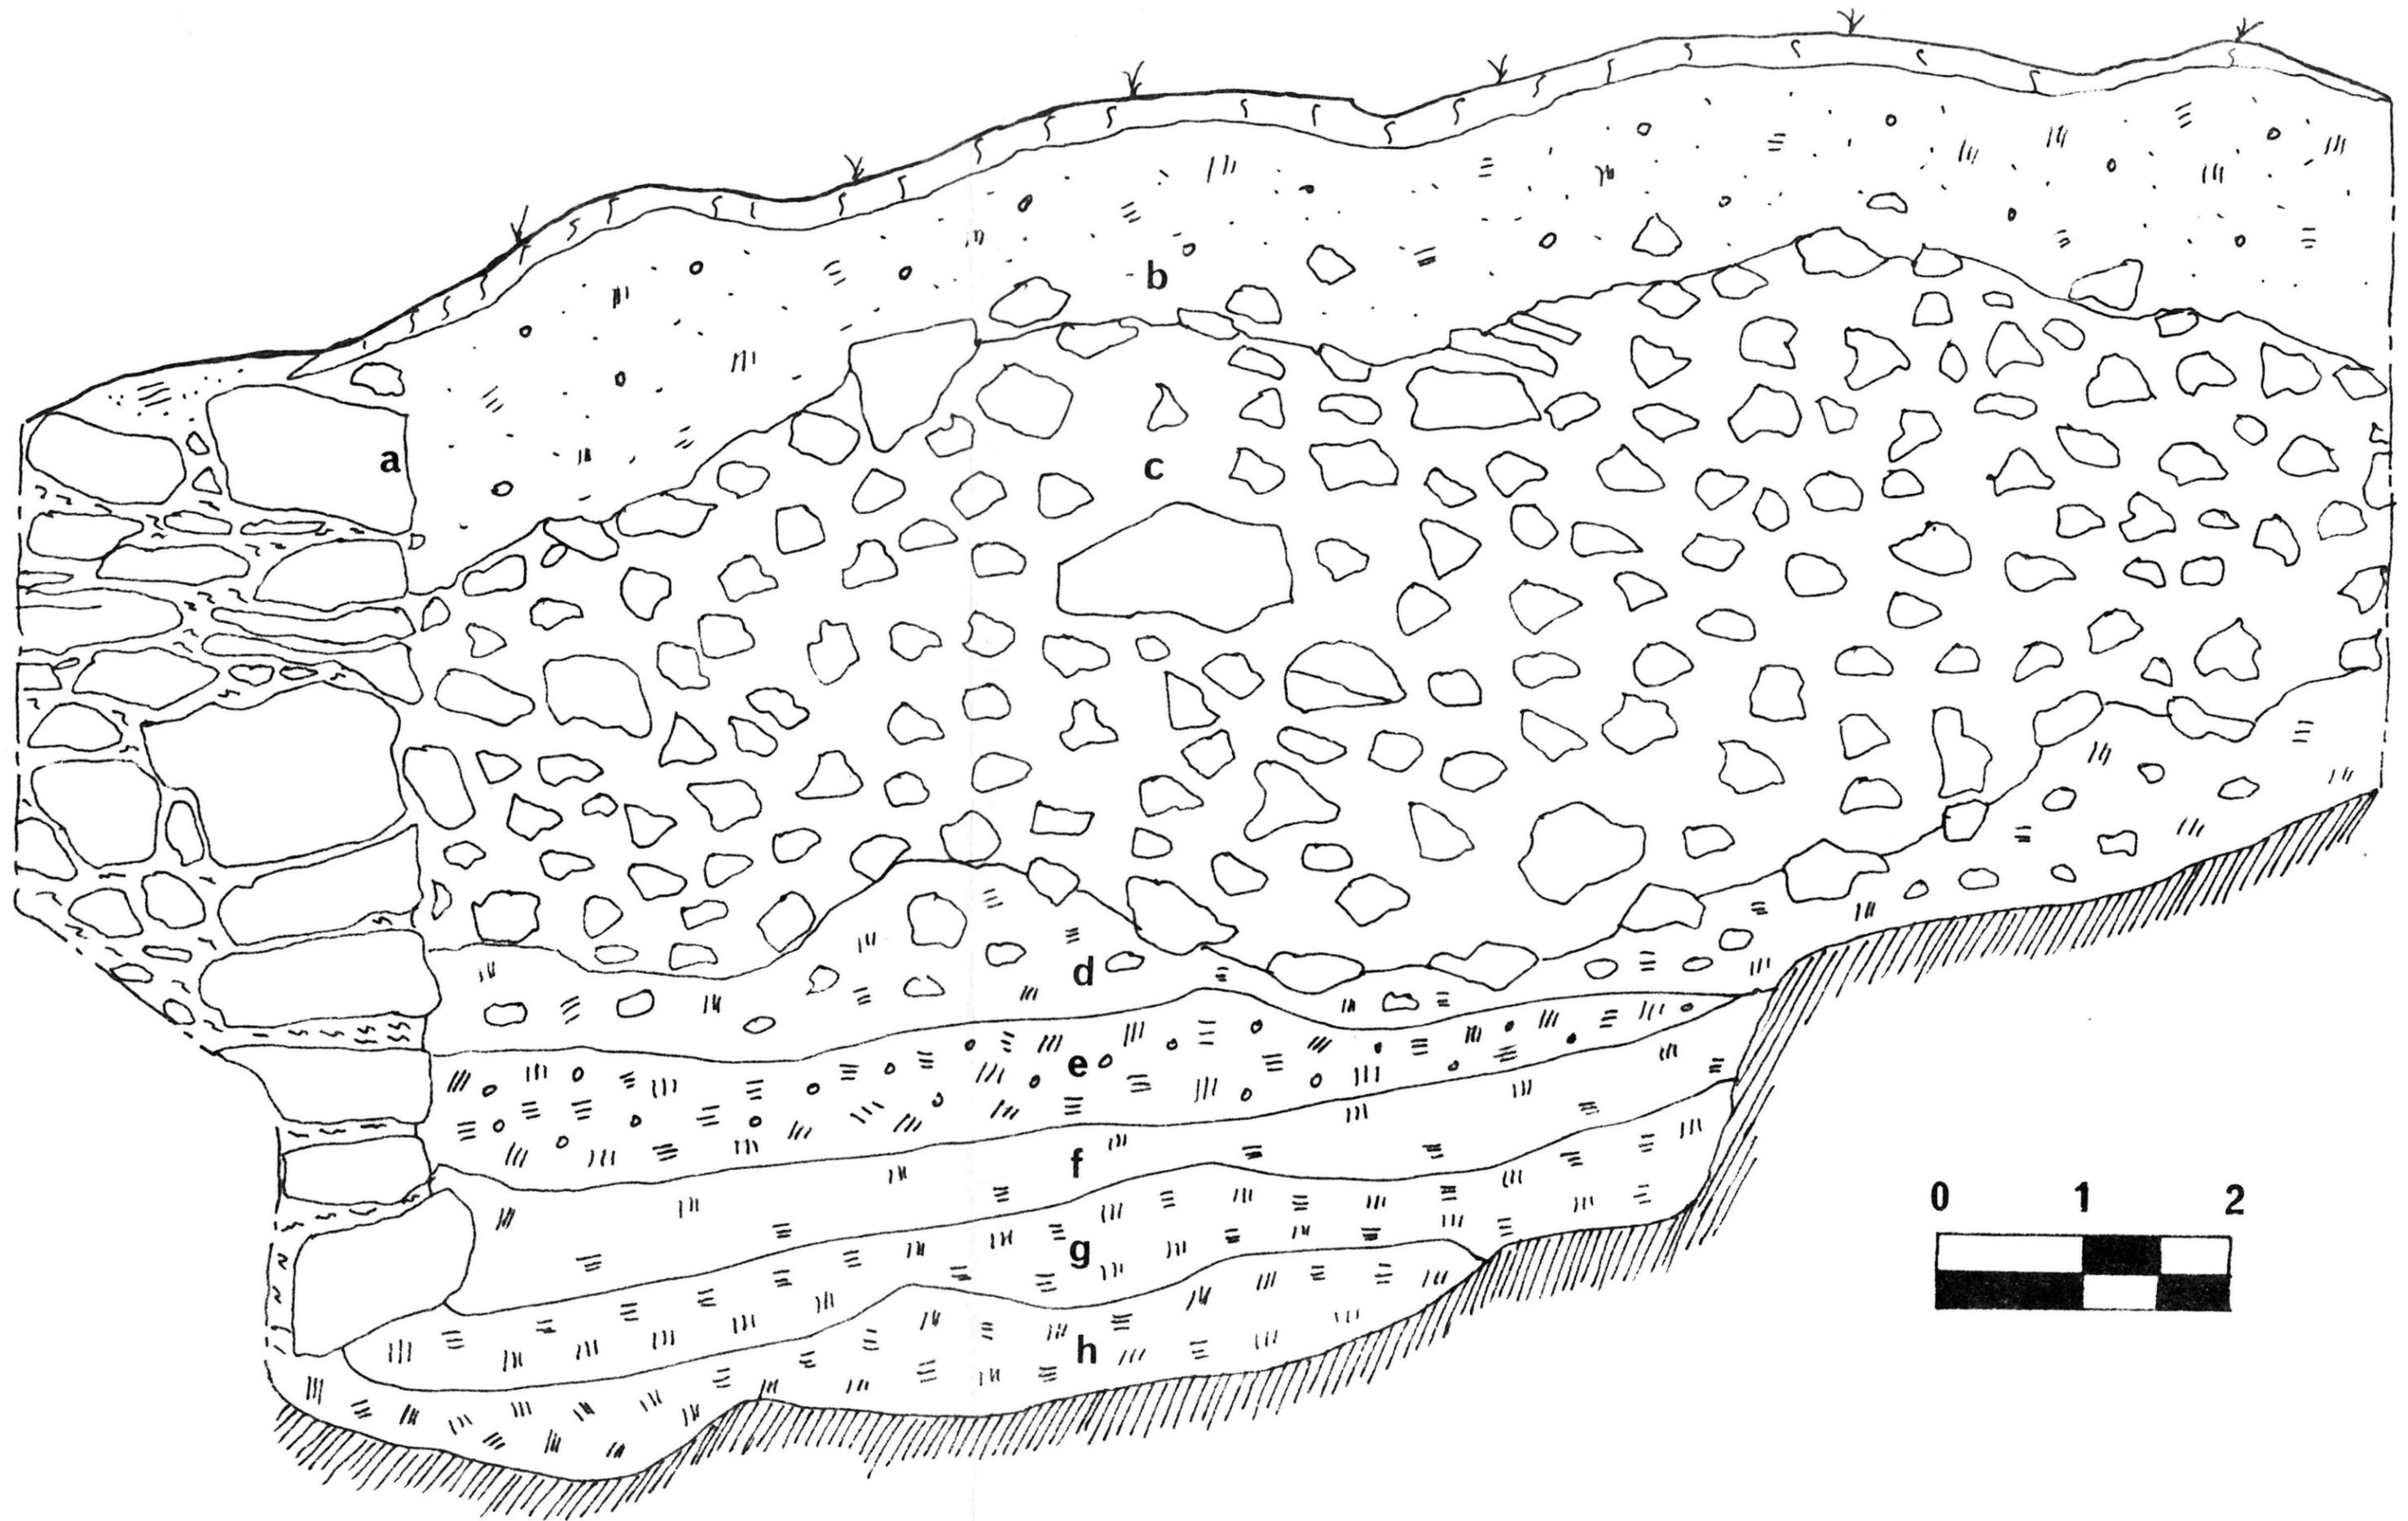
FIGURE 67

Figure 67. Sub-operation 9F, 9G. Looking toward the west at profile of rampart fill deposits.

Features shown: the interior corner of the west curtain wall at the re-entrant angle of the southwest demi-bastion (a), red brown fill (b), angular rubble (c), dark grey rubble (d), dark purple clay with little rubble (e), black clay and refuse (f), clay (g), red brown clay over bedrock (h). Scale in ft.

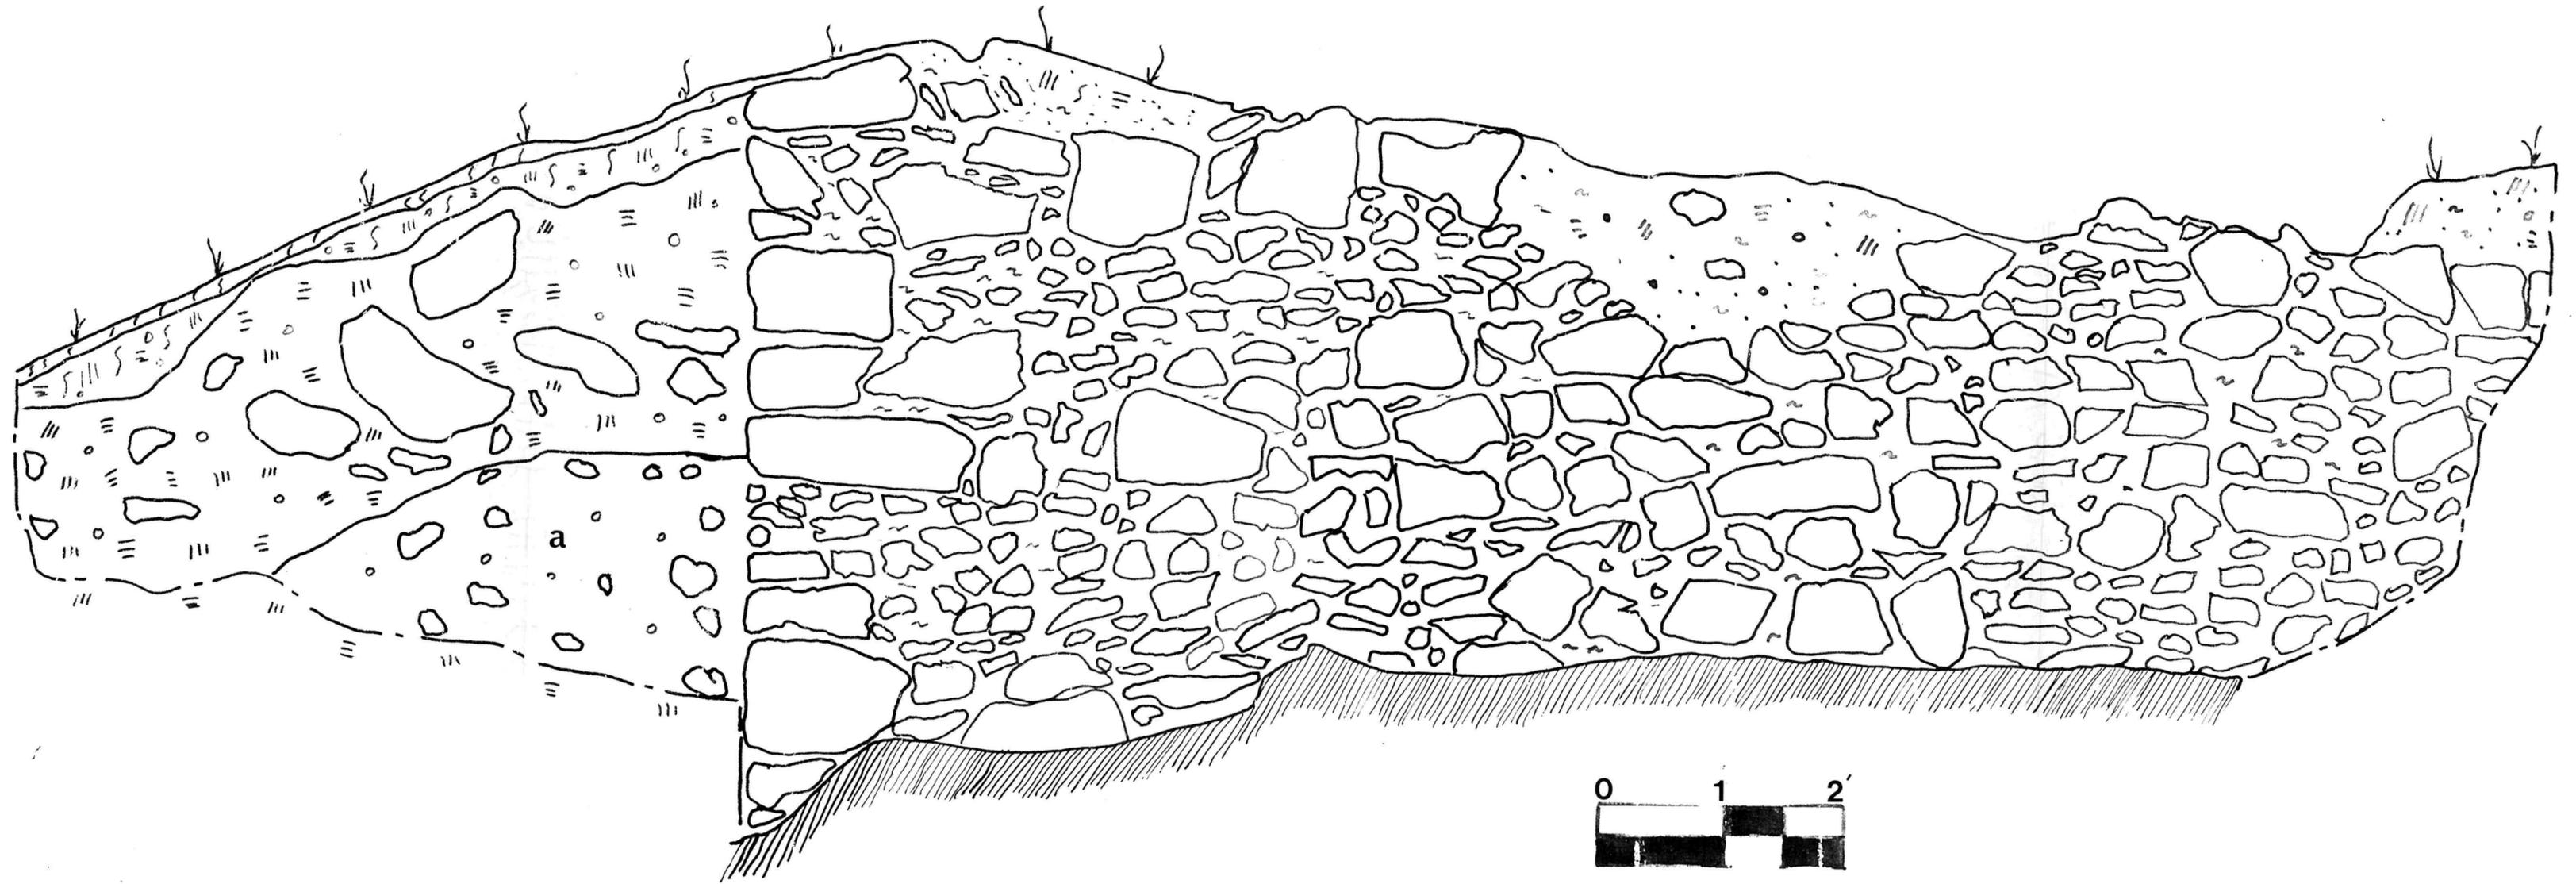
FIGURE 68

Figure 68. Sub-operation 9F and 9G. Looking east at an elevation of the exterior side of the west interior revetment wall and at rampart fill of the north gun platform shown in section on the left. Scale in ft.

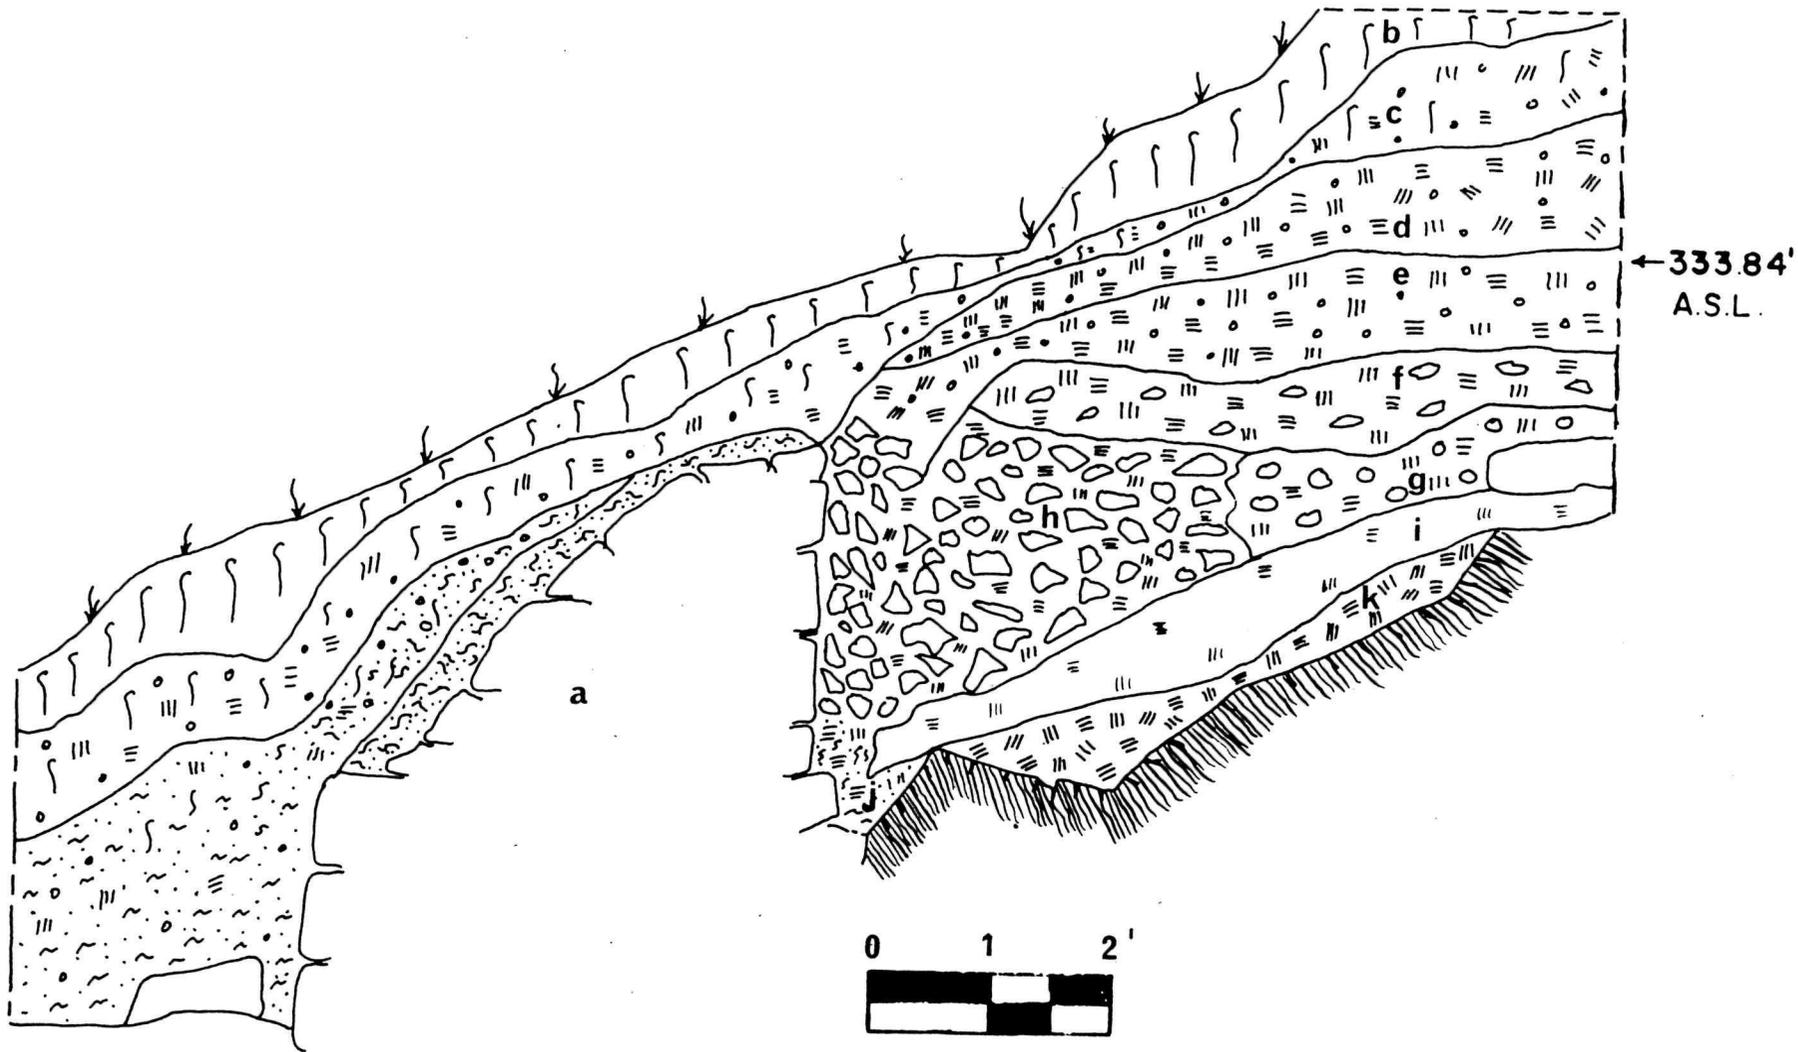
Figure 69. Sub-operation 9H. East profile showing stratigraphic deposits in rampart fill. Features shown: north curtain wall in cross-section (a), turf layer (b), 9H2 clay (c), 9H7 (d), 9H8 (e), 9H9 (f), 9H10 (g), 9H11 (h), 9H12 (i), 9H13 (j), 9H14 (k). Scale in ft.

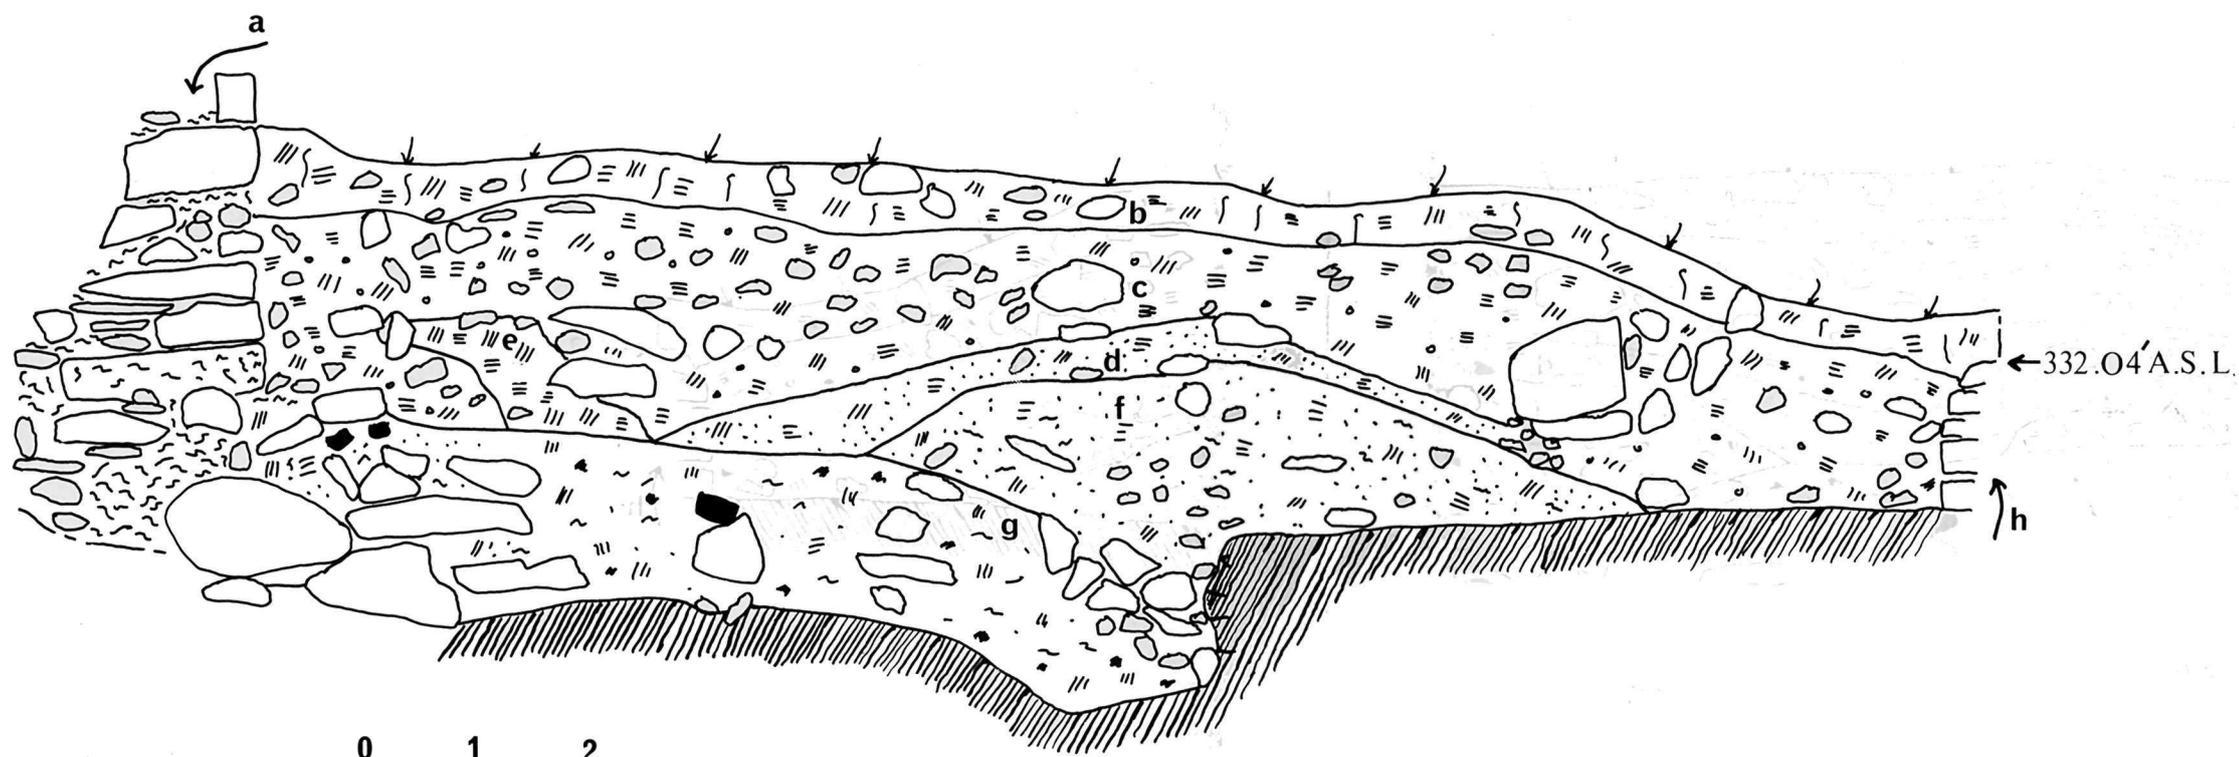
FIGURE 70

Figure 70. Sub-operation 9J. West trench profile showing stratified deposits in the north rampart fill. Features shown: corner of north interior revetment wall (a), 9J1 (b), 9J2 (c), 9J5 (d), 9J3 (e), 9J6 (f), 9J4 (g), inside line of the north curtain wall (h). Scale in ft.

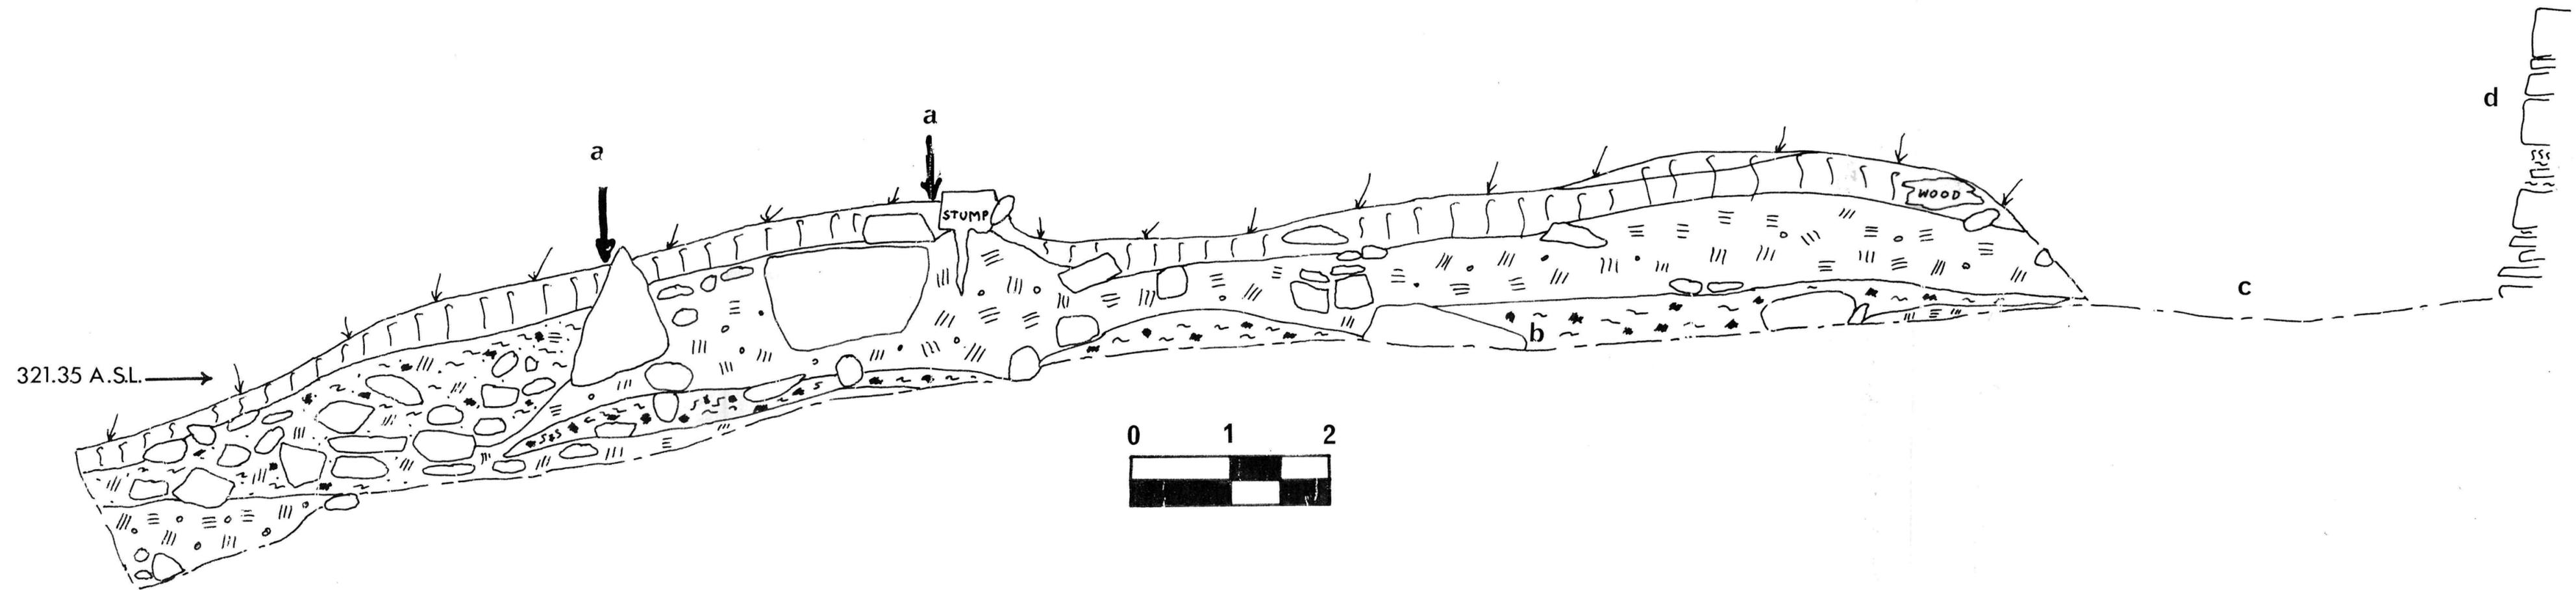
FIGURE 71

Figure 71. Operation 12. South trench wall profile showing stratigraphy. Features shown: area of stone wall visible on the surface (a-a), refuse layer beneath wall (b). Scale in ft.

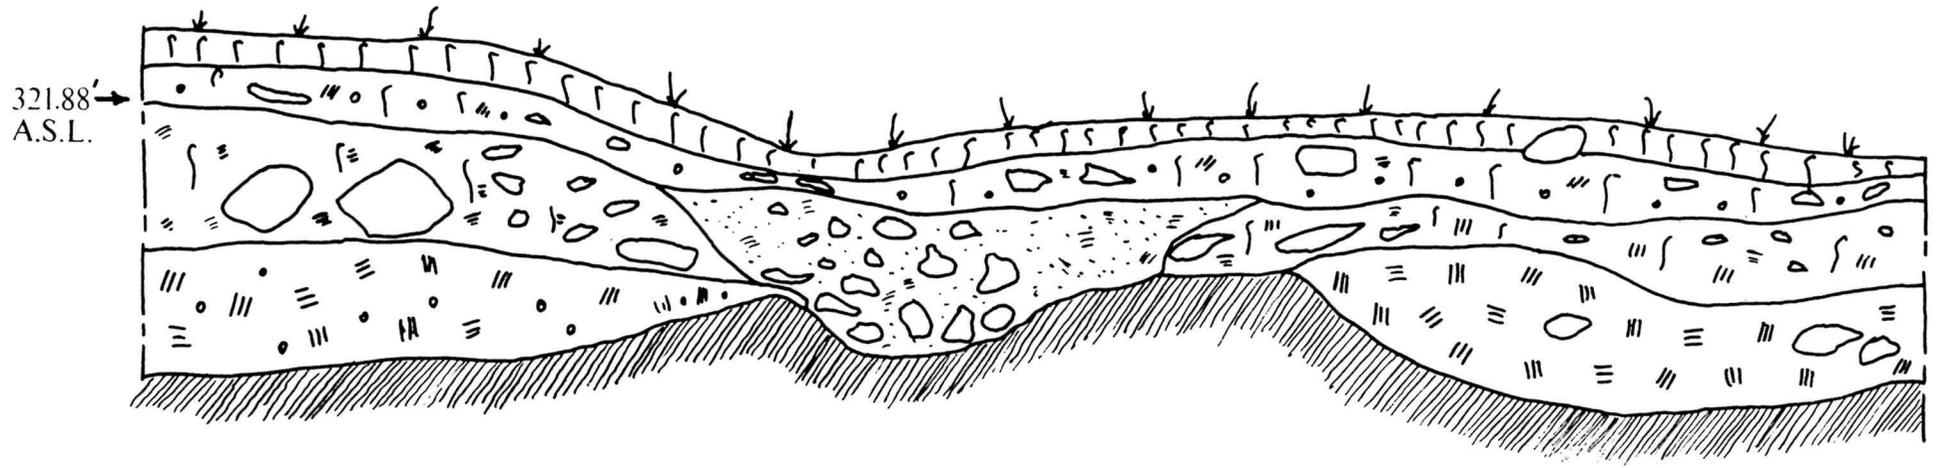
Figure 72. Operation 13. West trench profile.
Scale in ft.

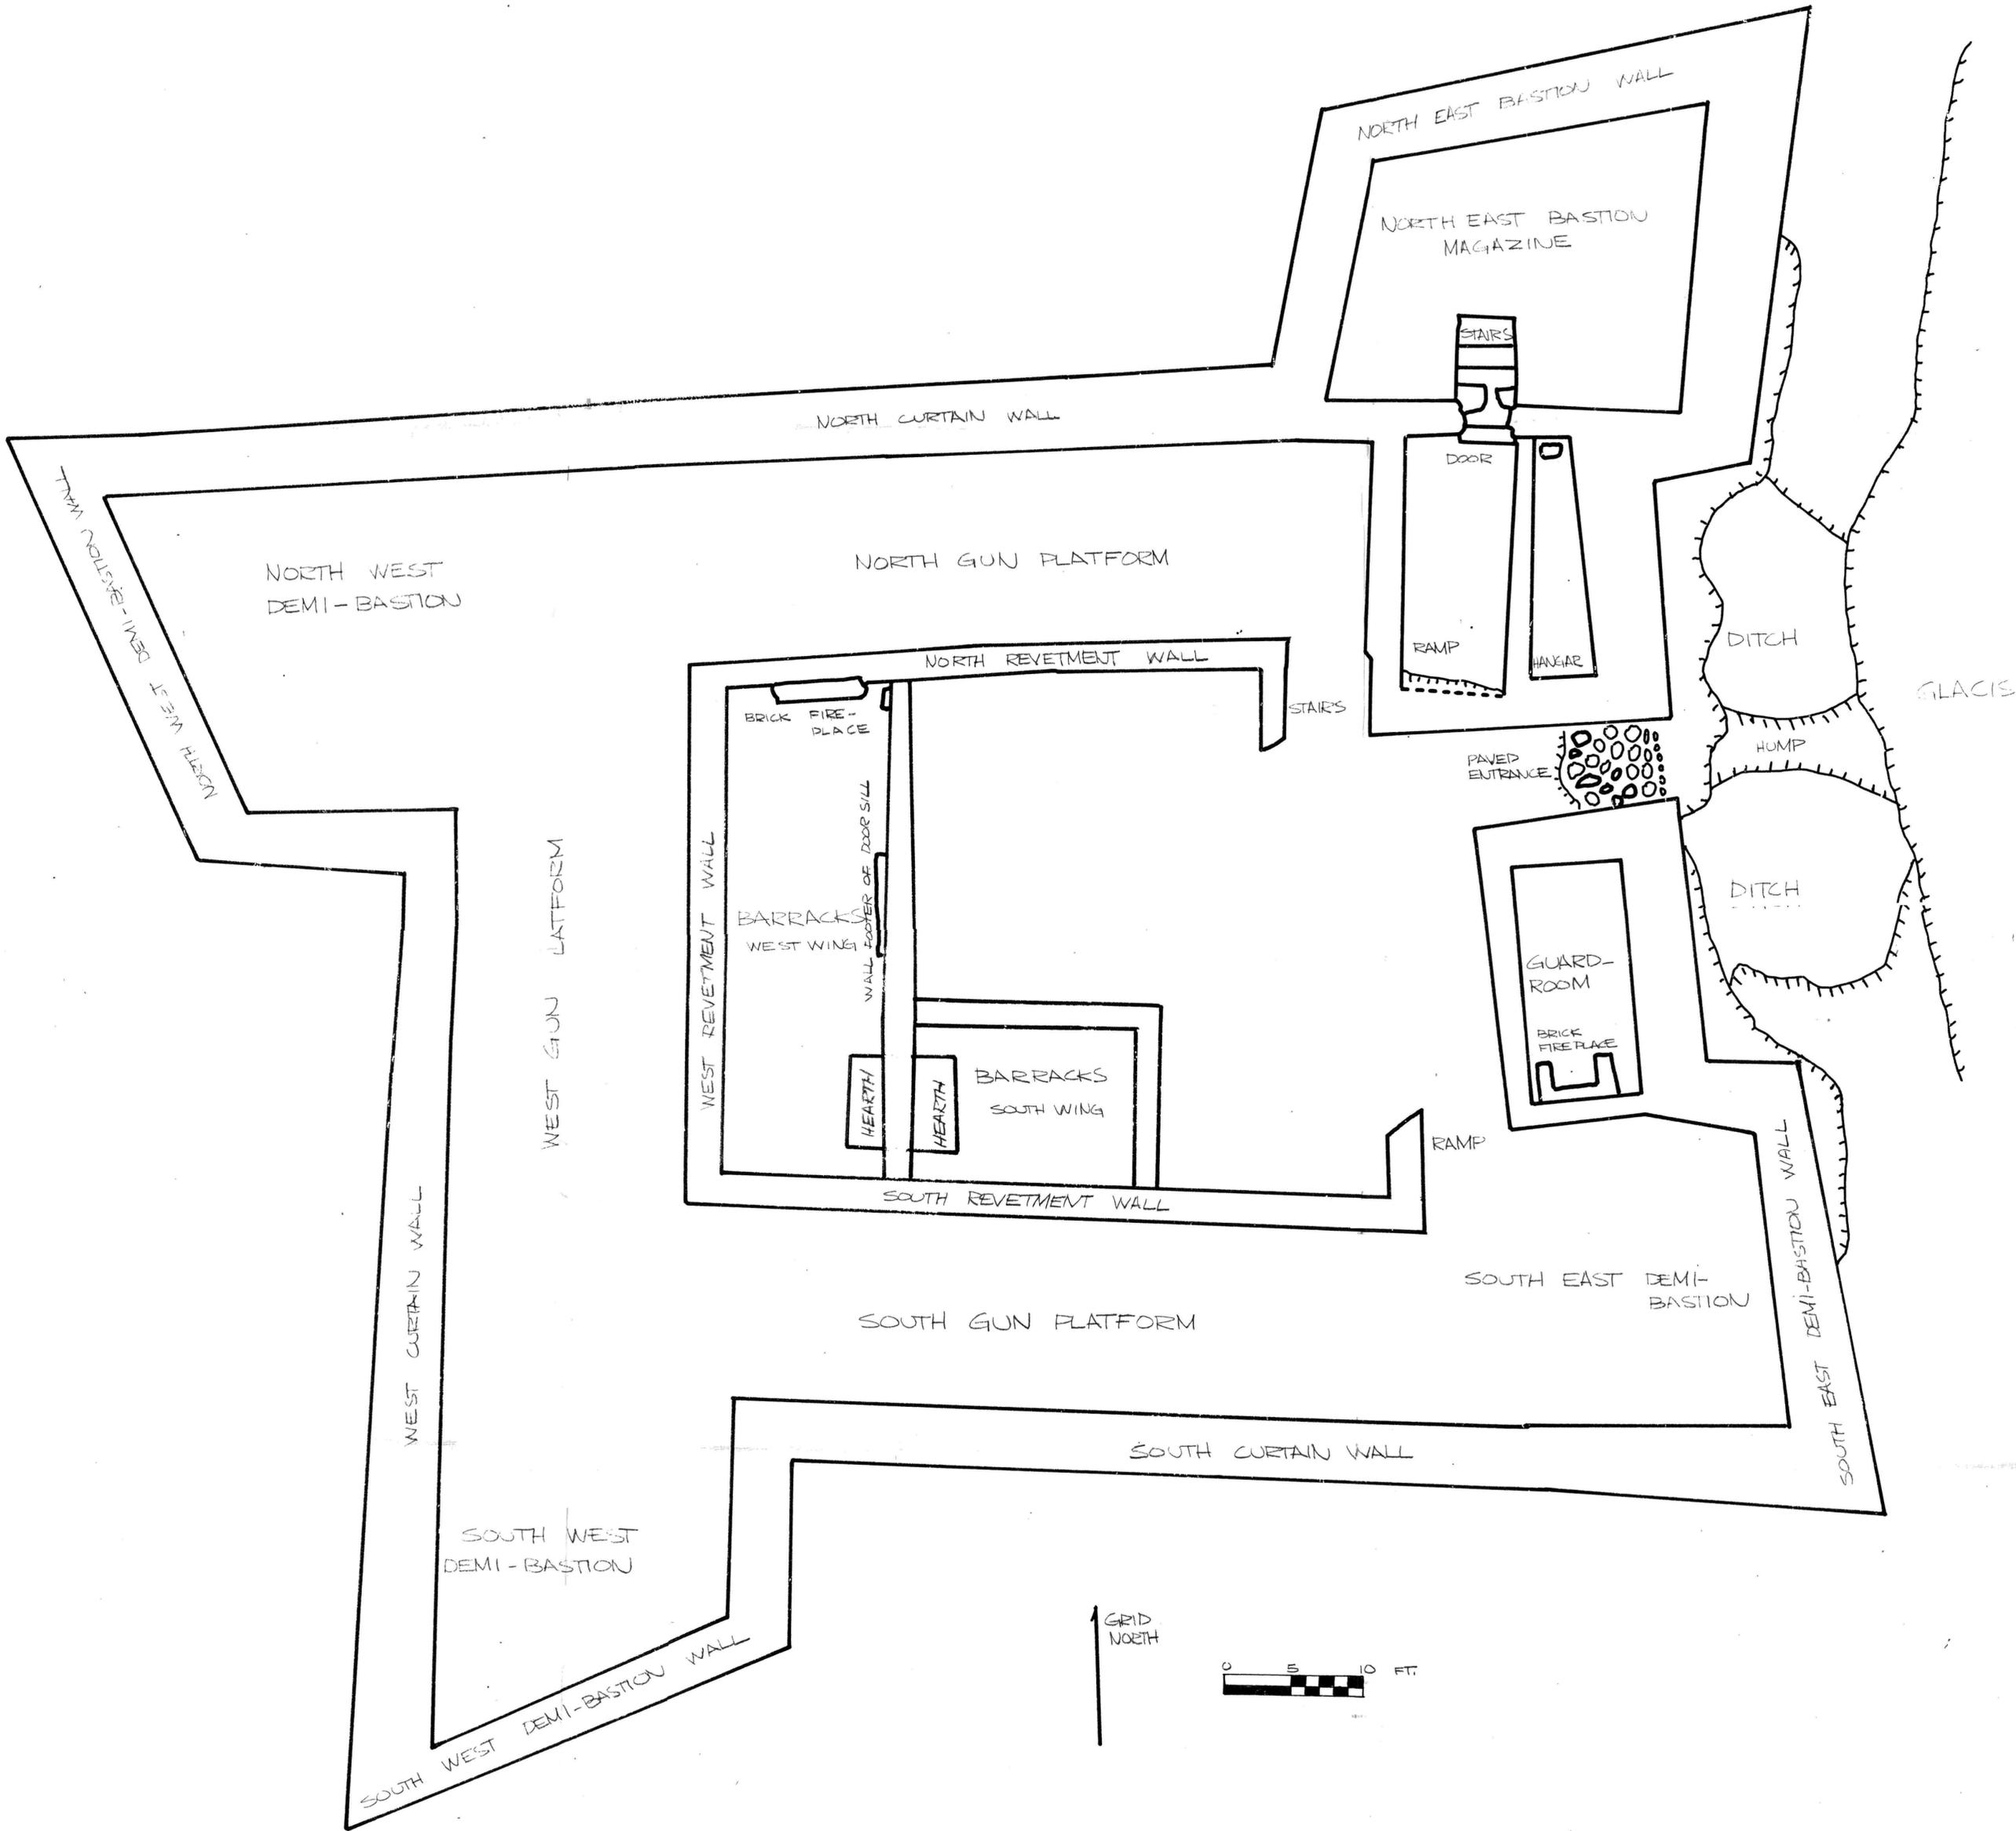
FIGURE 73

Figure 73. Plan of excavations showing features identified as French period structures. Scale in ft.
