NATIONAL HISTORIC SITES SERVICE

MANUSCRIPT REPORT NUMBER 46

EXCAVATIONS AT CASTLE HILL

September 1971

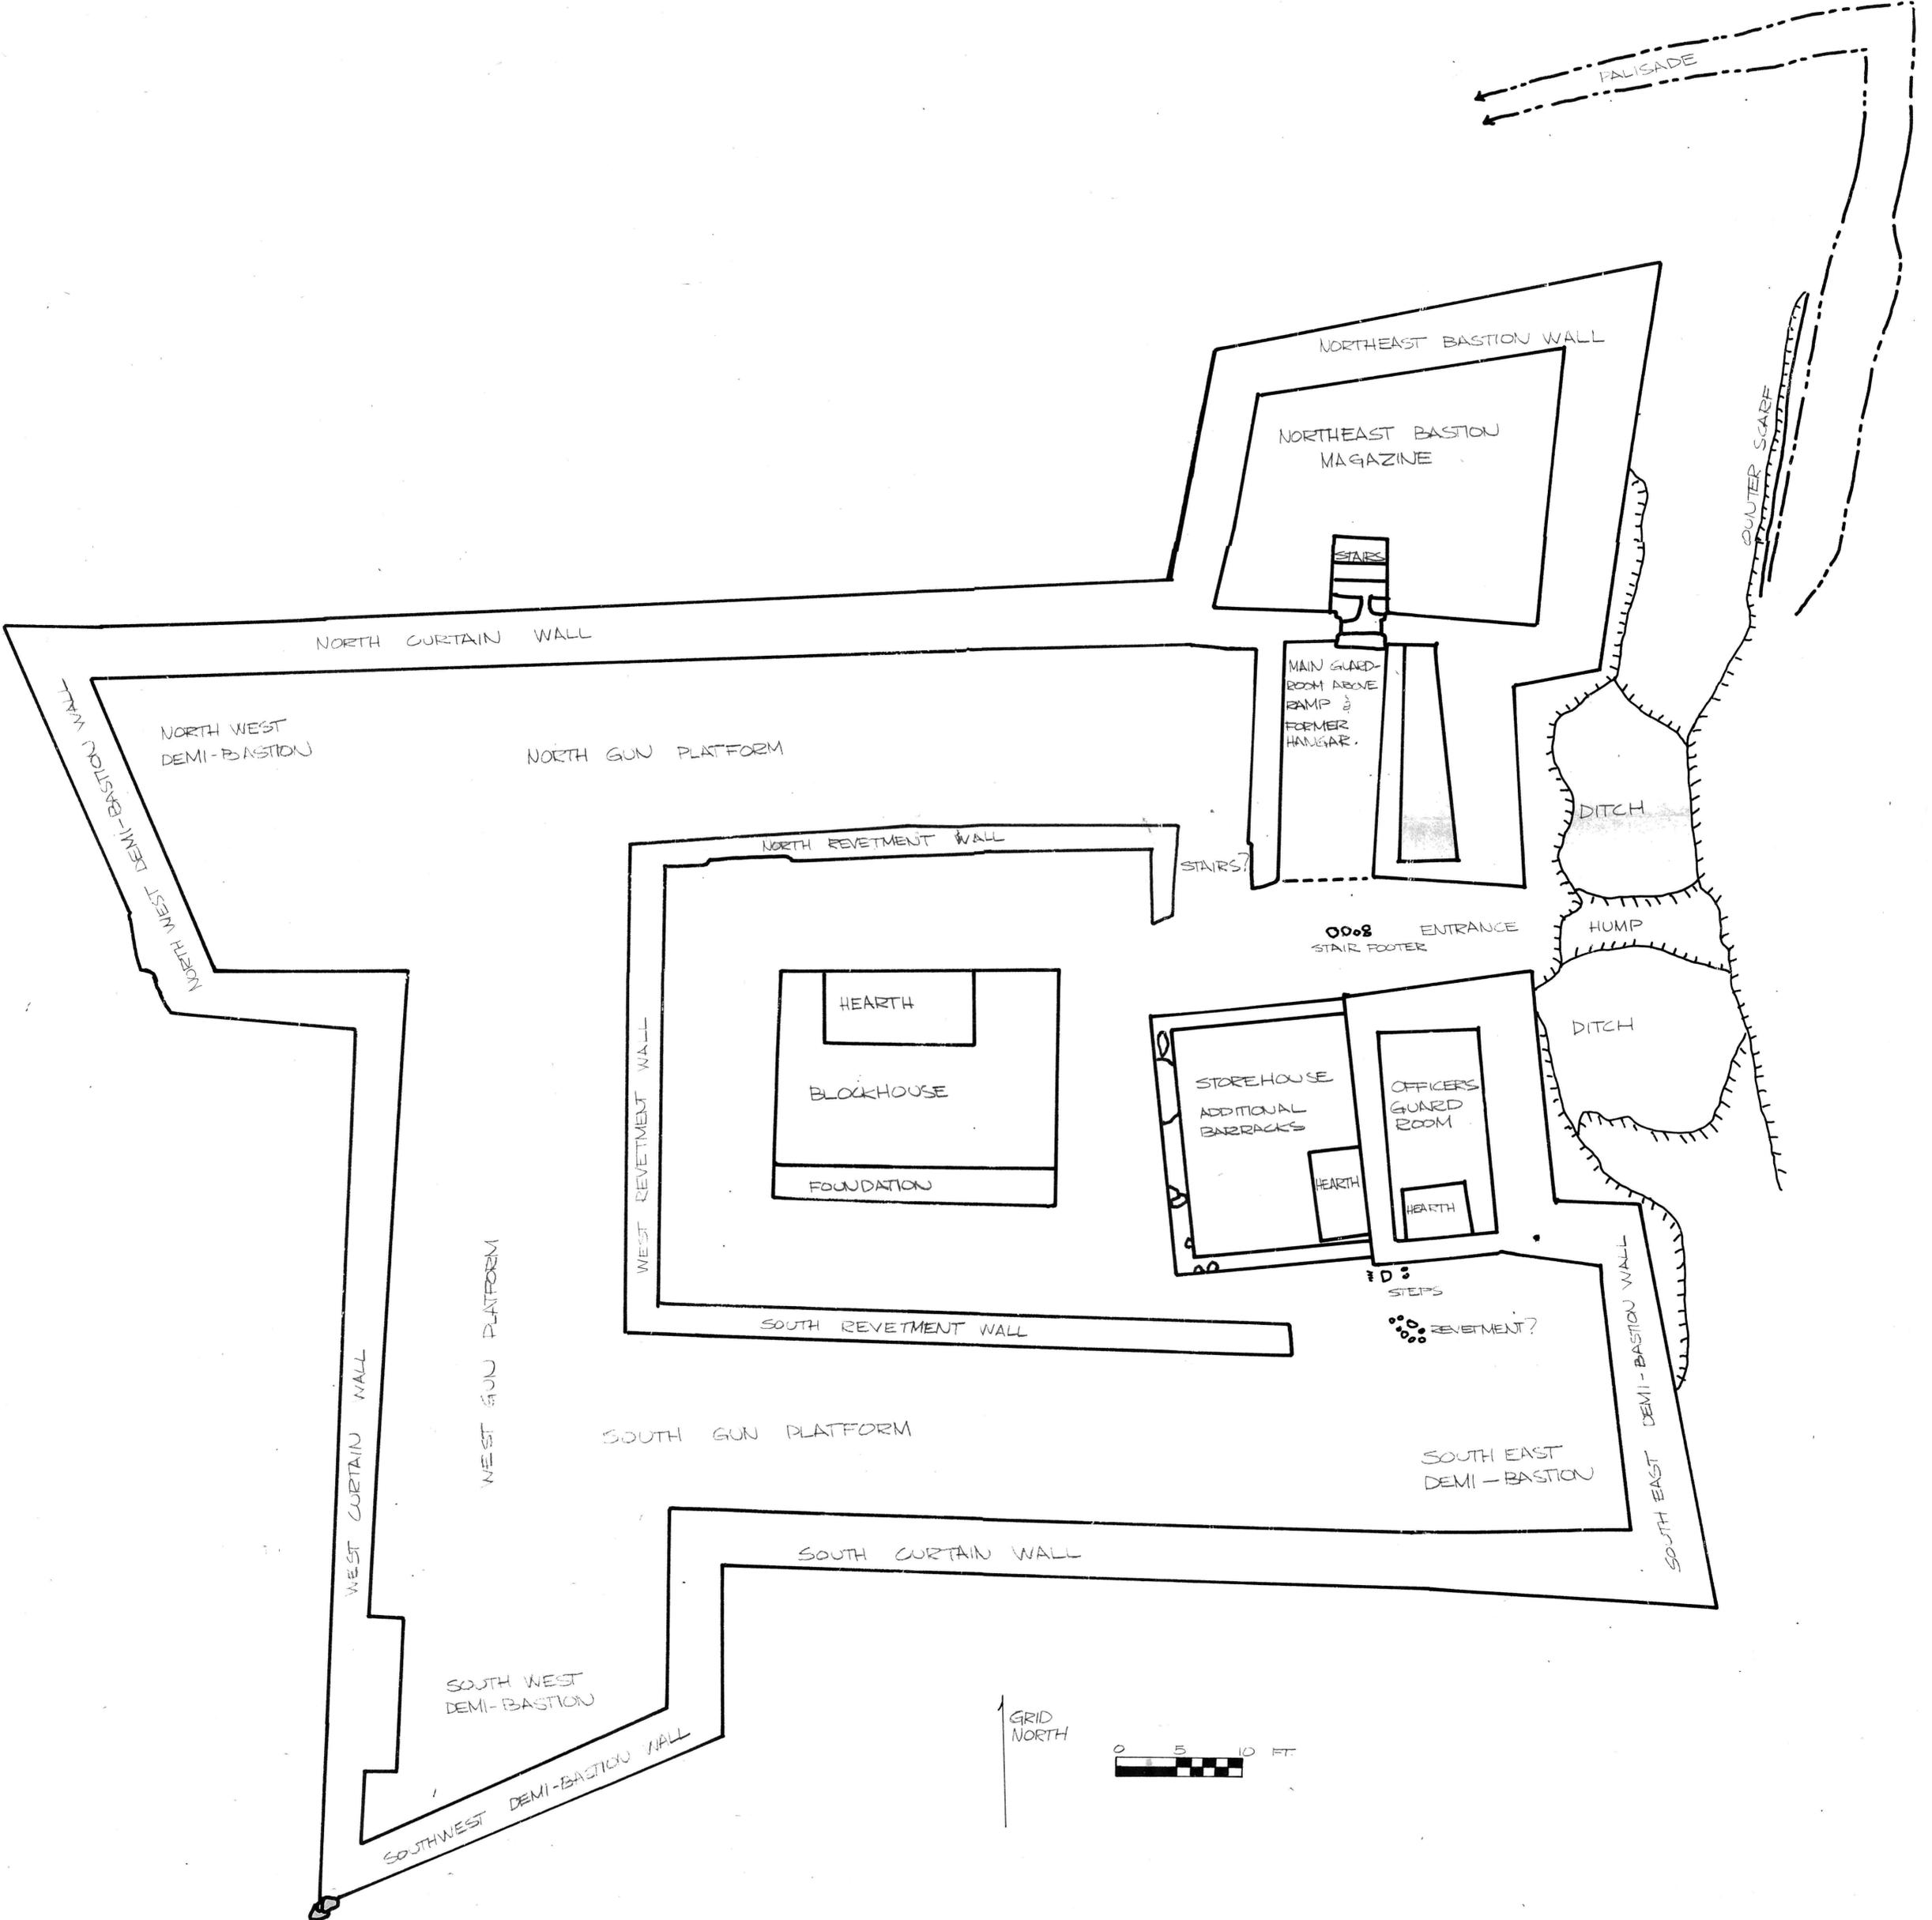
FIGURE 74

Figure 74. Plan of the excavations showing
features identified as English period structures.
Scale in ft.
